Report of
**Preliminary Investigation for
Determination of an Area in Need of Redevelopment**

Block 825, Lots: 53, 54, 55, 56, 57, 58, 59, 60, 61, 62, 63, 64, 65, 66, 67, 68, 69.01, 70, 72, 73, 74, 75, 76, 77, 78, 79, 80, and 81 (Mountain Hill), Block 638, Lot 31.01, Block 870, Lot 1 and 2, Block 871, Lot 3 and 7.02

DMR Architects
Francis Reiner, LLA - PP
License #: LI00616700

Township of Middletown
Monmouth County, New Jersey
December, 2017

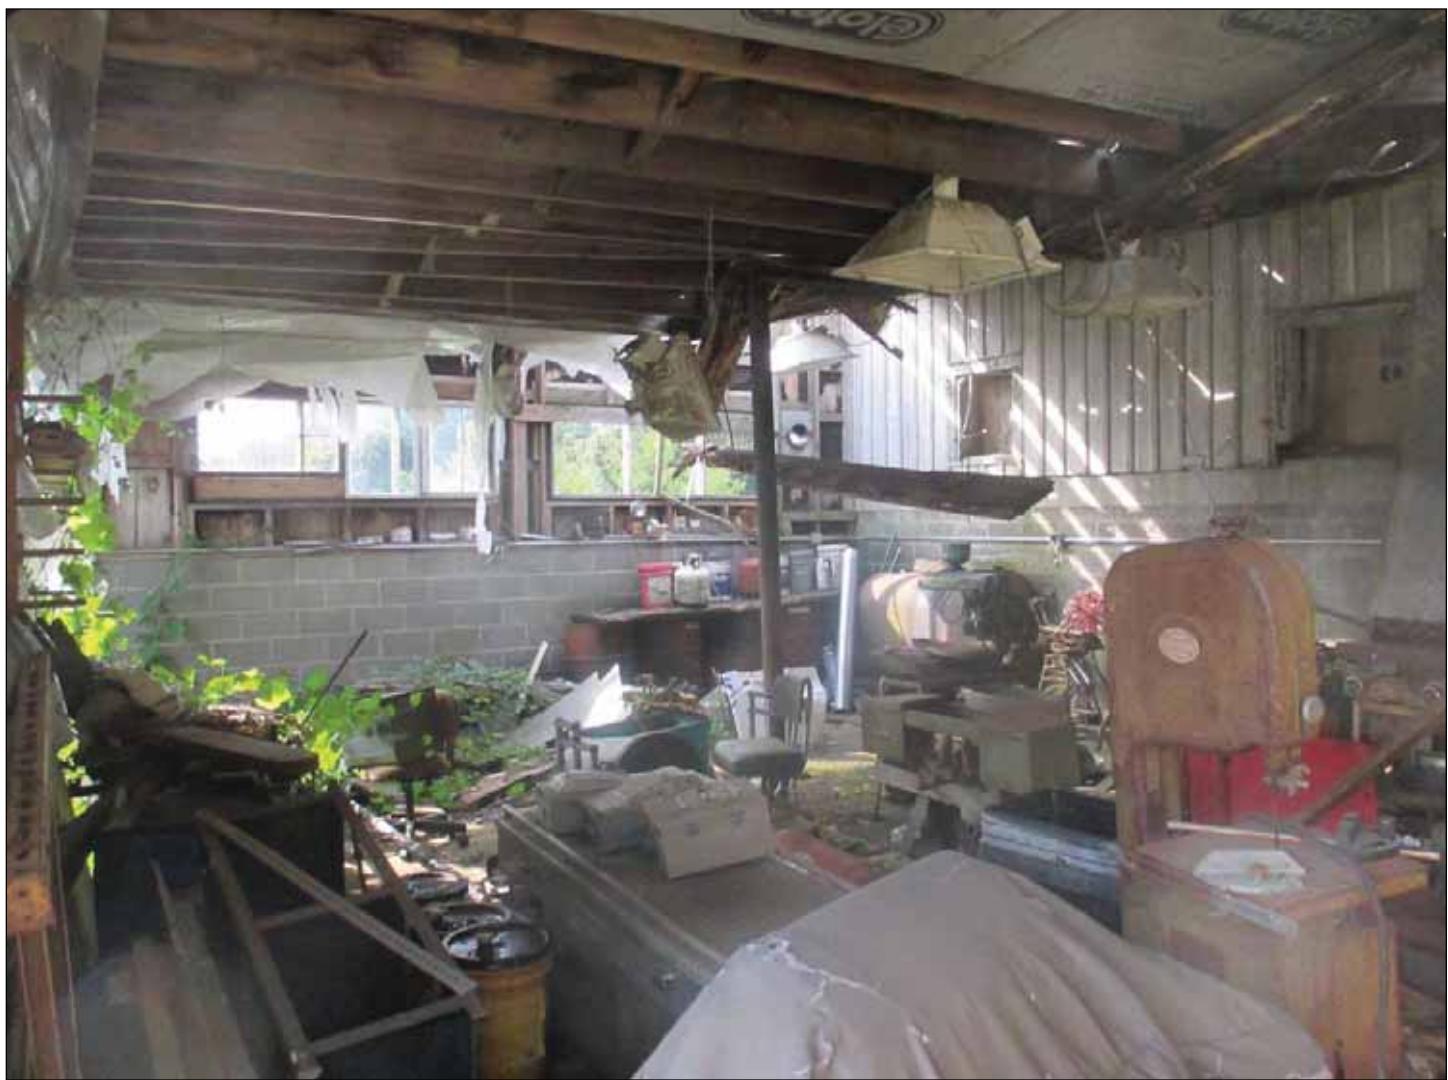
Image 1: Collapsing roof of barn structure side.

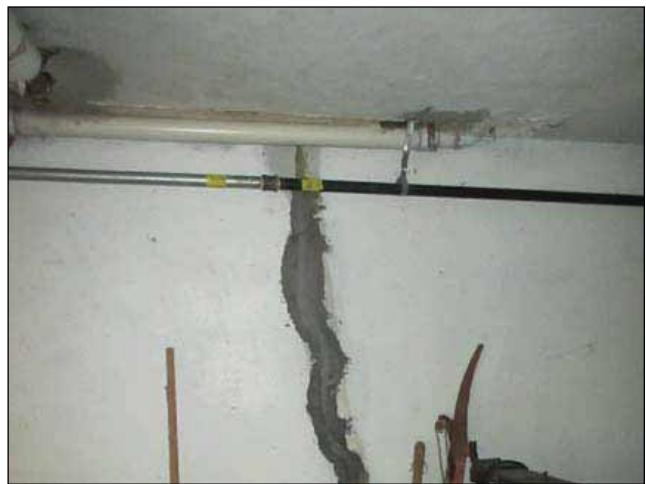
Image 3: Basement with cracking in exterior wall.

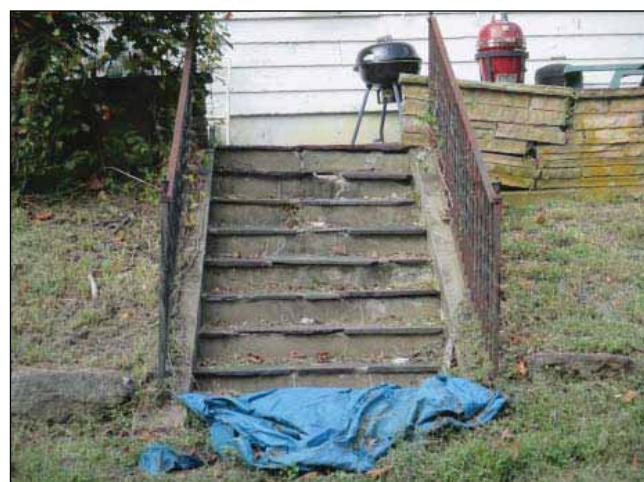
Image 15: Rear steps and retaining wall collapse

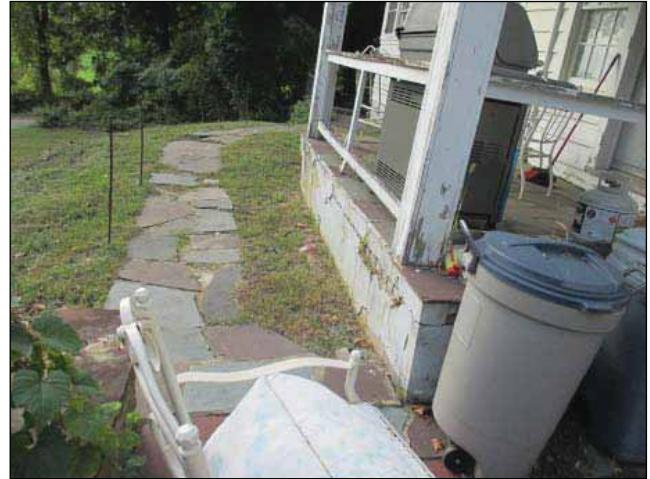
Image 17: Rear porch with damage.

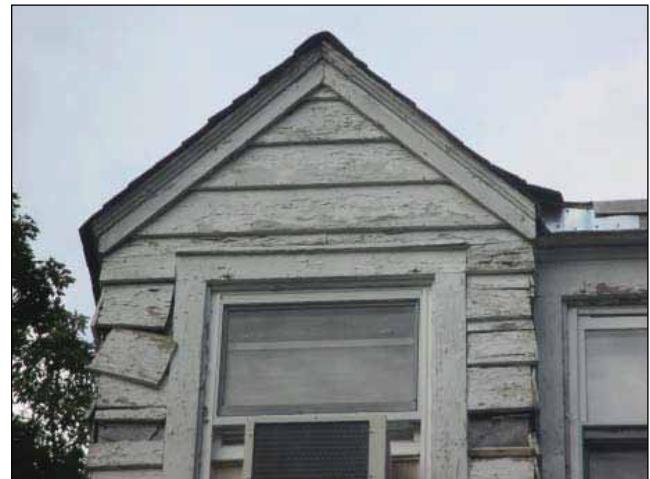
Image 19: Boards falling off and missing from rear eave.

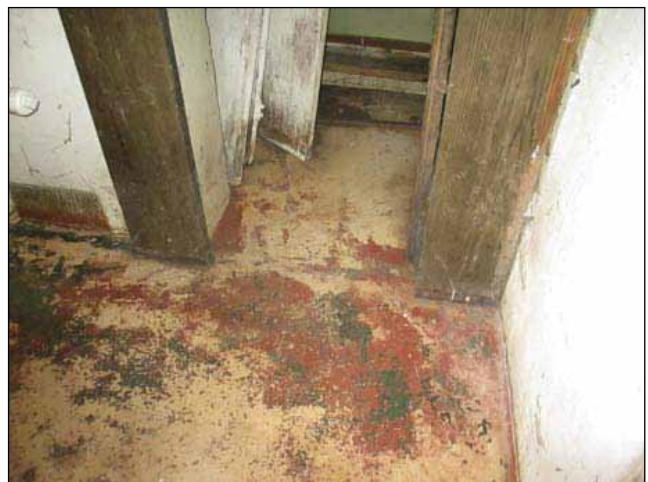
Image 23: Basement floor with water damage.

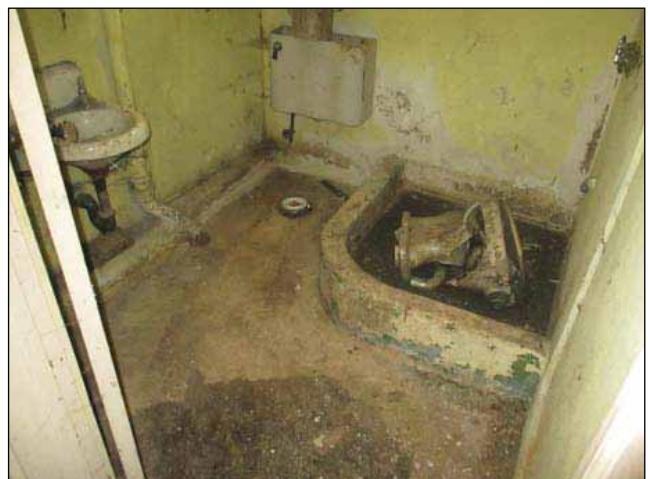
Image 25: Basement floor with water damage.

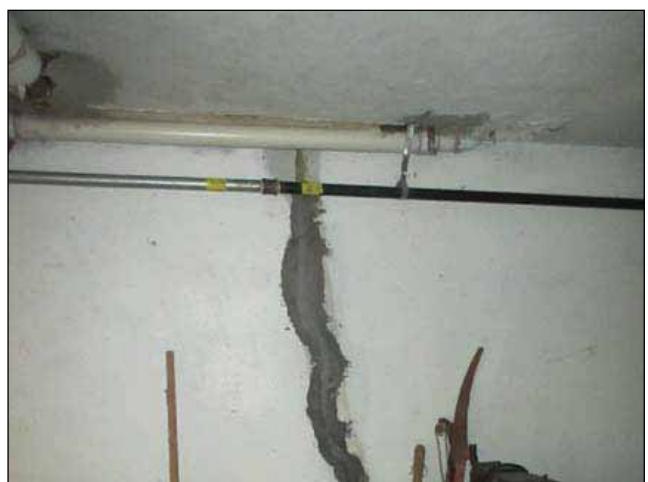
Image 27: Basement with cracking in exterior wall.

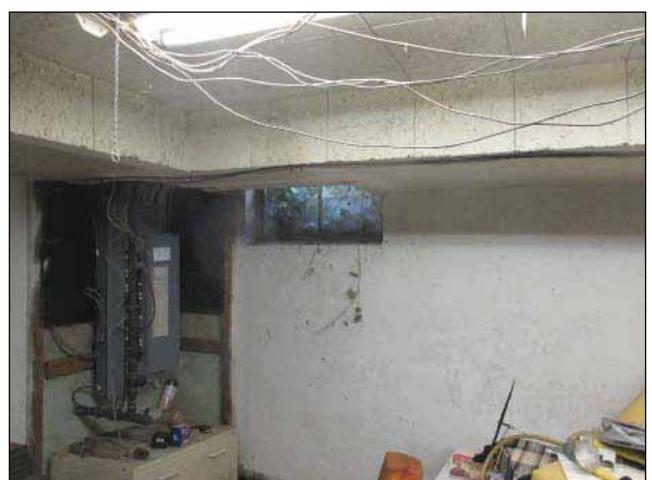
Image 31: Basement with vegetation growing in.

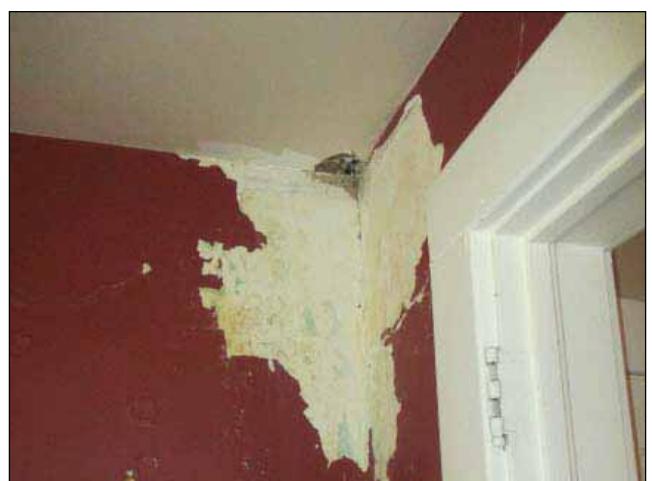
Image 33: Cracking in main house with water damage.

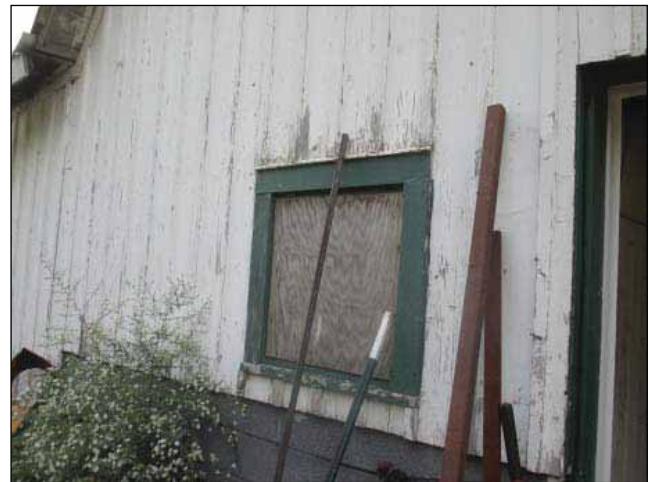
Image 41: Deterioration of side of barn structure.

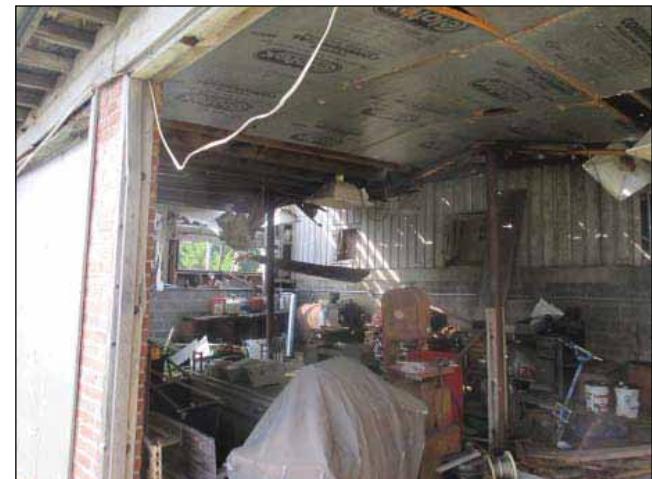
Image 43: Collapsing roof of barn structure side.

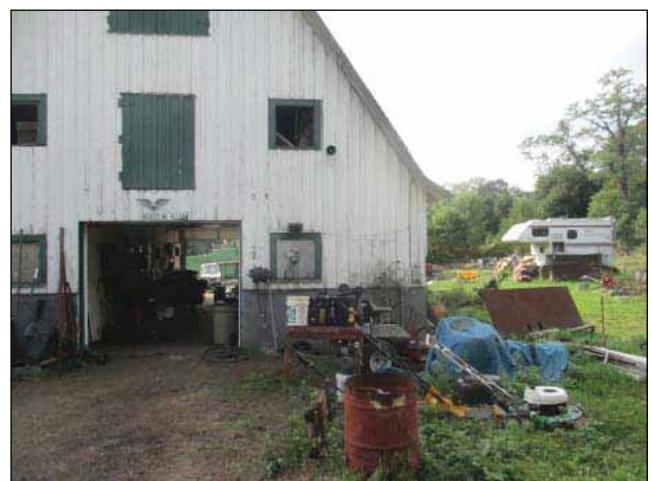
Image 45: Debris, vehicles, rusting parts adjacent to the barn structure.

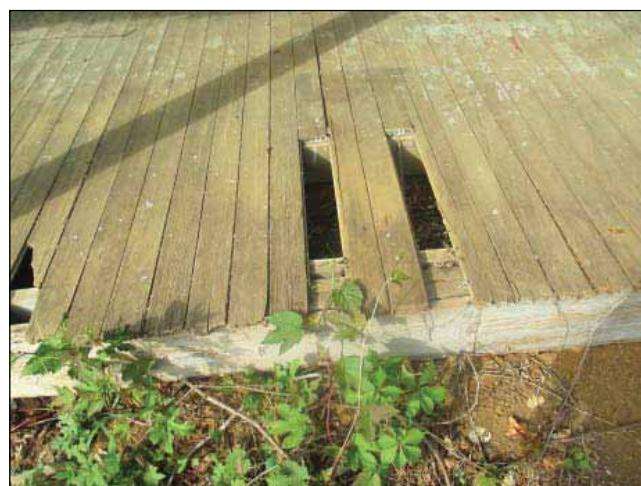
Image 53: Slats of cabin porch missing / broken.

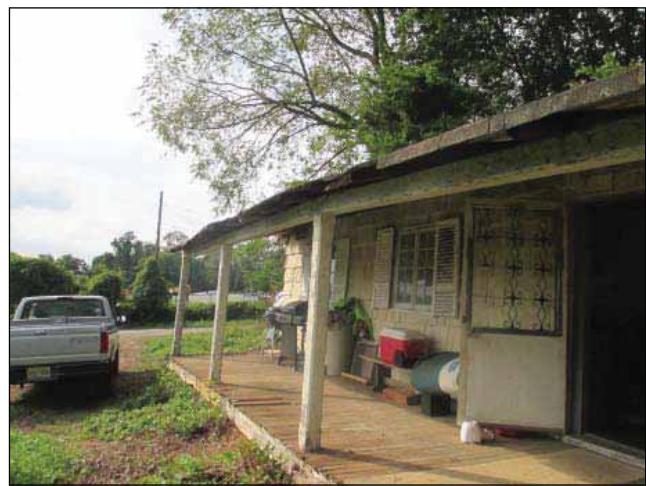
Image 55: Front porch area with pillars leaning.

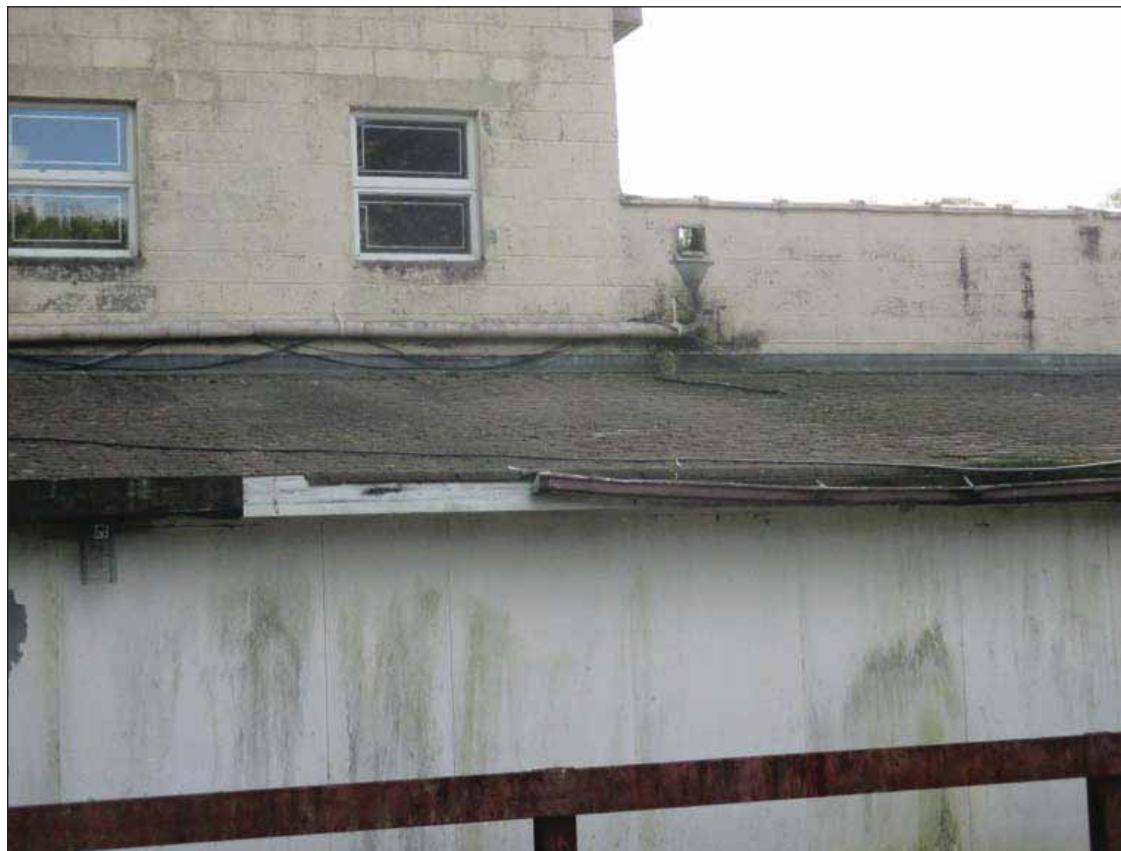
Image 1: Side elevation with significant damage to the roof.

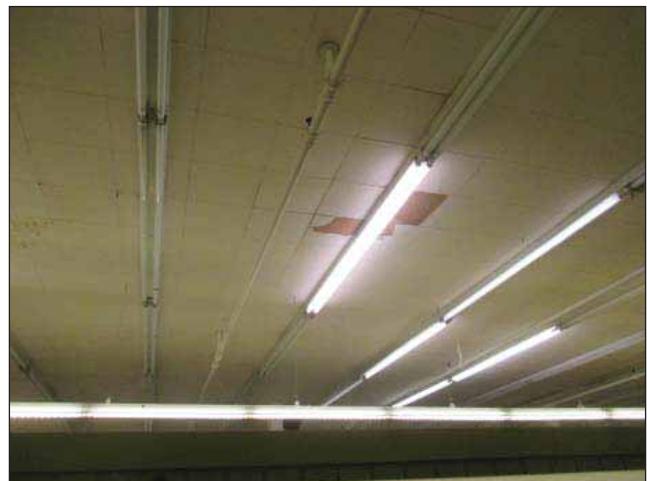
Image 3: Damage on ceiling tiles in the retail area

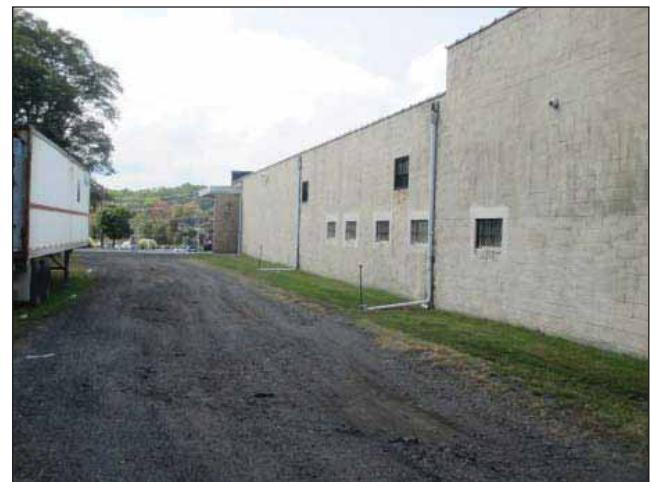
Image 21: Side elevation.

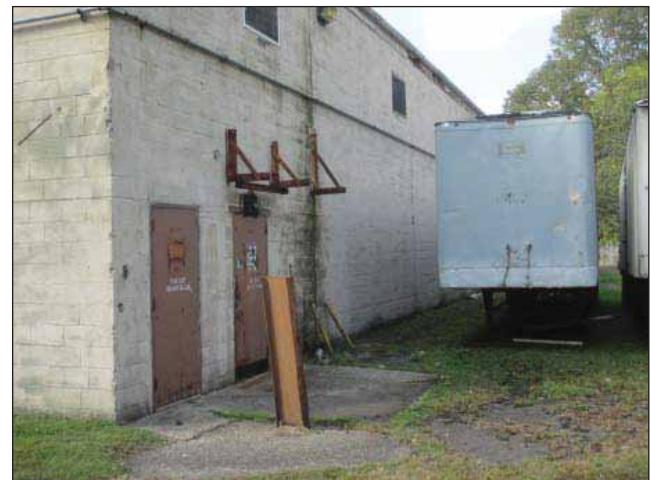
Image 23: Rear elevation with water damage along drain pipe.

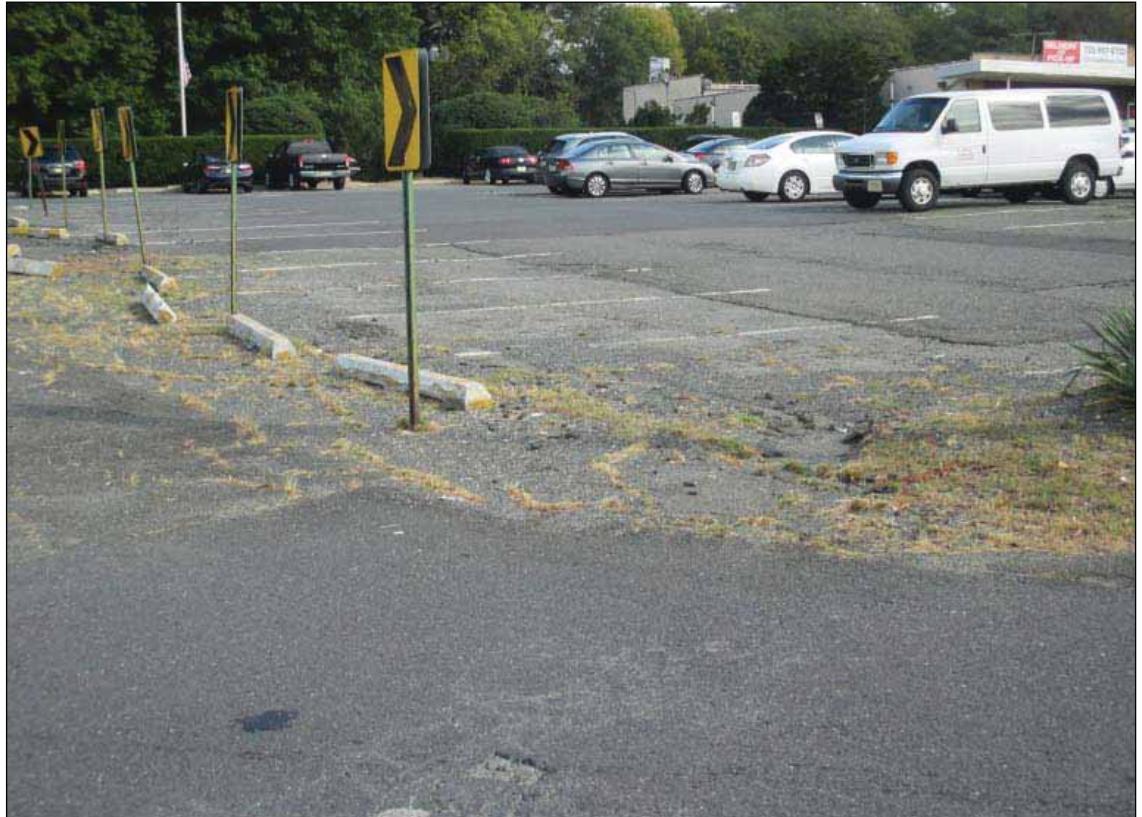
Image 1: Erosion of existing parking area depicting run-off damage toward Route 35.

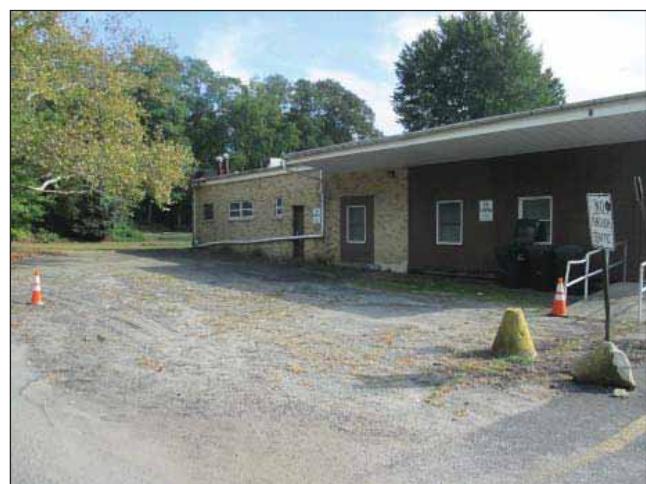
Image 9: Side view of building with asphalt and gravel depicting erosion caused by storm water run off along Kings Highway East.

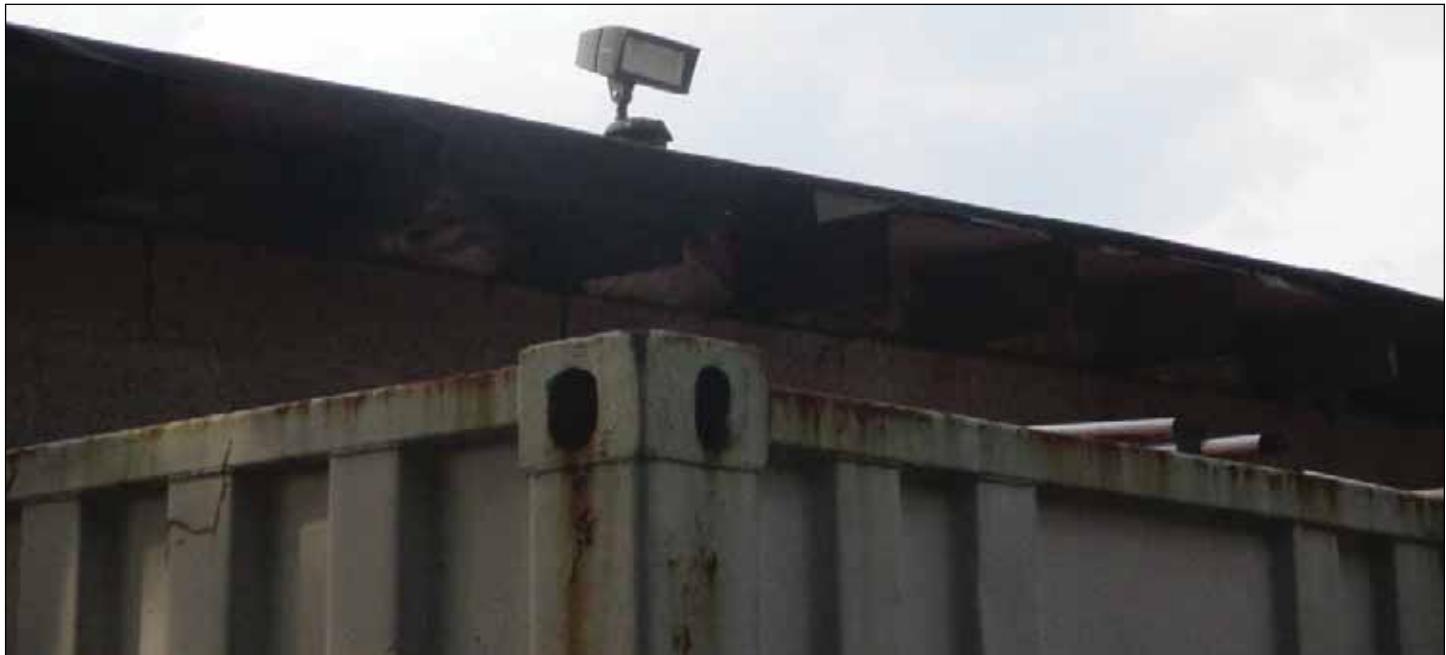
Image 1: Exposed insulation, water damage to beams and concrete with rusting

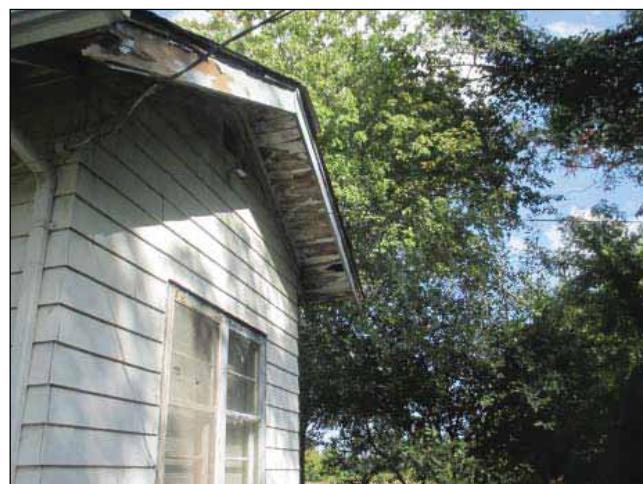
Image 5: Degraded roof beams.

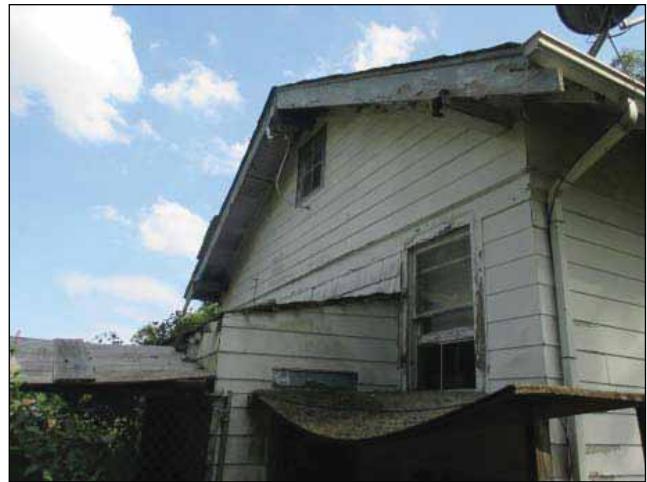
Image 7: Collapsing rear room with damage to roof beams.

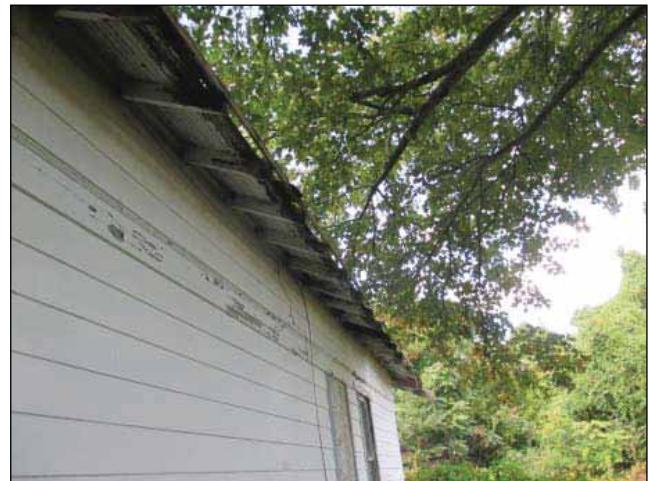
Image 9: Roof completely deteriorated at rear of house.

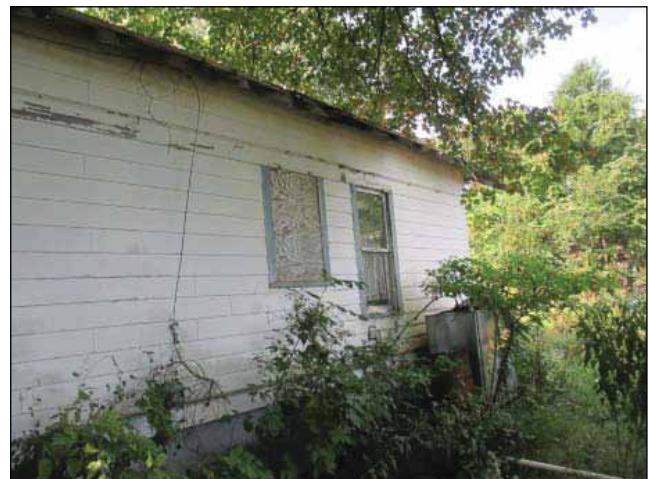
Image 11: Roof completely deteriorated at rear of house with window boarded up.

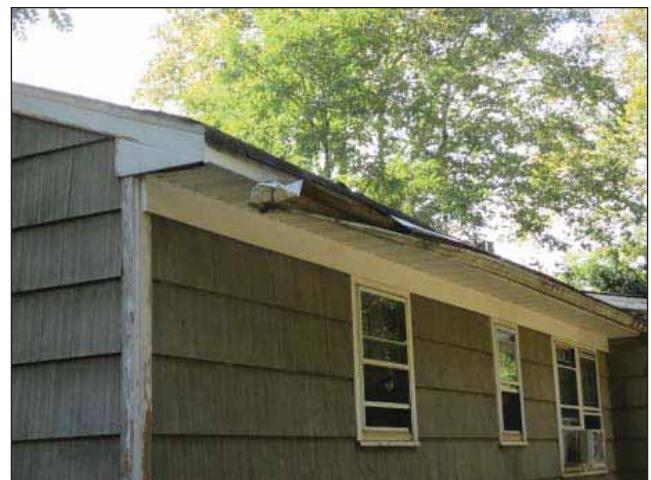
Image 6: Significant damage / rotting to the existing roof and gutters.

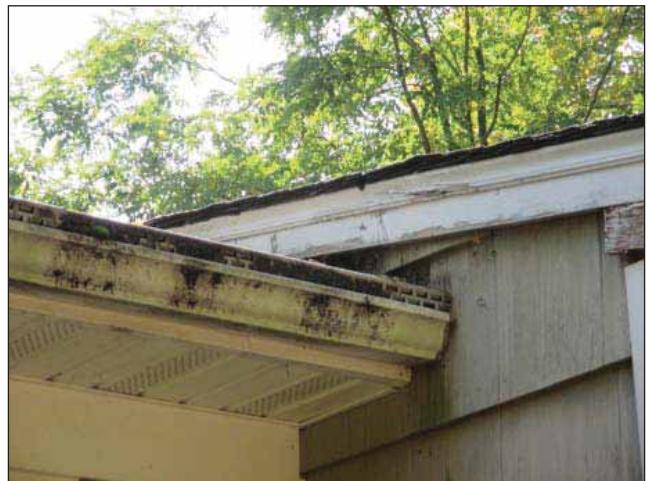
Image 8: Rotting and decay along roof line convergence.

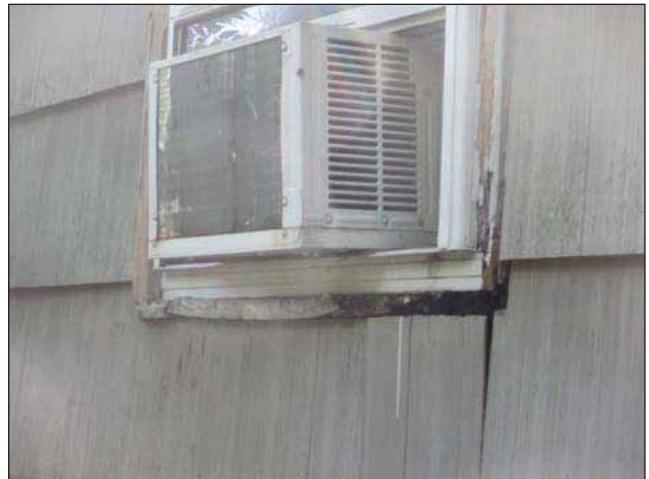
Image 16: Rotting wood framing around air conditioning unit.

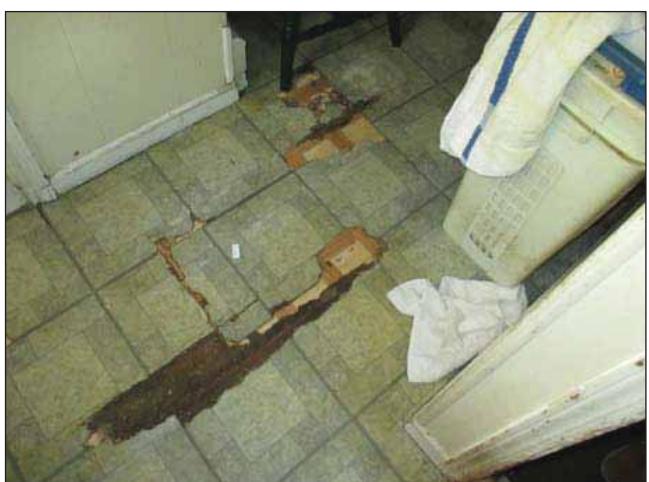
Image 18: Water damage in back entry.

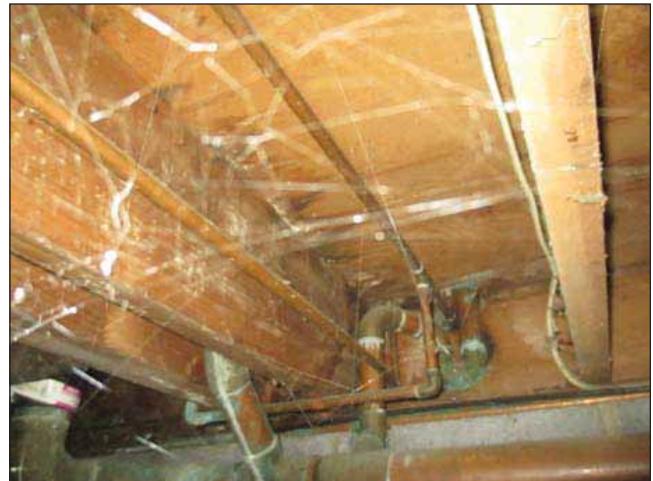
Image 20: Basement with discoloration of wood indicating water damage.

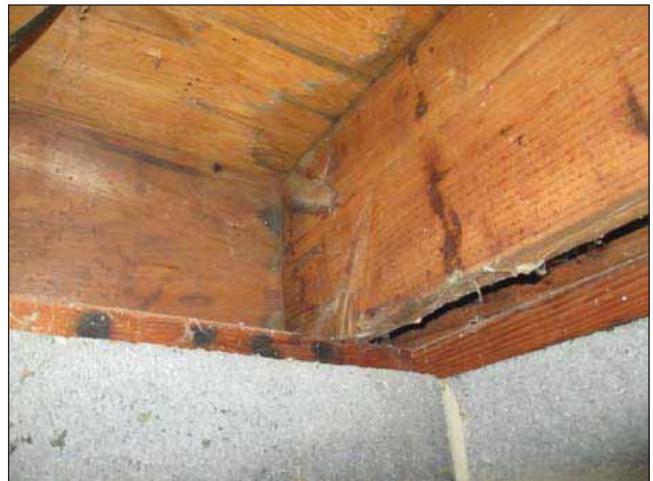
Image 22: Beams of basement with water damage

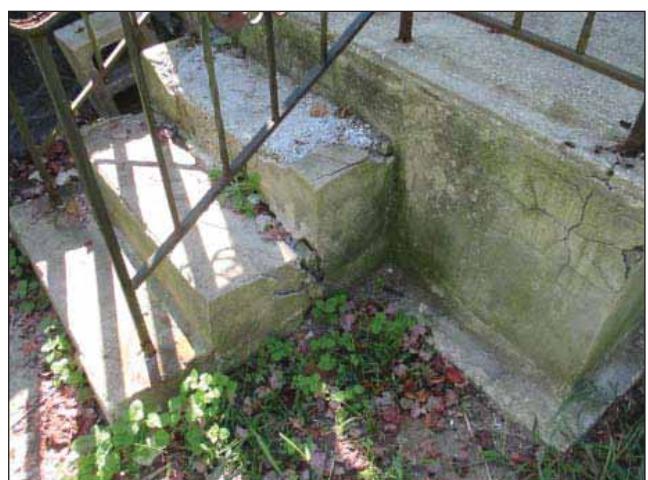
Image 6: Rear steps with corroded and broken concrete steps.

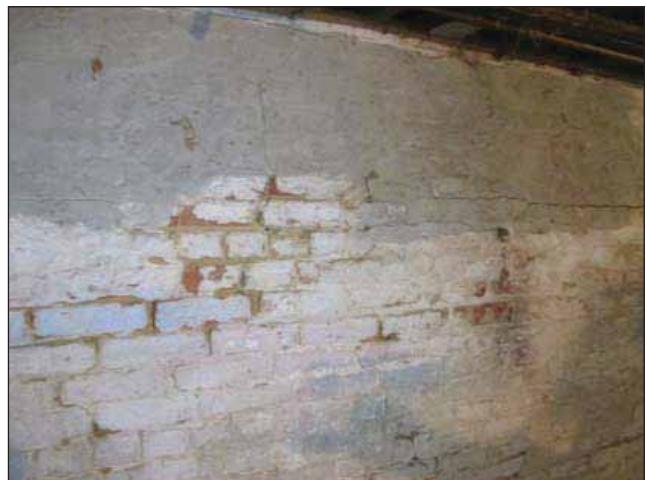
Image 24: Cracks along foundation wall in basement.

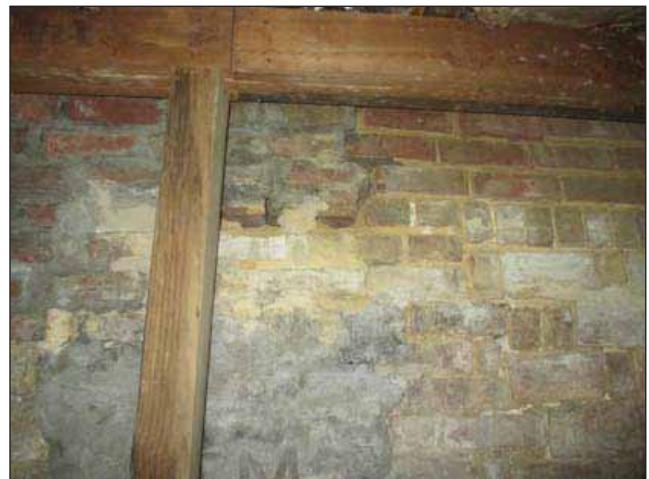
Image 14: Repaired foundation wall in basement with cracking.

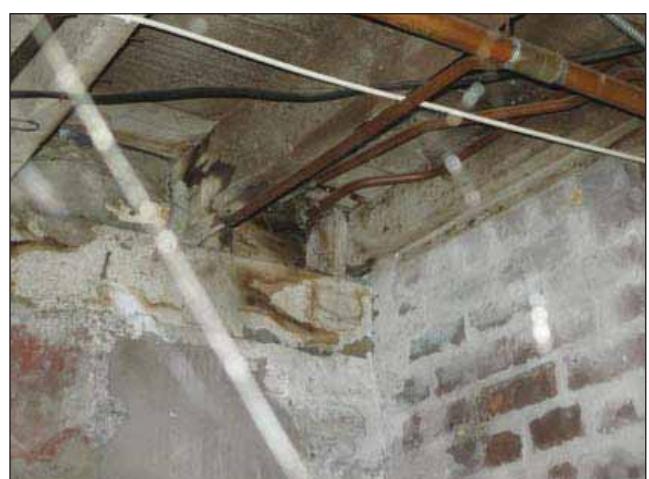
Image 18: Various patching repairs to the foundation walls in the basement.

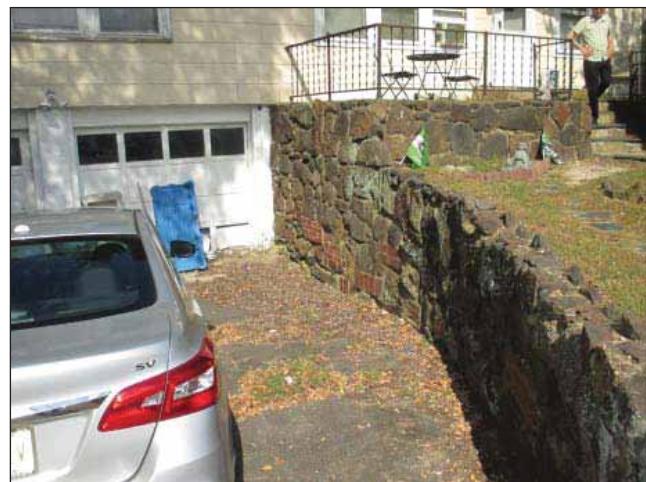
Image 2: Driveway retaining wall with cracking.

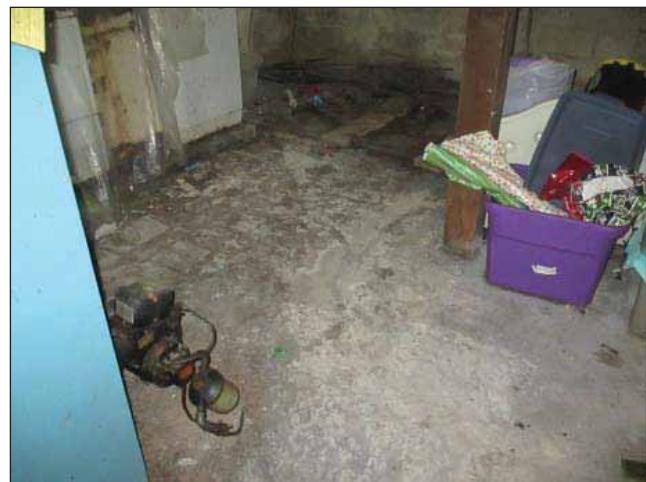
Image 6: Remnants of water on basement floor with wet conditions all the exterior perimeter walls.

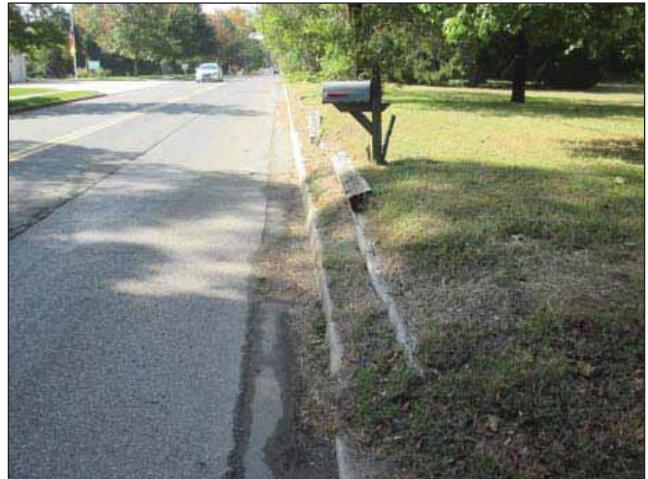
Image 2: Wood tie retaining wall on Kanes Lane leaning toward the street with no sidewalk.

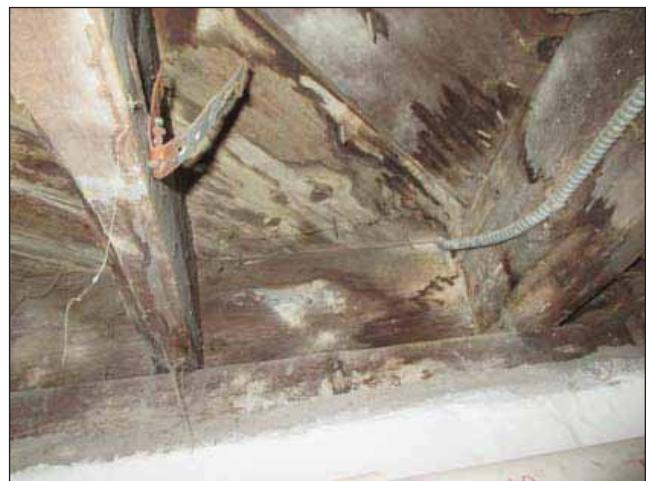
Image 16: Rotting wood and water damage in basement.

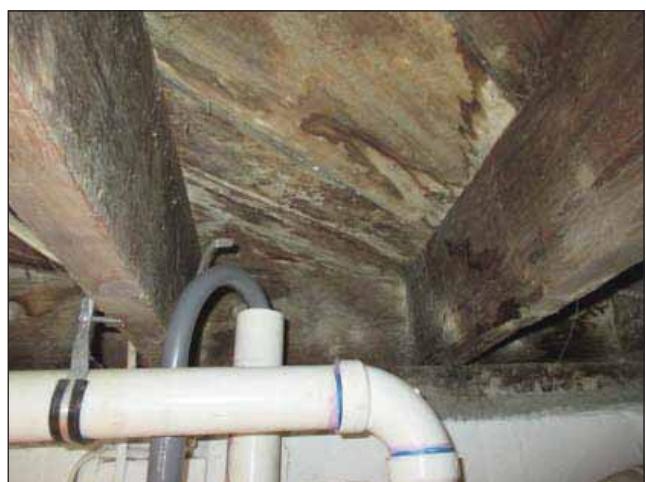
Image 18: Water damage on basement ceiling.

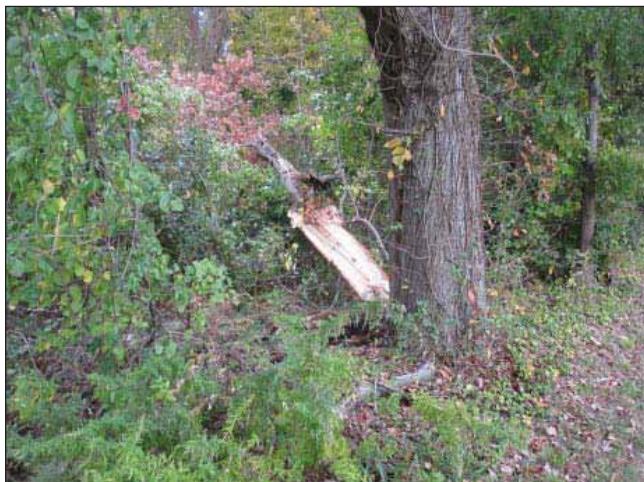
Image 9: Damaged tree adjacent to Highway 35.

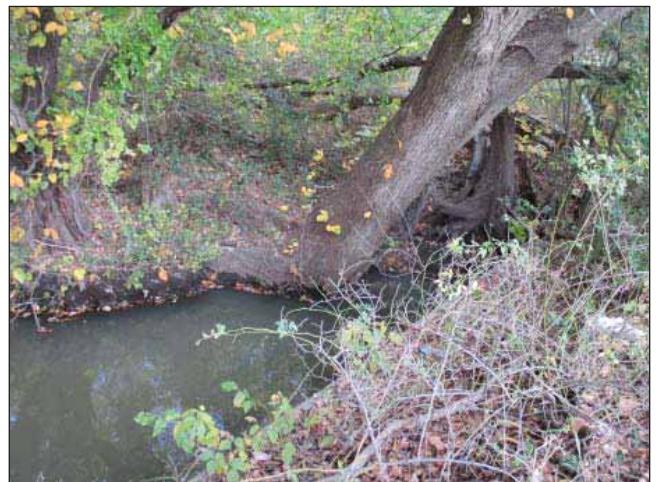
Image 10: Compromised tree hanging over sidewalk and Highway 35.

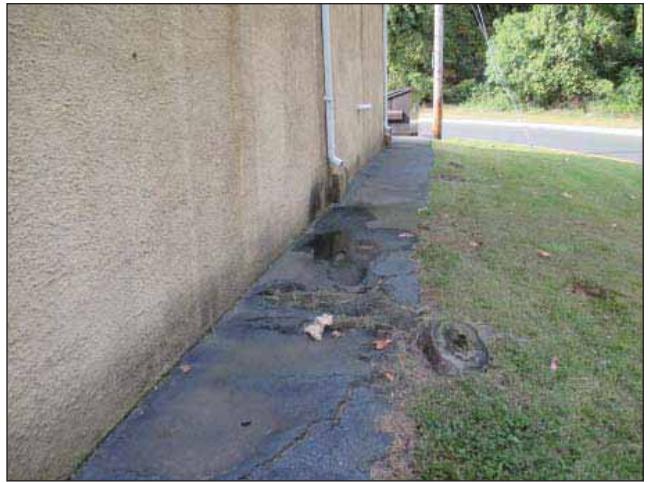
Image 6: Water damage along asphalt sidewalk at rear of the building with erosion.

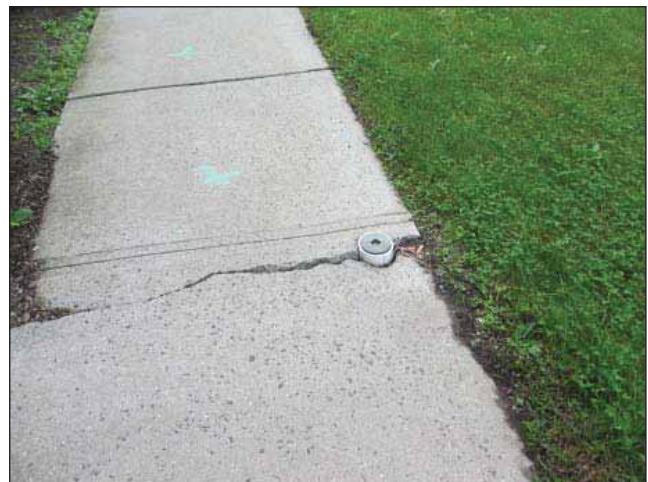
Image 12: Front sidewalk with cracking caused by a lack of proper drainage

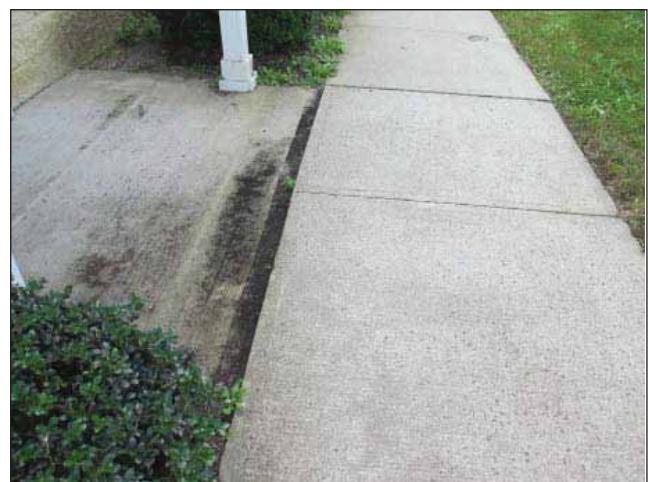
Image 18: Damage at the sidewalk and entrance pad caused by a lack of proper drainage

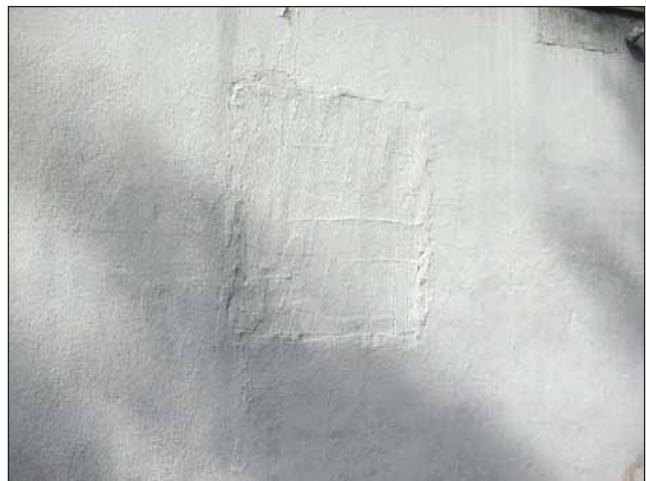
Image 8: Patch work of exterior wall.

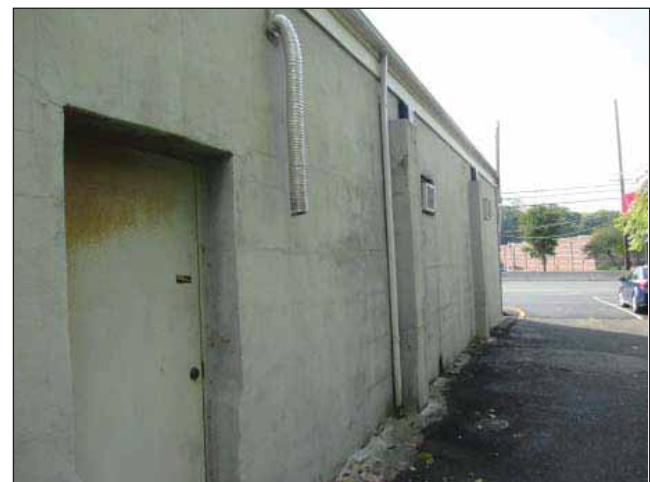
Image 18: Duct work hanging off the side of the building.
