# Campbell's Junction Redevelopment Area Determination of Need Study

Report Date: August 6, 2025

Scattered Sites in the Vicinity Campbell's Junction  
Extending along Leonardville Road from  
Church Street to East Road in Belford

*Middletown Township  
Monmouth County, New Jersey*

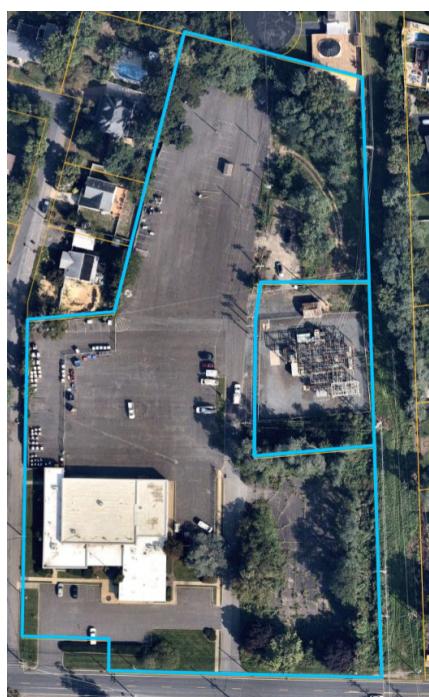
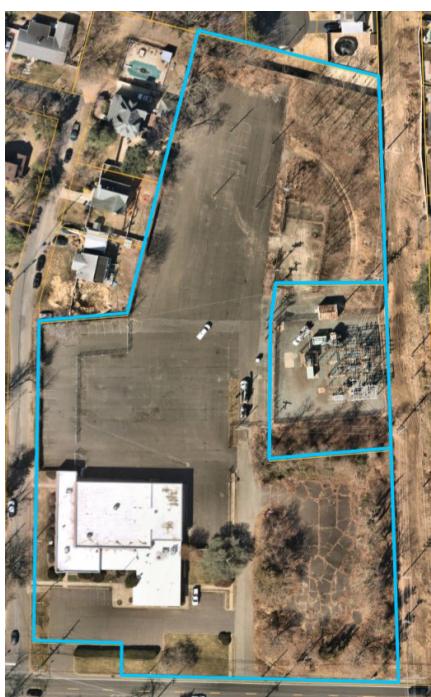
Figure 15: Aerial Imagery from September 2020 (left) and March 2021 (right).

As evident from the aerial imagery, the property appears to have been vacated sometime between September 2020 and March 2021, and has not been reoccupied since. This includes not just vehicles, but materials that appear to be stored in a fenced enclosure. Given that the period of time that this building has been vacant, it would qualify under the "b" criterion.

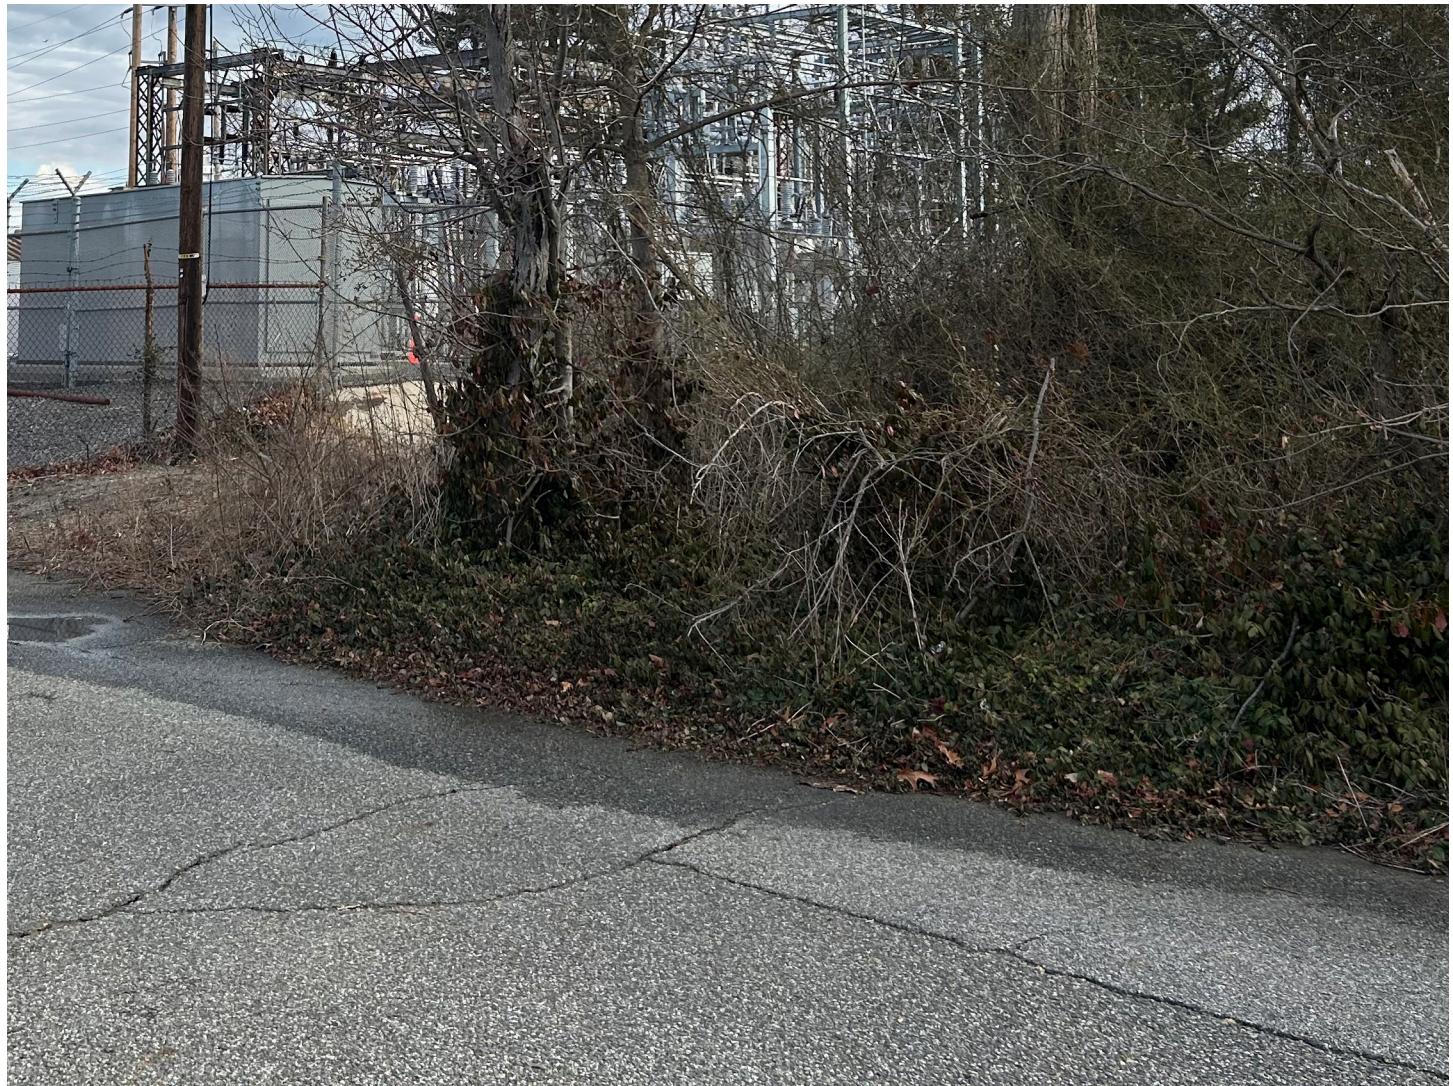
Figure 16: Substation at Lot 39.01

The property itself does not appear to exhibit conditions that would meet the redevelopment criteria; however, it should be included in order to ensure that any redevelopment of Lot 40.01 provides coordinated access to Lot 39.01.

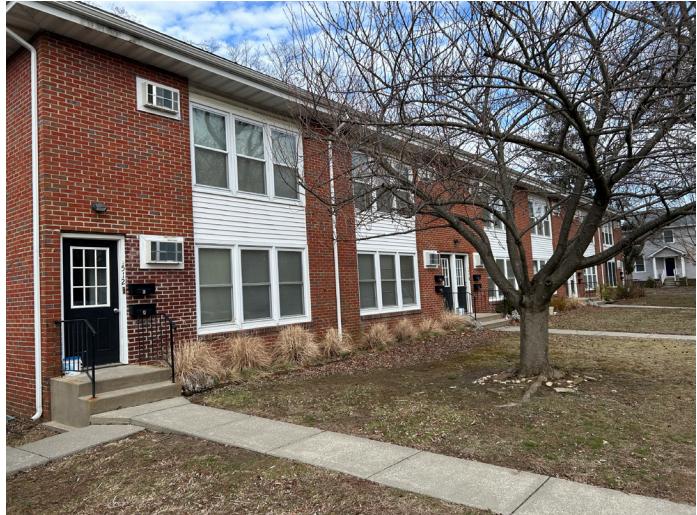
Figure 20: The garden apartment structure on Lot 1

The property contains a 12-unit garden apartment building, which was constructed in 1961. The property fronts along Garfield Avenue, while its side yard abuts Maple Avenue, and its rear yard abuts the alley separating Block 498 from Block 499, shown as Midway Drive in the tax maps. External observations suggest that the building is in good condition, with no visible deterioration noted.

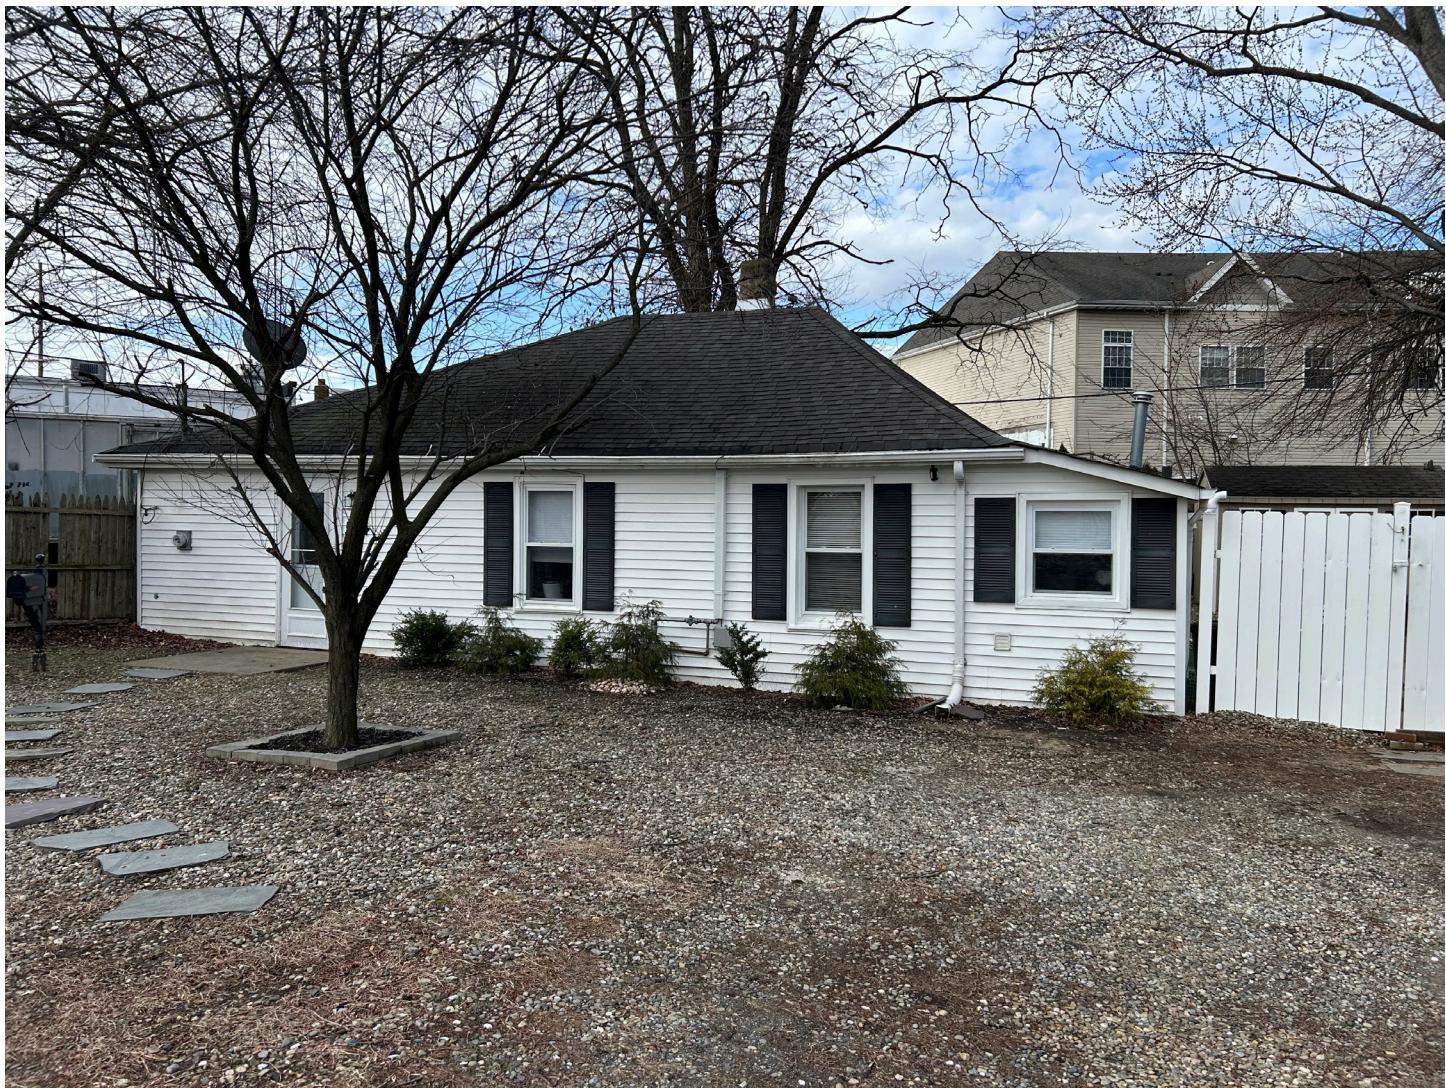
Figure 21: The residential structure on Lot 2

The property contains a single family residence on a triangular-shaped lot, with its rear yard abutting the Midway Drive alley separating Block 498 from Block 499. No noticeable exterior deterioration was observed. Tax records indicate that the dwelling was constructed in 1943.

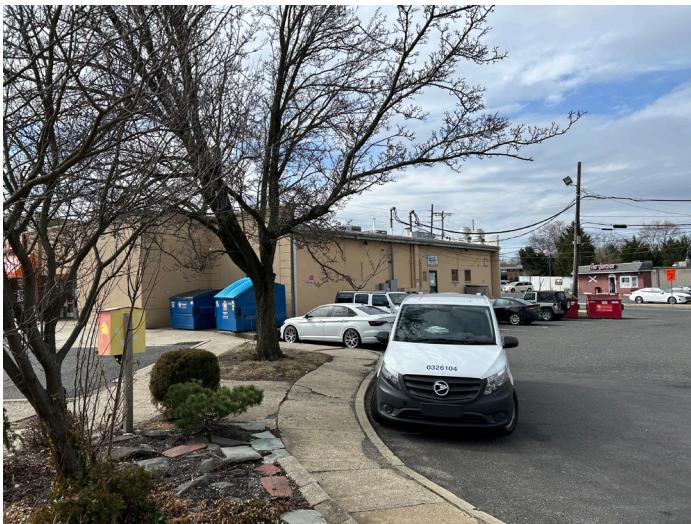
Figure 23: Photo illustrating the rear of the structure on Lot 1, including its unorganized storage of dumpsters.

As noted above and evident from the site observation and the aerial imagery, the property shows signs of overcrowding conditions. The property is providing parking and access to neighboring properties, while it cannot effectively centralize and enclose its own refuse containers. Hazardous conditions include the storage of dumpsters on the sidewalk and the driveway apron. In addition, police records also show that two calls to the site included motor vehicle accidents.

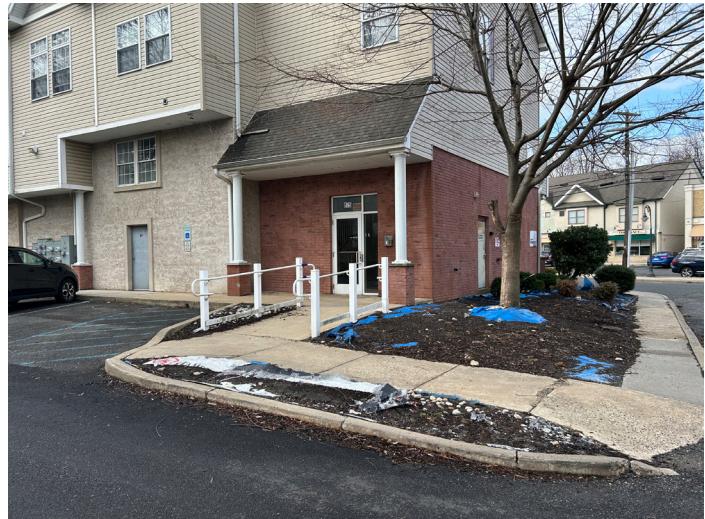
Figure 24: Photo illustrating the side of the building and mulch erosion.

Similar to Lot 1 (and all the other lots within this block), overcrowding conditions exist on the site, as parking and circulation to each lot is interconnected in an odd arrangement. Dumpsters along Midway Drive were

observed outside of their enclosure and located on both sides of the alley, encroaching onto neighboring Lot 1 of Block 498. Police records show motor vehicle accidents at the site in 2012, 2013, 2015, 2017, and 2022. The property also appears to have a grading issue along the northern property line, as the mulching has washed off of the landscaping and into Midway Drive.

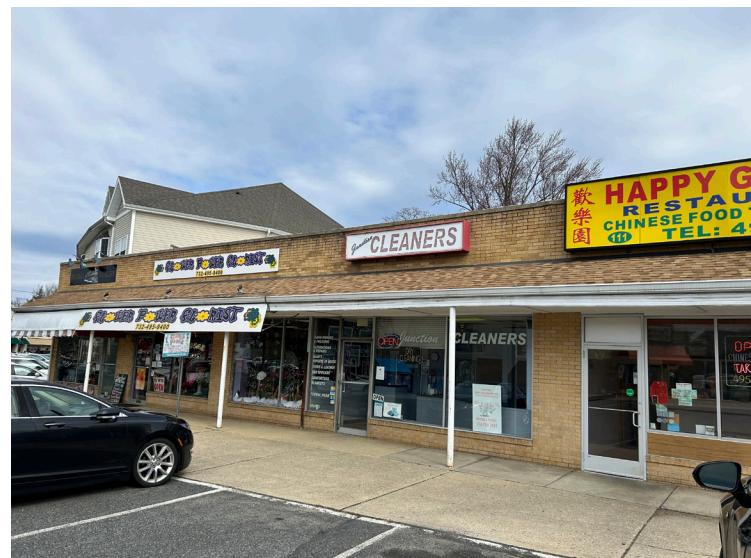
Figure 26: Photo illustrating the front of the structure, including the unseparated sidewalk and parking lot.

The property contains a single-story, multi-tenant commercial building. Based on the tax maps, the property has street frontage only along the rear 1-way alley, known as Midway Drive. The building is oriented in the opposite direction, however, facing the parking and circulation network located on adjacent Lot 1. While Lot 3 appears to contain several parking spaces in this area, access to them is only possible through Lot 1. The frontage along Midway Drive shows signs of overcrowding, with sheds, vehicles, and dumpsters being stored in an unorganized fashion.

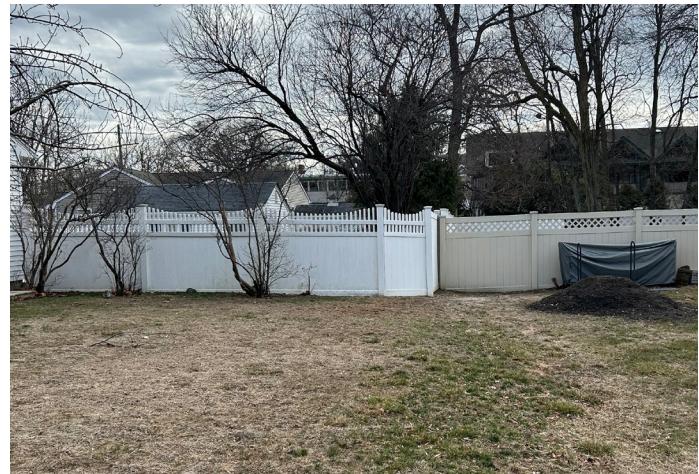
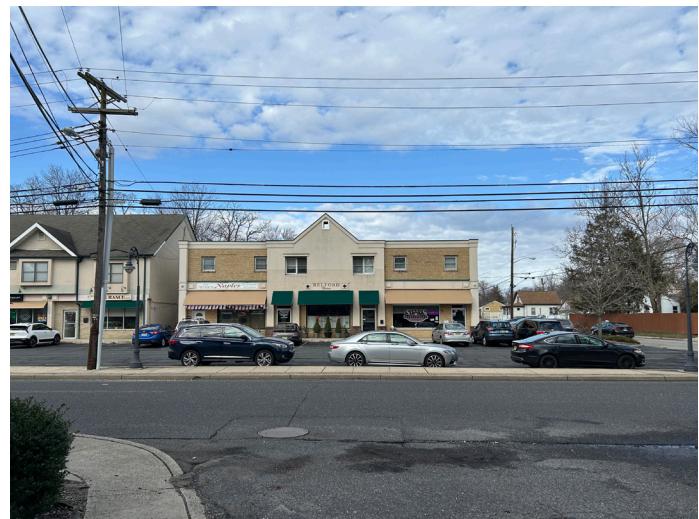
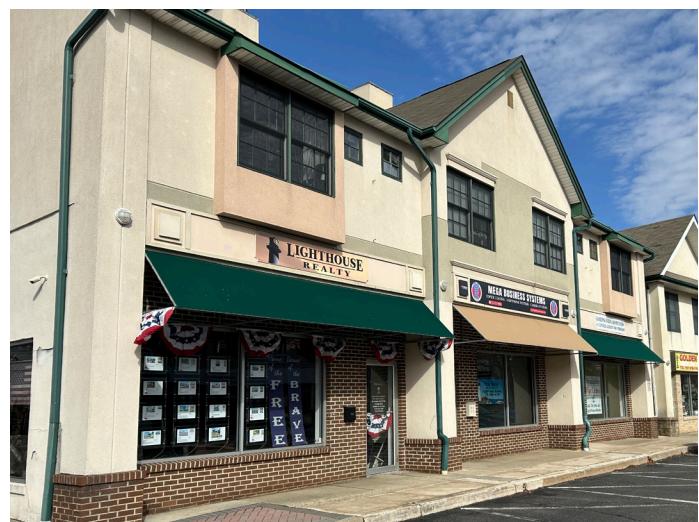
Figures 32-34, from top to bottom: Photo of Vacant Lot 3 and the fence enclosure (top). Photo of the two buildings on Lot 6 with the two "sections" of main street shown (middle). Photo of the building on Lot 8 (bottom).

Lots 6 and 8 would qualify under the "d" criterion given the overcrowding conditions observed on site. While the buildings are well-kept, accommodation of the parking and front yard circulation extend into the Main Street right-of-way. Similar to what was observed at Block 496 with the "secondary" Leonardville Road, this section of Main Street includes the street itself, a curbed sidewalk, and then the majority of the entrance driveway to Lots 6 and 8. This "secondary" section of Main Street appears to be used for internal circulation of Lots 6 and 8 (as well as Lot 7), along with off-street parking. Police records show numerous motor vehicle accidents associated with Lot 6, including accidents in 2024 (2 accidents), 2023, 2020 (3 accidents), 2019, 2017, 2014, and 2013. One accident was associated with Lot 8.

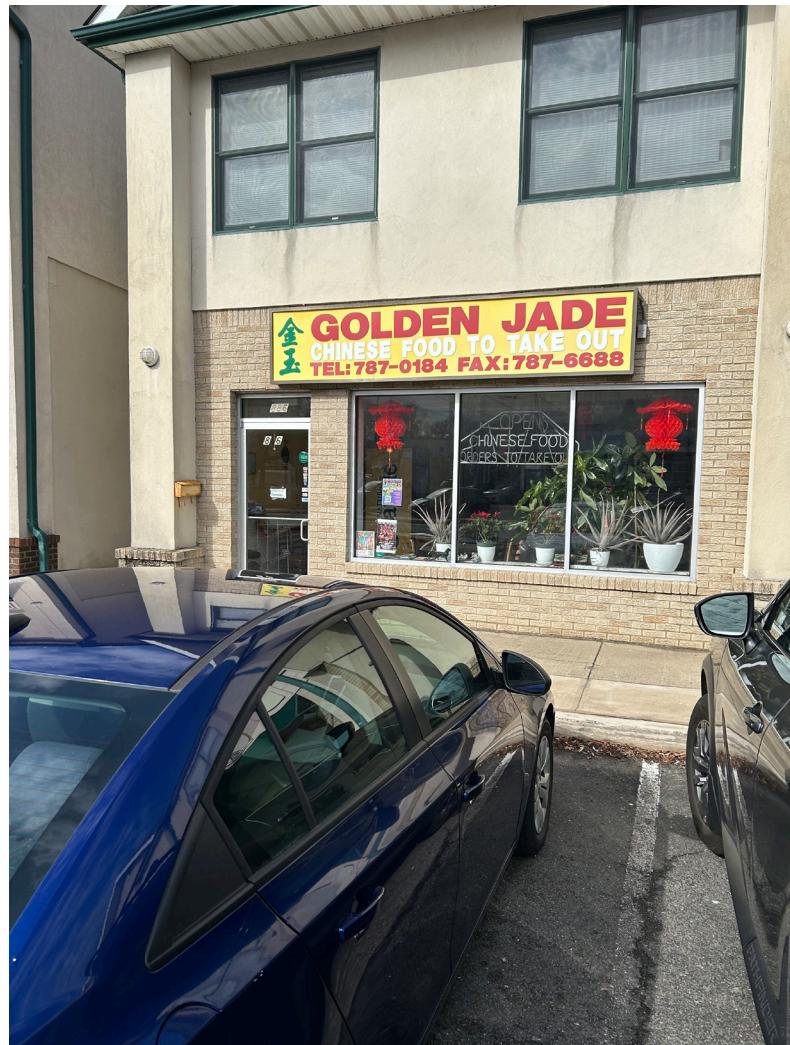
Figure 37: Photo illustrating the building on Lot 7. The image also shows one of the two narrow alleyways along each side of the building and the adjacent buildings on the neighboring lots.

The property contains a two story mixed-use building on a 4,754 square foot lot. Lot 7 is sandwiched between Lots 6 and 8, as noted earlier in this report, with two very narrow pedestrian alleyways separating the buildings on each side.

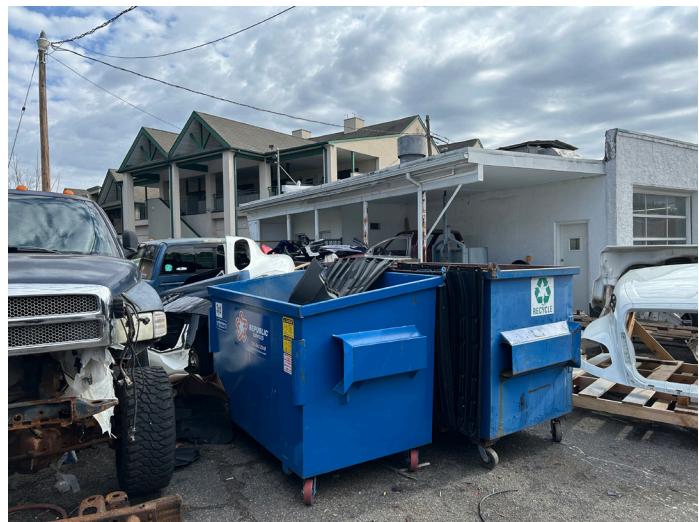
Figure 38: Photo illustrating the vehicle, materials, and refuse storage behind the structure on Lot 9.

lifts correctly. The parking and storage of vehicles in front of Lot 9 appears to extend off the property and well into the Main Street right-of-way. Aerial imagery shows that the paved area behind the building on Lot 9 extends into the area of Lot 1 as well. Police data suggest that 900 Main Street was the site of motor vehicle accidents in 2013 and 2023. Aerial imagery of Lot 17 shows that the side yard of one of the residential dwellings appears to be used for additional storage area for the garage.

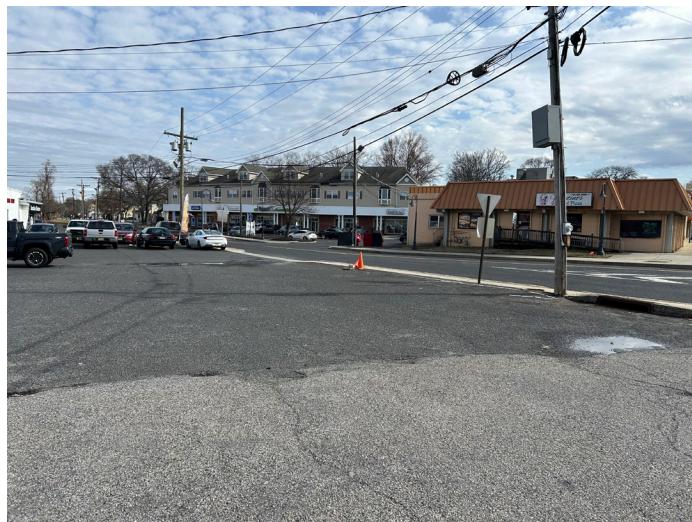
Figure 43: Photo illustrating the parking area of Lots 11 and 12 in the foreground, which extends far into the Main Road right-of-way.

Both properties are held in common ownership. Lot 11 contains a single-story structure, used as a bar and restaurant. The adjacent Lot 12 is vacant, and is used as an outdoor seating and gathering area associated with the restaurant and bar. As illustrated in the aerial imagery and site visit photos, the parking lot, located in the front of the two lots, extends 50-70 feet into the Main Street right-of-way. Lot 11 is essentially a corner lot, given the use of adjacent linear lot 10.

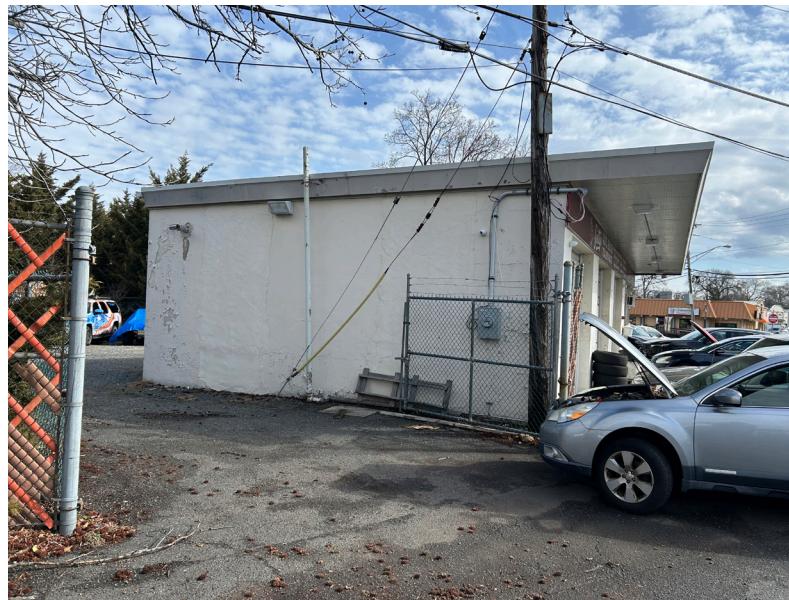
Figure 45: Photo illustrating the side of the building along the Drift Road frontage, and outdoor maintenance activities.

The property contains a single story commercial building used as an auto body. Google Street View imagery shows that the property was previously used as a gas station until around 2008. As noted in a previous section, this historic use on the property appears to be tied to the presence of known contamination. The property is a corner lot, with its side yard abutting Drift Road, and its front yard at the junction of Main Road and Leonardville Road.

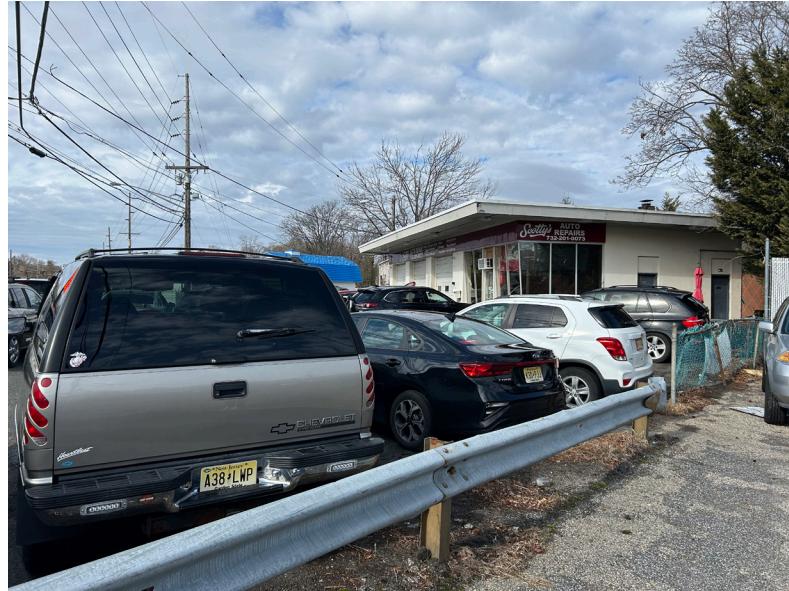
Figure 46: Photo illustrating the overcrowding conditions of vehicle storage in the right-of-way.

Similar to other properties in the area, overcrowding conditions exist on account of the oversized right-of-way. In this instance, the aerial imagery suggests that the building itself encroaches into the right-of-way, with the parking area extending almost 70 feet into the right-of-way. The contamination associated with the former gas station includes a Classification Exception Area (CEA)<sup>6</sup> that appears to be located within the right-of-way. Similar to other auto bodies in the study area, the storage of vehicles appears to be haphazard, with vehicles stored in front of the building and into the right-of-way. The building itself is unable to accommodate all maintenance activities, as vehicles undergoing maintenance were observed outside of the building. Other hazards on the property were evident through a review of police records, which included a parking violation in 2019, and numerous motor vehicle accidents (2023, 2021, 2020-2; and 2012). Moreover, the storage of vehicles and equipment presents an invitation for criminal behavior.

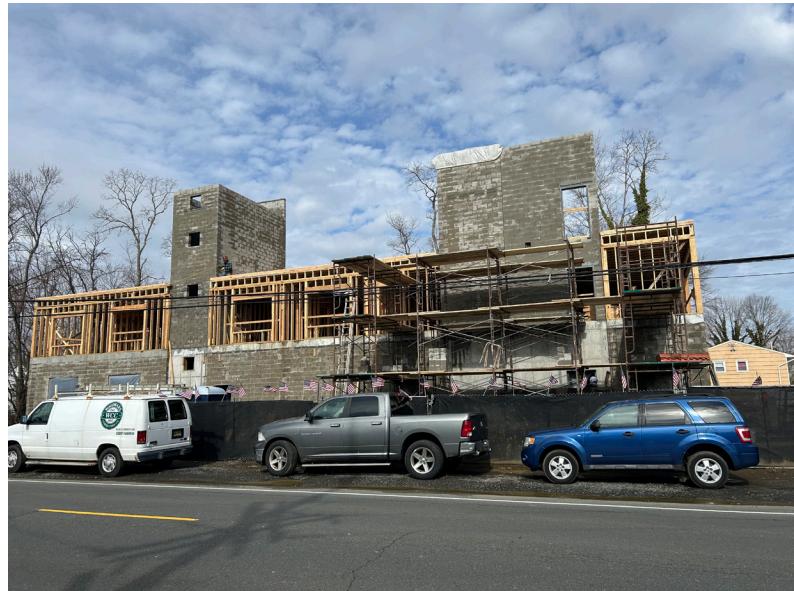
Figure 51: Photo illustrating the construction underway on Lot 2.01.

At the time of the site visit, the site was under construction as part of a municipally-sponsored veterans housing project. At the time that the redevelopment investigation was authorized, the property was identified as 5 separate lots, which have since been consolidated into a single Lot 2.01, currently owned by the Township.

As noted in the previous section to this report, the property contains several environmental constraints, including a floodplain, species habitat, wetlands, and a known contaminated site. Presumably, these constraints were addressed when the recent development was approved.

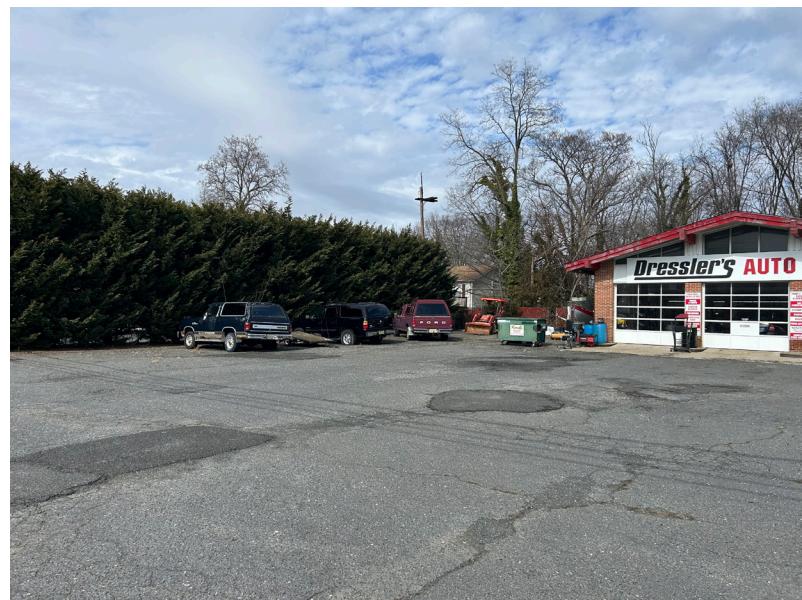
Figure 53: Photo illustrating the building on Lot 13, along with the unenclosed storage of vehicles, equipment, and dumpster.

The unsecured storage of construction equipment and materials presents an invitation for criminal behavior. Police records included 3 incidents of theft (2013 and 2019-2), along with 2 abandoned vehicles in 2018. The property has undefined parking and circulation, and the entire property frontage serves as a continuous curb cut onto Leonardville Road, which creates a hazard for vehicles entering and exiting onto the road. The rear of the property, particularly along the fence contained litter, and there were drainage issues observed with the parking lot.

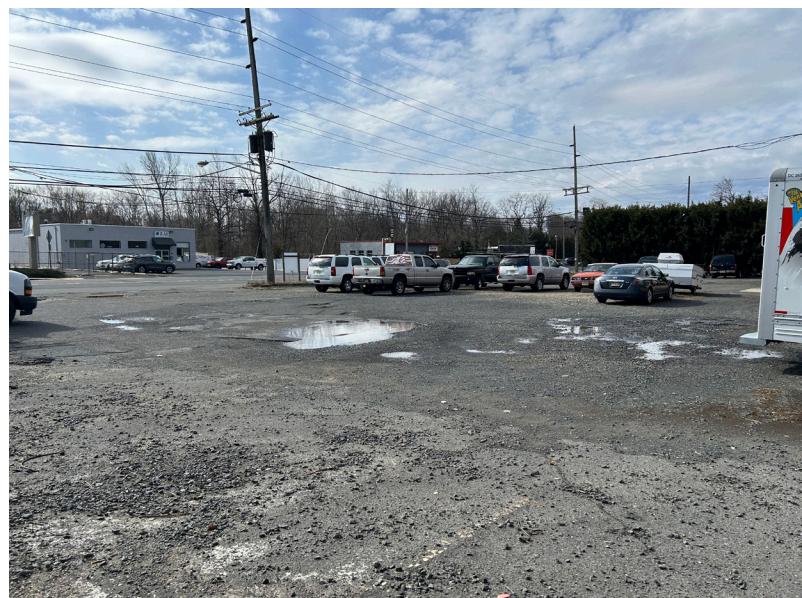
Figure 54: Photo illustrating the parking lot and drainage issues.

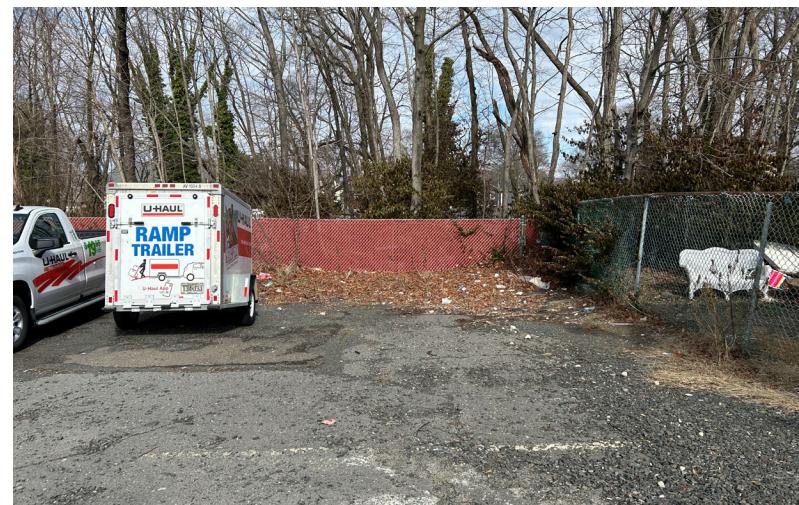
Figure 55: Photo illustrating the rear property fence and storage of rental vehicles.

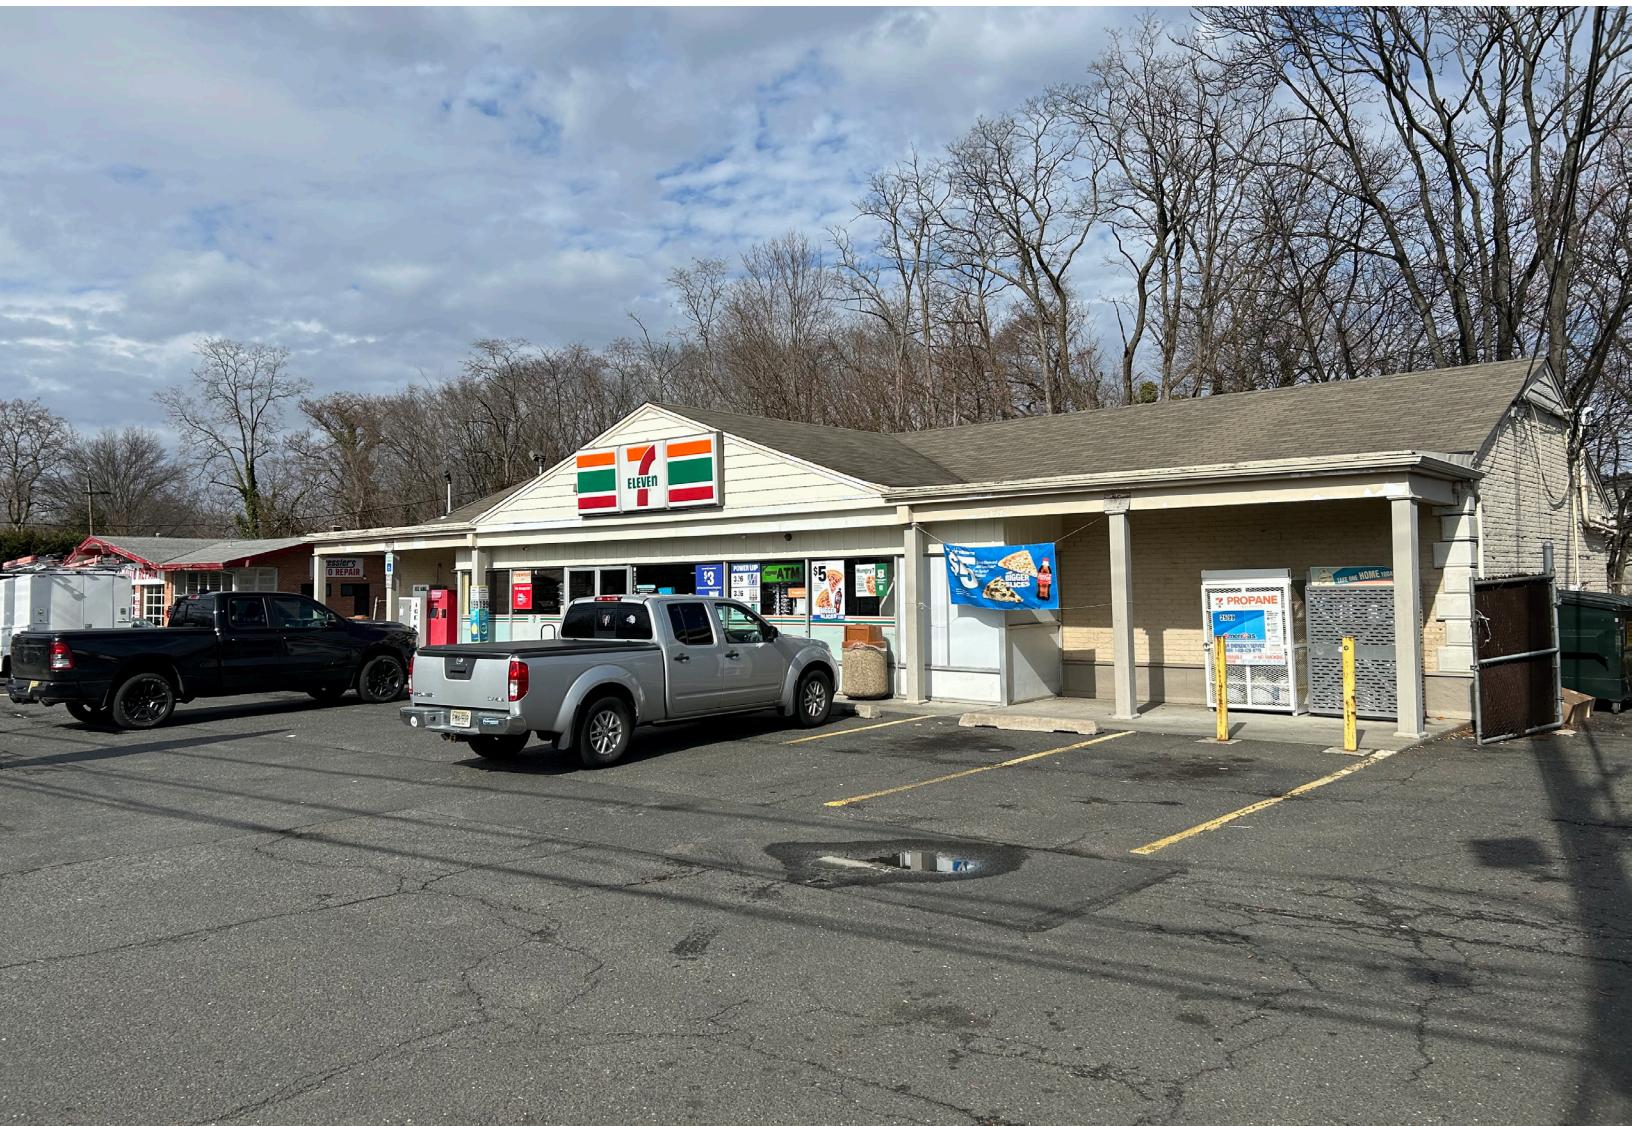
Figure 56: Photo illustrating building on Lot 14 and the front yard parking lot.

As evident from the accident data, the layout and circulation of the parking area creates hazardous conditions. Additionally, puddles in the parking area suggest that the property contains drainage issues.

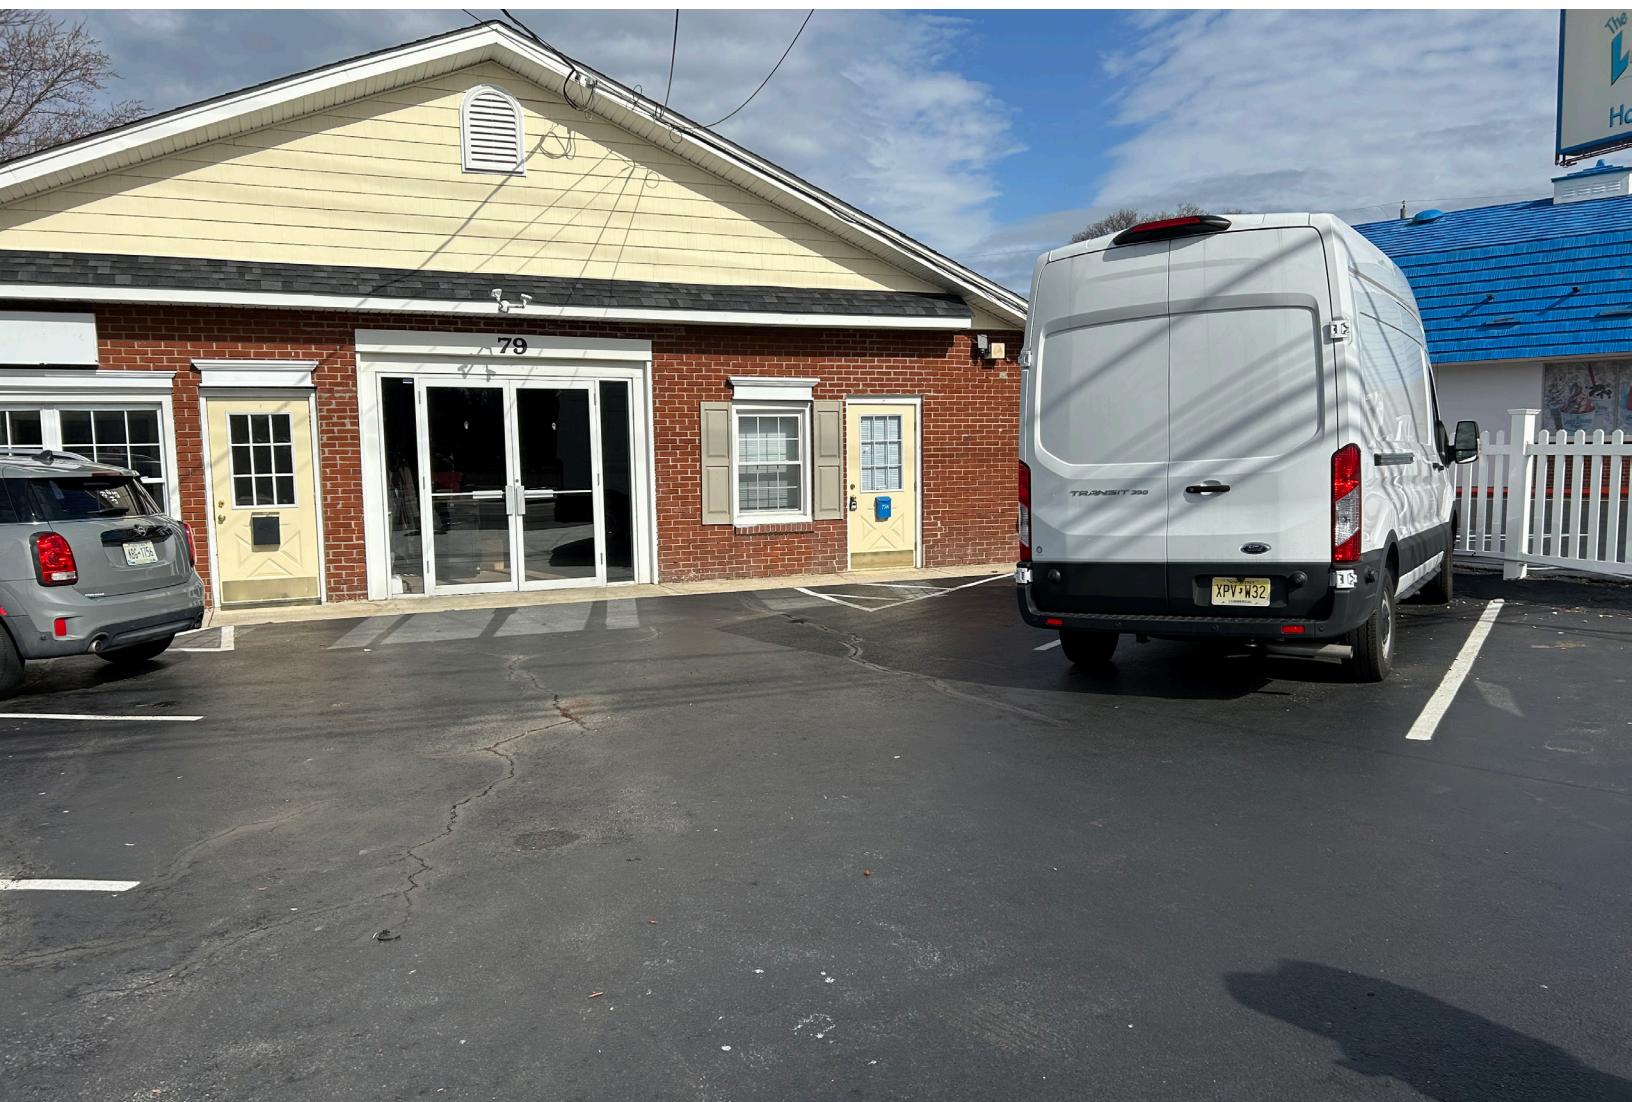
Figure 57: Photo illustrating building on Lot 15 and the front yard angled parking.

The parking layout creates a hazardous condition. While vehicles can easily enter the site and park "head in," they must then back out onto Leonardville Road. The alternative would be for vehicles to back into a parking space from Leonardville Road. It should be noted that police records show at least two motor vehicle accidents at the site, occurring in 2022 and 2021.

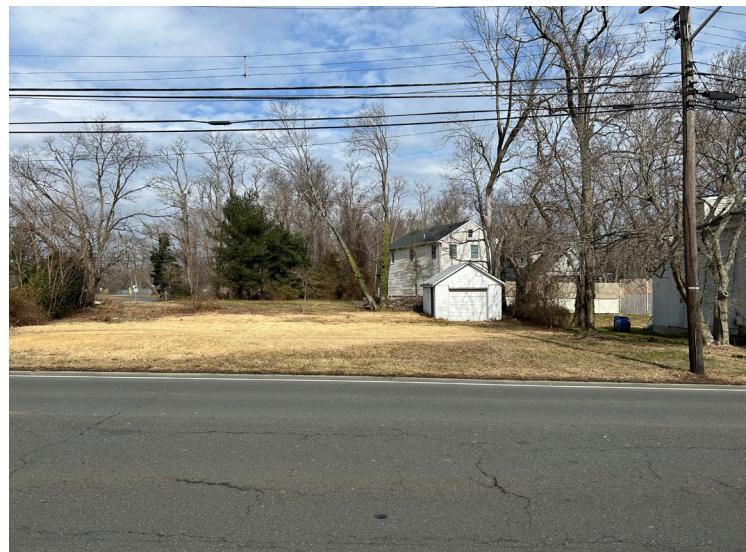
Property tax records suggest that this property is assessed for residential use, despite the structure on the property being demolished sometime between 2011 and 2012. As noted in the previous section, this site appears to have contained the historic structure incorrectly attributed to a property on Block 646. The property is dual frontage, with frontages along Leonardville Road and Church Street. Despite the demolition of the principal structure, the property appears to still have a detached accessory garage structure on the site.

Figure 63: Photo showing the accessory structure remaining on Lot 5.

Based on the data reviewed and the site visit, this property does not appear to exhibit conditions that would meet any of the statutory criteria for redevelopment at this time. Additional information, particularly from the property owner, may help to identify reasons why the property has remained vacant for an extended period of time. This information could help to support an argument under the "C" criterion.

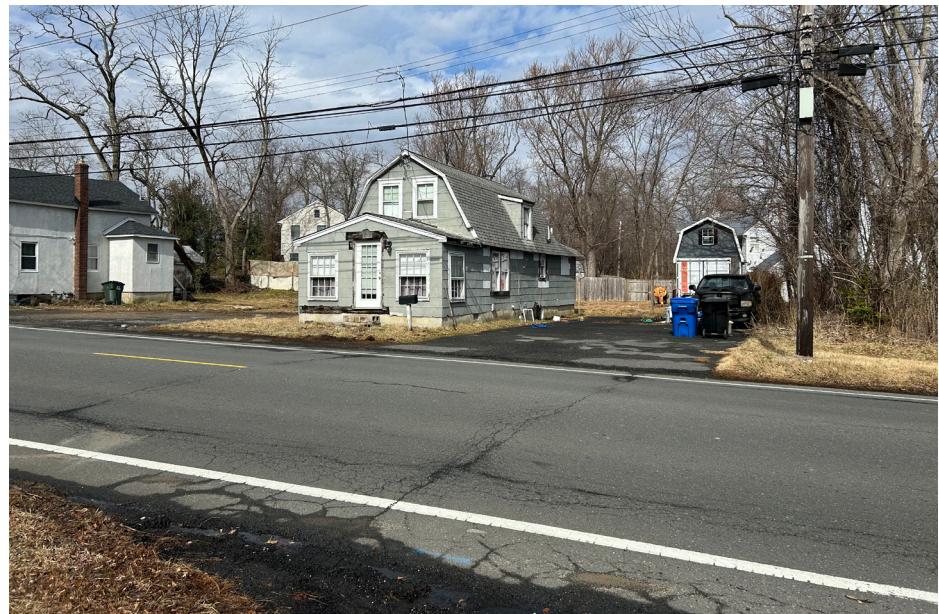
The property contains a single family residence on a lot with frontage along Leonardville Road. Tax records indicate that the dwelling was constructed in 1923. The exterior of the structure shows signs of deterioration, including missing shingles (which appear to be cementitious or asbestos). In areas where shingles are missing, tar paper is visible, and several areas show the underlying wood. The property is also missing a permanent front set of stairs, instead using cinder blocks. Google Street View shows that a front set of stairs, with railings, existed through at least July 2016, before being removed sometime before September 2017. The property does not appear to have any building permits associated with the removal of the front stairs. The site has been subject to numerous complaints, however, records suggest that most, if not all, have been addressed by the property owner.

As noted, the building shows notable evidence of severe dilapidation. Cracked or damaged asbestos shingles can pose an air quality hazard. The missing shingles and tar paper provide a space for entry for water, which can lead to structural damage, as well as mold, which can pose an interior air quality hazard. Moreover, the exposed wood underneath the front door shows signs of deterioration and rot, which can create a safety hazard for those trying to enter or exit the building. Similarly, the cinder block front stairs, if not properly installed, can pose a slip, trip, and fall safety hazard. As such, the building is conducive to unwholesome living conditions.

Figure 67: Photo showing the dwelling on Lot 12.

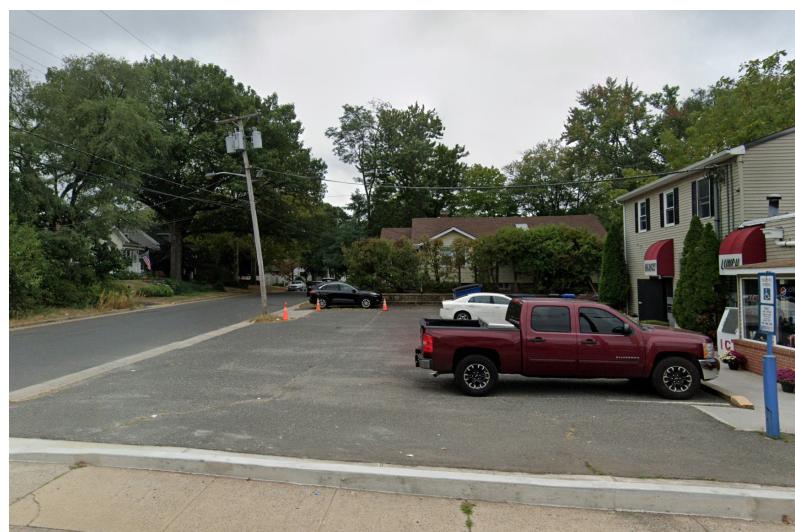
While the property and building appear to be well-maintained, the layout and design exhibit signs of obsolete layout and design. As illustrated from the site visit photos, the ADA reserved parking space contained a large puddle of standing water that did not appear to have a place to drain. The property has also recorded numerous vehicle-related issues according to police reports, including motor vehicle accidents in 2024-2, 2023, 2022-2, 2021, 2020, 2018, 2015-2 and 2014-2. In reviewing the data with the Township Business Administrator, he had noted that there have been numerous incidents where cars have backed into the telephone pole along Garfield Avenue, which may explain the need for the traffic cones illustrated in the September 2024 Google Street View imagery. Additionally, police records also show numerous parking violations in the past 10 years on the site, including 2024, 2019, 2018, 2016-3, 2015, and 2014. This information suggests that the parking area exhibits unsafe and hazardous conditions which could be ameliorated through redevelopment.

Figure 77: Google Street View photo of the parking area (and traffic cones near the utility pole), taken September 2024.

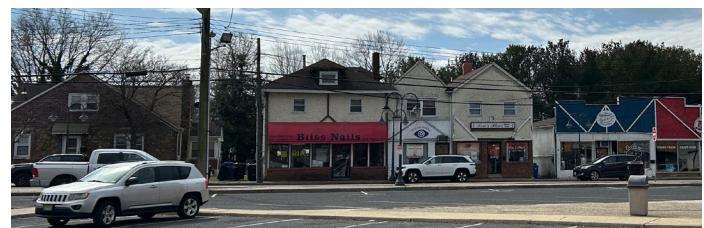
The property contains three distinct structures: a 1.5 story detached single family structure (tax records indicate it was constructed in 1944); a 2 story commercial building containing 3 ground floor tenants (nail salon, psychic readings, and barbershop) and potentially residential units upstairs; a 1 story commercial building containing three tenant spaces (Belford Brewing Company appears to occupy two of the spaces, and a restaurant). A chimney at the rear of the 1 story commercial building showed signs of severe deterioration, including broken or missing concrete. Subsequent inspection by the Township's Fire Inspector indicated that the chimney is most likely connected to the furnace, and that the liner would ultimately need to be replaced at the time that the furnace is replaced. The rear parking area contained unenclosed dumpsters and bulk debris along the fence line.

Front entrances to the two story commercial building are not accessible, as evident by their entry steps. Additionally, the rear parking area, which appears to be accessible through adjacent Lot 8.01 only, showed signs of deterioration, including potholes. An unenclosed dumpster was located in the parking area along the rear property line, along with bulk debris, including shipping palettes, and cinder blocks. While the parking area appeared to be striped in places, vehicles were also observed parked in unmarked spaces, which could interfere with internal circulation, trash collection, and emergency response. The property appears to also contain off-street parking along the side of the lot, however, it looks like they are split between Lots 7 and 8.01.

Figure 82: Photo showing the dwelling on Lot 7 (left), and the two commercial buildings (center and right) on Lot 7.

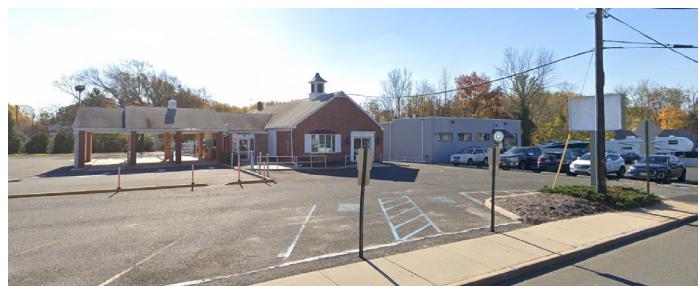
Google Street View imagery shows that by 2021, the building and freestanding signage had been removed, and the building has sat vacant since then, a period far in excess of 2 years.

Figure 87: Google Street View imagery from November 2021 showing the freestanding sign and the building signage removed.

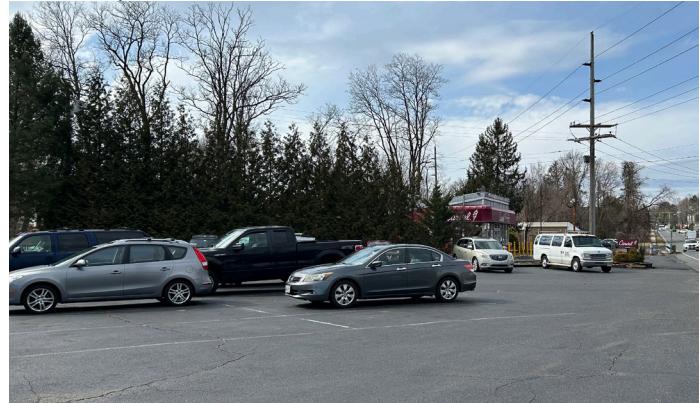
Figure 90: Photo showing the front storage/parking area on Lot 22.

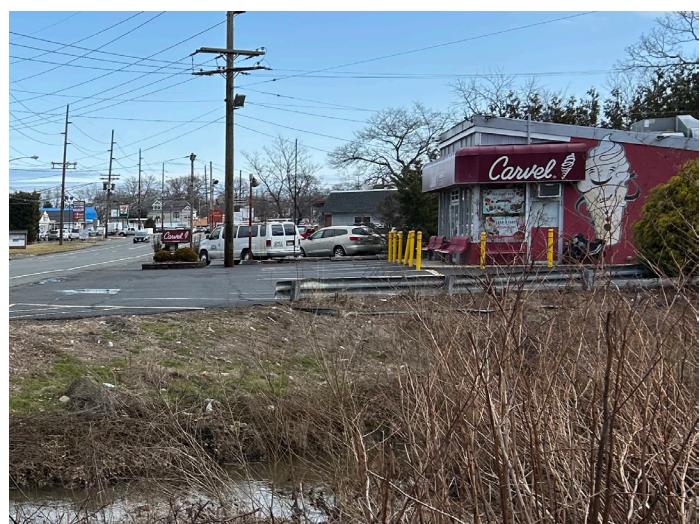
Both lots are held in common ownership. The property contains a single-story building currently utilized as a Carvel ice cream shop, which is located on Lot 23, along with paved parking, circulation, and seating areas. Lot 23 is oddly shaped, with only 43 feet of frontage along Leonardville Road, however, the parking area and driveway spill into adjacent linear Lot 25, which is owned and used by JCP&L. This Lot 25 separates Lot 23 from Lot 26, a small (approximately 900 square foot) triangular lot, which contains no buildings, but appears to be used as another portion of the parking area. As noted in the previous section, a significant portion of the property is located within the floodway of Compton's Creek.

both properties (as well as Lot 25) is paved, with striped parking spaces extending into the Leonardville Road right of way. The lack of curbing along Leonardville Road creates an uncontrolled ingress/egress situation. Police data indicates that the site has been host to numerous motor vehicle accidents, including 2 in 2022, 2021-3, 2020, 2019, 2018-2, 2017-5, 2016-3, 2014-2, 2013, and 2012. Moreover, the location of the building and improvements in the mapped floodway can impede flood flows, causing water to slow down and back up, resulting in higher flood elevations for the surrounding properties. Considering that tax records show that the building was constructed in 1956, it predates modern floodplain requirements.

Figure 91: Photo showing the ice cream shop and front yard parking area on Lots 23, 26 (and 25), along with Compton's Creek in the foreground.

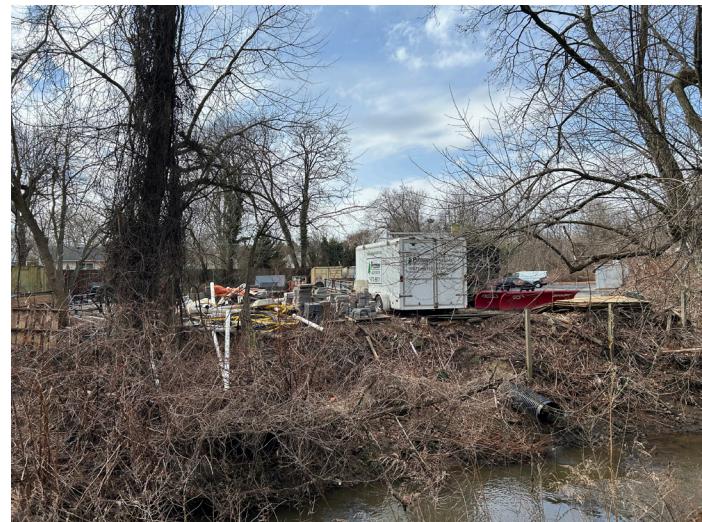
Figure 93: Photo showing the storage of equipment, and trailers along Compton's Creek as photographed from across the creek.

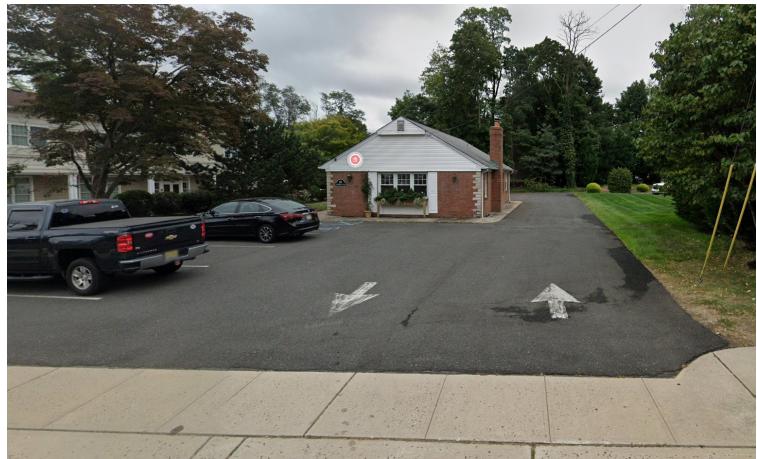
The building, while dated, appears to be maintained in good condition, and contains a dental office.

Figure 98: September 2024 Google Street View image showing the building at Lot 31.

Based on the data reviewed and the site visit, this property does not appear to exhibit conditions that would meet any of the statutory criteria for redevelopment.
