# Campbell's Junction Redevelopment Area Determination of Need Study

Report Date: August 6, 2025

Scattered Sites in the Vicinity Campbell's Junction  
Extending along Leonardville Road from  
Church Street to East Road in Belford

*Middletown Township  
Monmouth County, New Jersey*

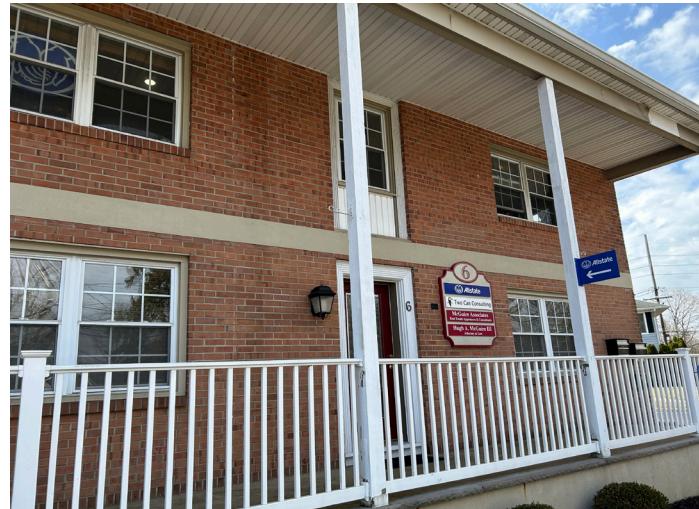
The property contains a commercial office building, which, while dated, appears to be maintained in good condition. Records provided by the Township indicate that the property contains a rooftop cellular system.

Figure 99: Photo showing the building at Lot 32.

Based on the data reviewed and the site visit, this property does not appear to exhibit conditions that would meet any of the statutory criteria for redevelopment.
