ENVIRONMENTAL RESOURCE INVENTORY

**BLOCK 1045, LOT 12
MIDDLETOWN TOWNSHIP
MONMOUTH COUNTY, NEW JERSEY**

SEPTEMBER 2024

PRINCETON HYDRO, LLC
35 CLARK STREET, SUITE 200,
TRENTON, NJ 08611

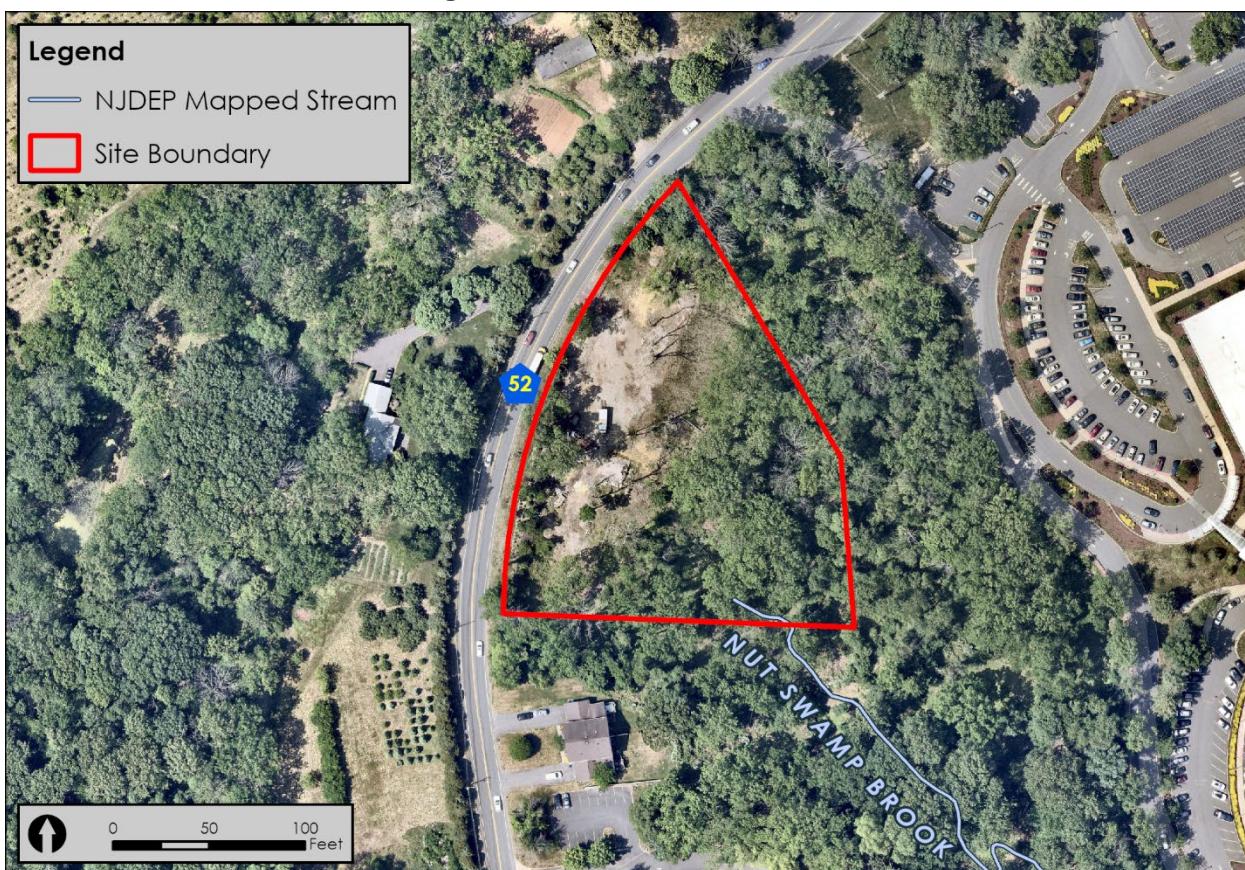
Figure 1: Site Overview – 2023

Based on a review of historic imagery published by the New Jersey Geographic Information Network (NJGIN), the Site appeared primarily non-forested in early 20th century (**Figure 2**). No obvious historical land use can be identified based on the imagery. By the 1980s, the Site was predominantly reforested, with the exception of a small unpaved lot/open field along the western edge of the Site (**Figure 3**). The unpaved lot/open field was expanded between the 1980s and 2023 (**Figure 1**). Site investigations in 2024 confirmed that the Site was composed of a cleared, unpaved lot along its western edge, upland forest along its eastern edge, with a cleared hillside connecting these two areas.

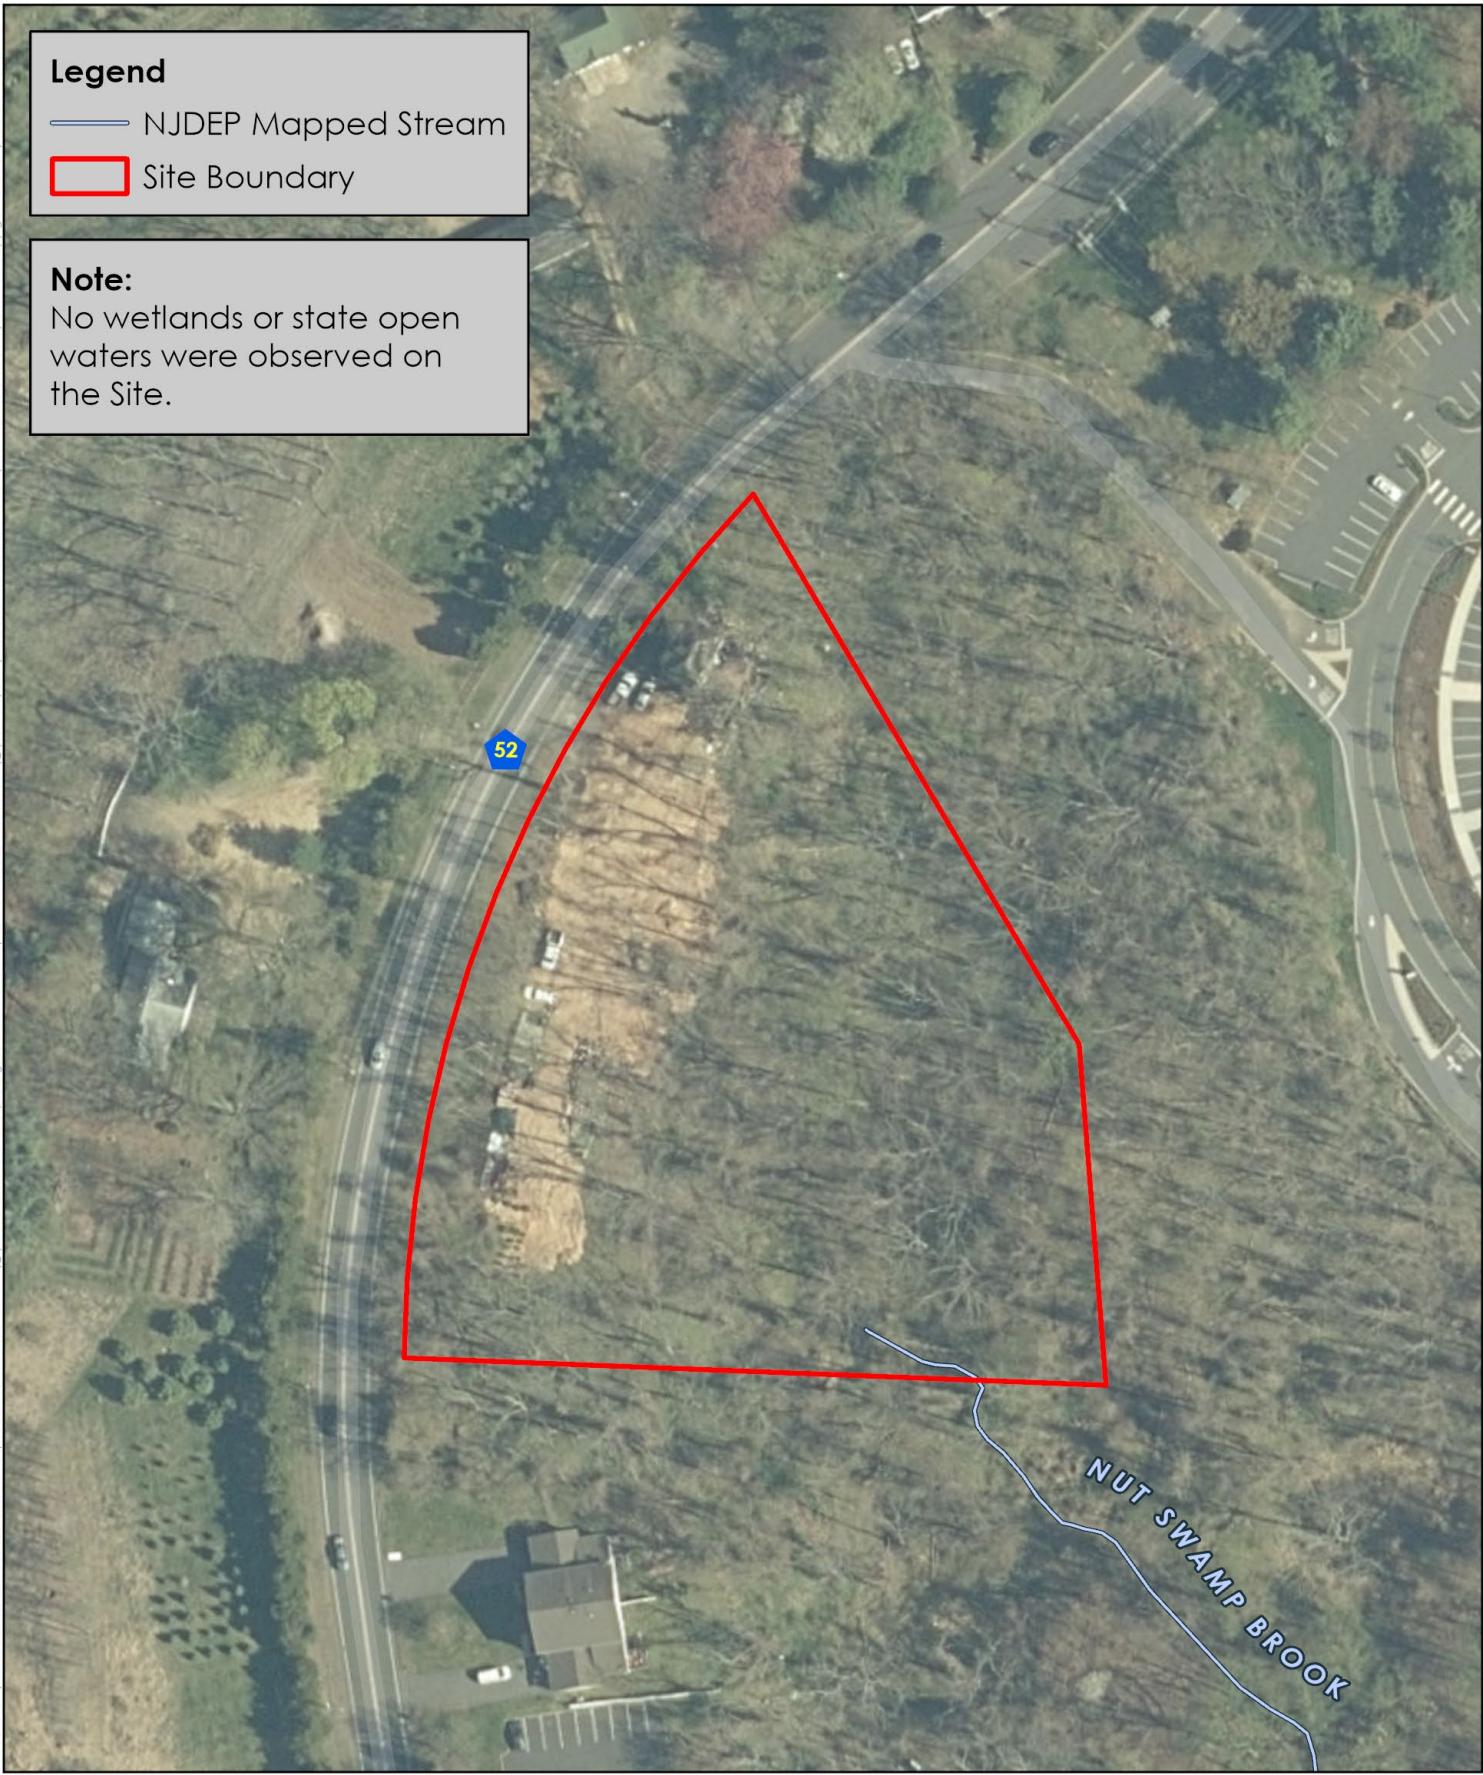
WETLAND & STATE OPEN WATER DELINEATION MAP

No wetlands or State open waters were observed on-Site. This result is consistent with the Freshwater Wetlands LOI, submitted by the Adoni Property Group, and approved by the NJDEP in May 2023 (NJDEP PI No. 1331-23-0003.1 [FWW230001]) (**Appendix IV**). Off-Site waters were not assessed, but stream mapping published by NJDEP indicated the headwaters of Nut Swamp Brook are located along the southern property boundary and flow south, discharging to Shadow Lake and the Navesink River Estuary approximately four miles downstream.

No wetlands or state open waters were observed on the Site.

Land development on the Site would not directly impact any wetlands or open waters, or associated wetland transition area, riparian zone, or flood hazard area, as none are present on the Site. However, on-Site land development would remove permeable land in uplands, replacing it with impervious surfaces (e.g., roads, buildings) and other less-permeable surfaces (e.g., lawns and other landscaped areas). Such alterations are reasonably likely to increase local stormwater runoff, increase non-point source pollution, and decrease local groundwater recharge capabilities. This may result in the indirect degradation of on-Site and downstream open waters and associated wetlands, depending on inclusion, design, and maintenance of mitigating features such as storm sewers, stormwater basins, vegetated buffers, and/or other stormwater best management practices.

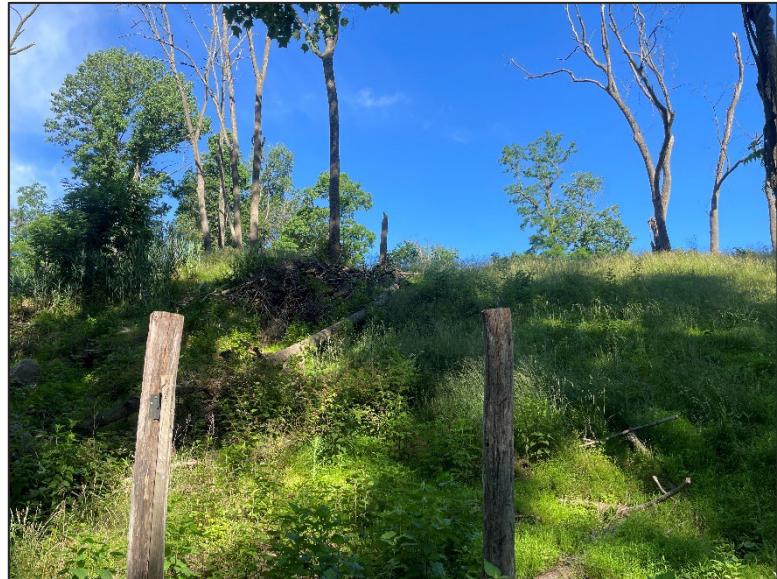
Figure 4: Photo of an On-Site Steep Slope

The Site's steep slope areas appear to be largely stable under current conditions; no signs of significant slope erosion, such as gully formation, were observed in these areas during on-Site assessments in March 2024. The Site's steep slope areas were generally vegetated with grasses and other herbs (**Figure 4**), which are providing additional stability to these slopes.

Based on the conceptual development plan, the footprints of the proposed building and paved surfaces would cover approximately 0.75 acres (~50%) of the Site's steep slope areas (>15% slope), including 0.43 acres (~53%) of the Site's critical slope areas (>25% slope), as defined by Middletown Township's municipal code. Actual disturbances to steep slopes would exceed these estimates, because the overall limit of disturbance required to construct the proposed development (i.e. including all Site clearing, earthwork/grading, landscaping, etc.) would extend beyond the exact footprints of the proposed building and paved surfaces. Furthermore, because the Site's steep slopes form a contiguous area bisecting the Site, the eastern part of the Site cannot be accessed or developed without crossing a steep slope. Land development and/or the removal of vegetation within these areas are reasonably likely to disturb steep slopes and increase local soil erosion and runoff, which may in turn degrade the water quality of downstream open waters and associated wetlands, depending on

inclusion, design, and maintenance of mitigating design features and best management practices. The replacement of existing vegetation in steep slope areas, such as removing established trees and shrubs and replacing them with turf grass or ornamental plantings, is also reasonably likely to decrease slope stability, because mature, well-established vegetation tends to more effectively bind and stabilize a slope.

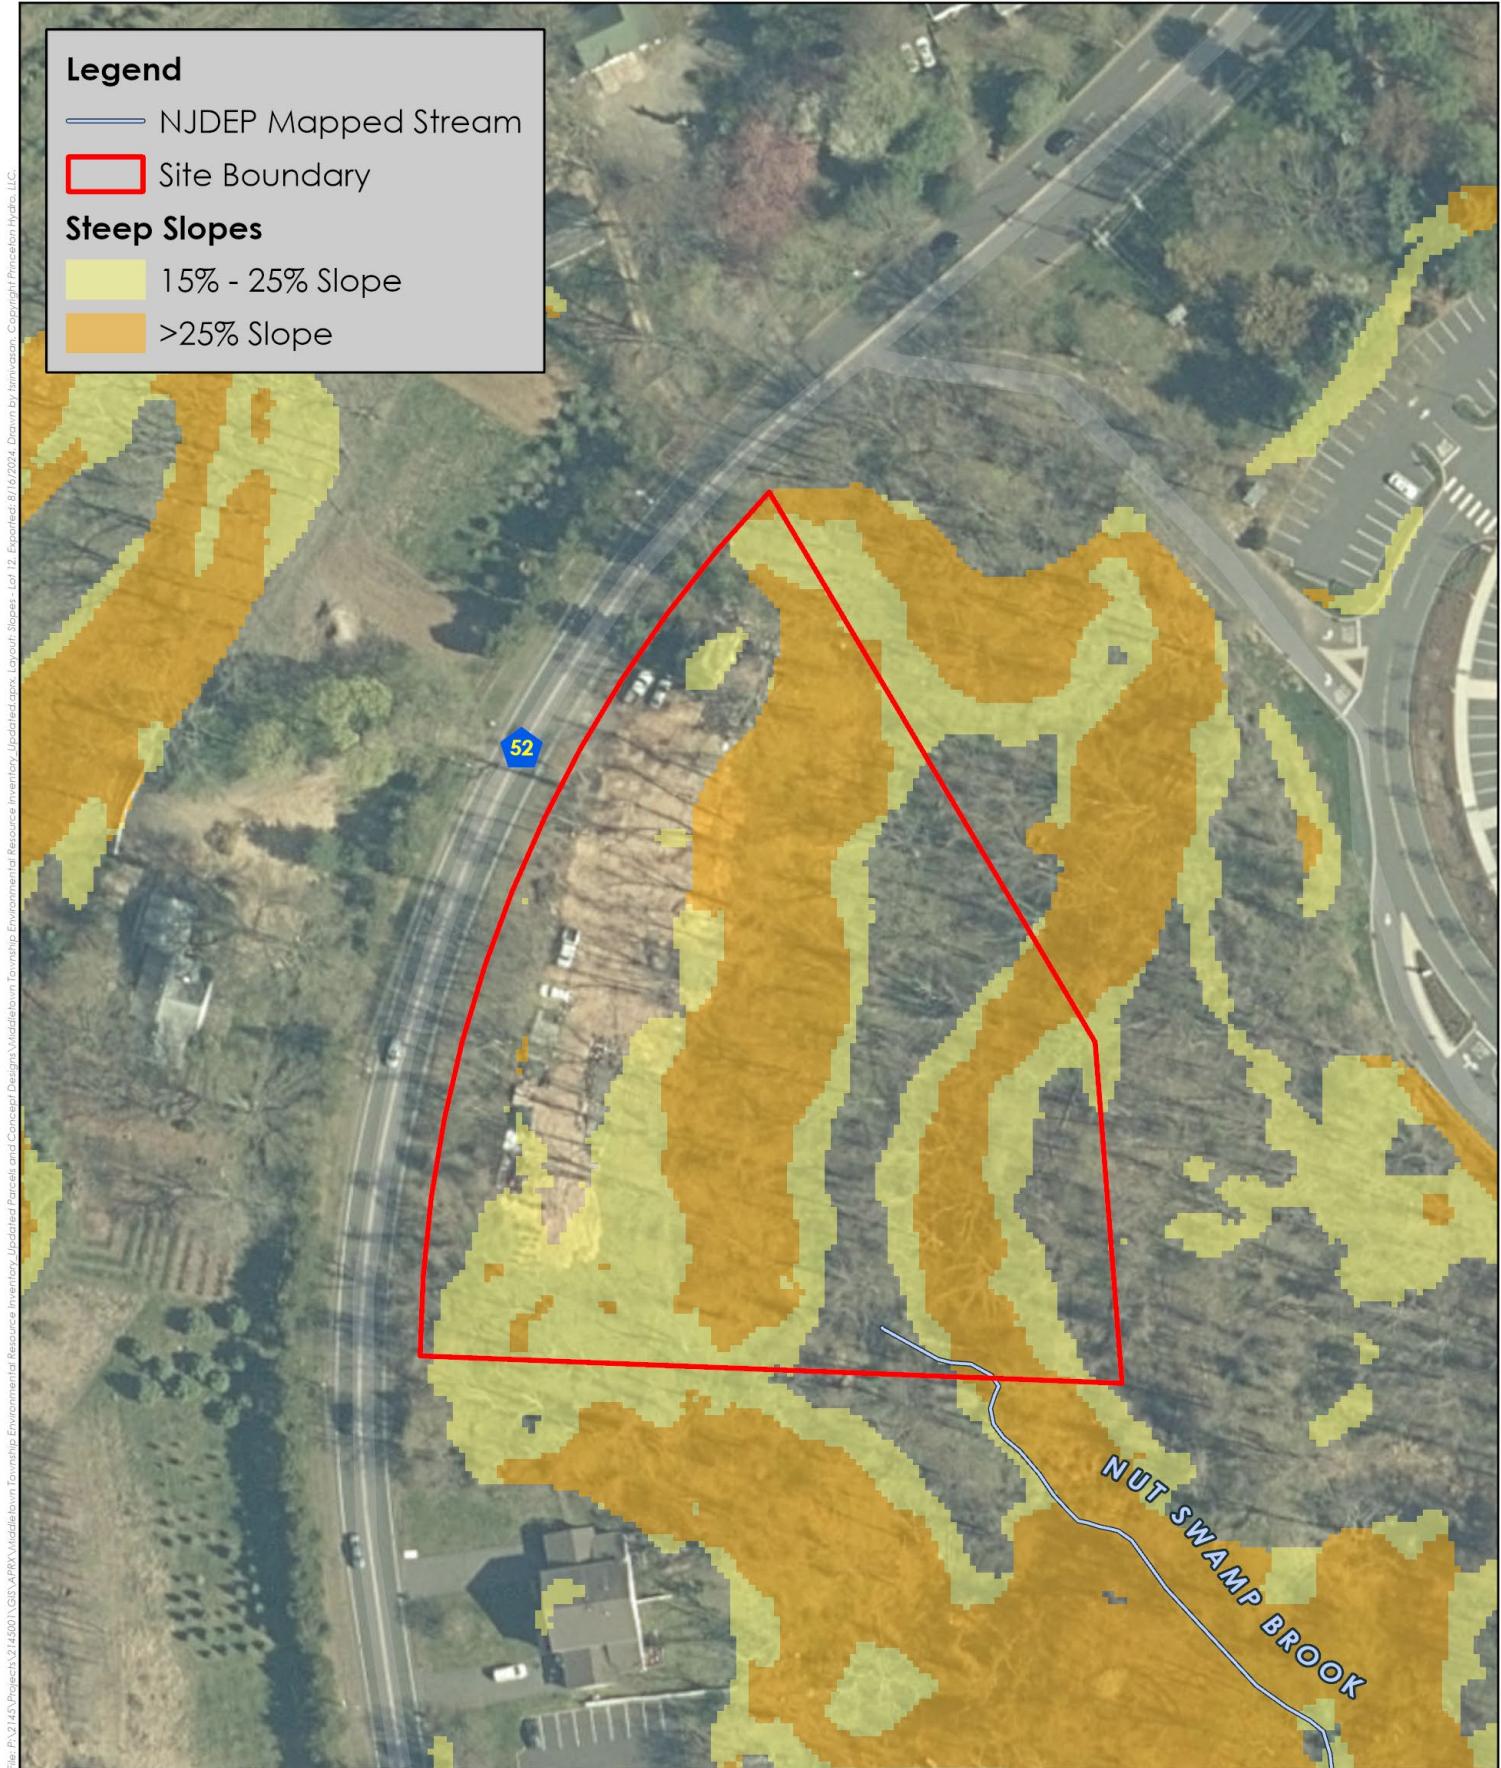
STEEP SLOPES MAP

Steep slopes (>15% slope) comprise approximately 1.48 acres, or 57.9% of the Site. Of those steep slopes, approximately 0.81 acres, or 31.6% of the Site, would be classified as critical slopes (>25% slope) under Middletown Township municipal code. The largest contiguous area not encumbered by steep slopes is present within the western portion of the Site.

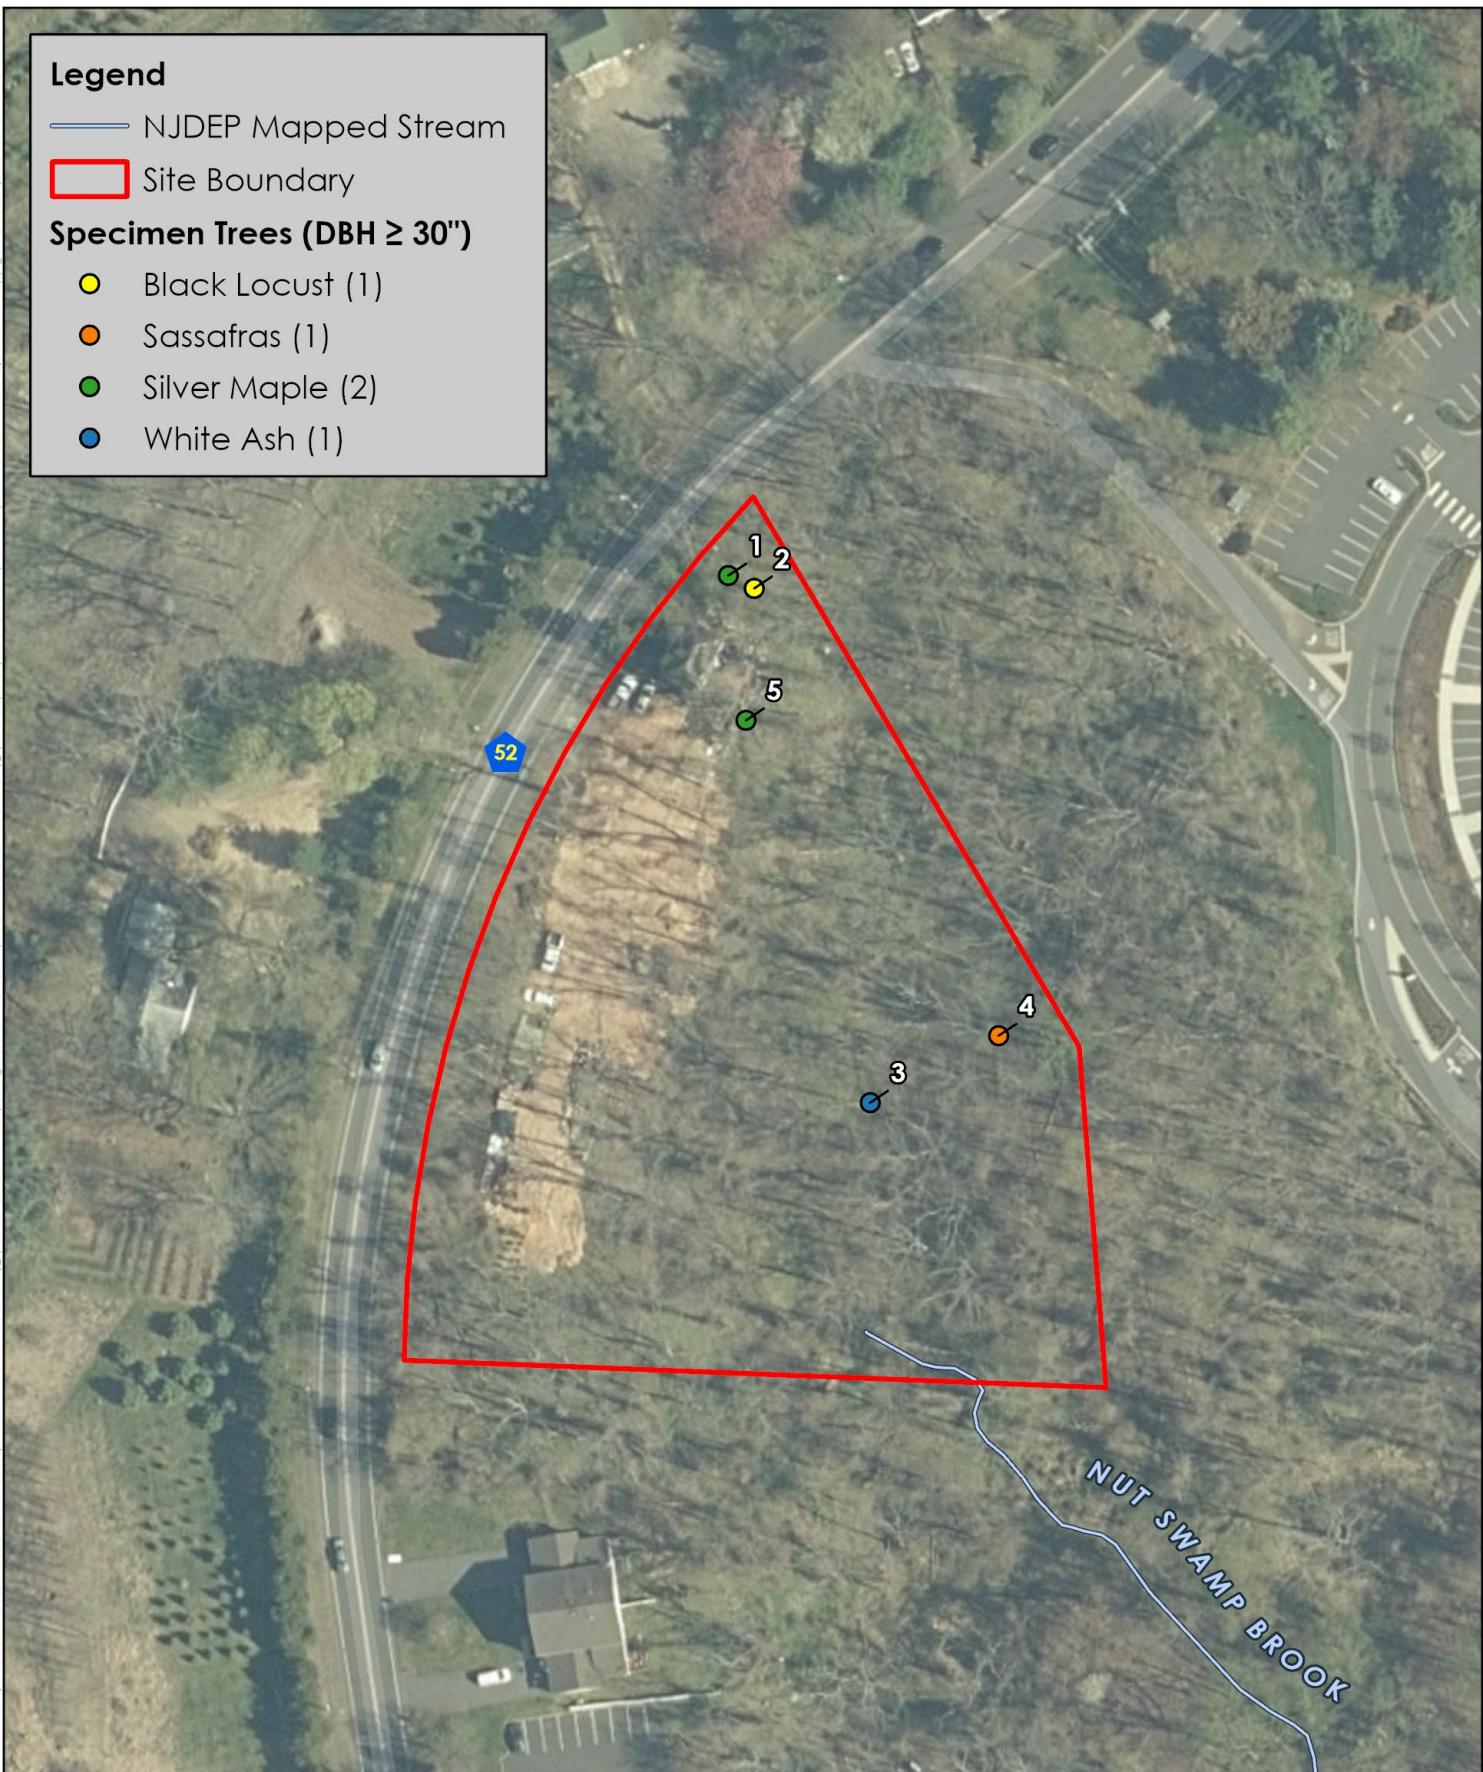
TREE INVENTORY MAP

Five (5) individual trees fitting the inventory criteria were identified on-Site, specifically the criteria for a specimen tree, with a DBH of 30" or greater. The DBH of specimen trees ranged from 31.1 to 40.7 inches. The specimen trees were comprised of four species.

Land development on the Site may require the removal of small to mid-sized trees. Disturbance to the on-Site forest through the removal of trees is reasonably likely to interrupt and hinder the ongoing forest maturation process by removing established trees, creating canopy openings, and fragmenting the forest. Any remaining forest habitat after development is reasonably likely to be of lower ecological quality and higher vulnerability due to habitat fragmentation; Fragmented habitat generally has a lower diversity of plant and animal species, lower tolerance to disturbance, and greater vulnerability to non-native and/or invasive species which typically outcompete native species in disturbed settings (NJDEP 2020). The removal of trees, and other forest vegetation, is reasonably likely to increase the soil erosion and stormwater runoff, which may in turn degrade the water quality of on-Site and downstream open waters and associated wetlands, depending on inclusion, design, and maintenance of mitigating design features and best management practices.

trees on-Site which would receive such protection under §540-651C include all healthy specimen and mature shade trees of twelve-inch caliper or greater, healthy specimen trees of eight-inch caliper or greater, and healthy ornamental trees of four-inch caliper or greater. Additionally, the extent of tree removal and clearing activities required by development of the Site would likely constitute a regulated activity under §540-534B. As such, per §540-534C and §540-534D, any Site development plans must undergo a review and approval process with the Township Zoning Officer and Township Engineer, and shall be reviewed for potential drainage or erosion impacts to adjoining properties, and potential alternative or optional measures that could mitigate the impacts of tree removal and clearing activities.

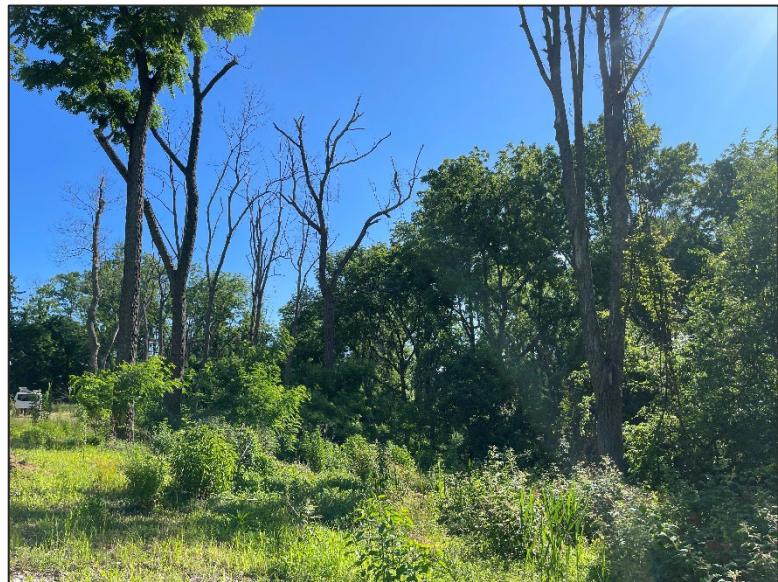
Figure 5: Photo of On-Site Large Standing Dead Trees

Red-headed Woodpecker habitat is generally characterized by a scattering of mature trees with an open or herbaceous understory or forest edge associated with nearby open areas. Nest cavities are usually in dead trees or, less frequently, dead limbs in living trees (NJDEP 2023). The Site contains such forest edge habitat, and notably contains several large standing dead trees (**Figure 5**) which could serve as potential nesting sites for Red-headed Woodpecker.

In summary, development of the Site will not impact any confirmed threatened and endangered species habitat. However, development may reduce undocumented and/or potential nesting habitat for Red-headed Woodpecker, a threatened species in New Jersey, and may hinder the natural development of potential habitat for Wood Thrush, a species of special concern in New Jersey.

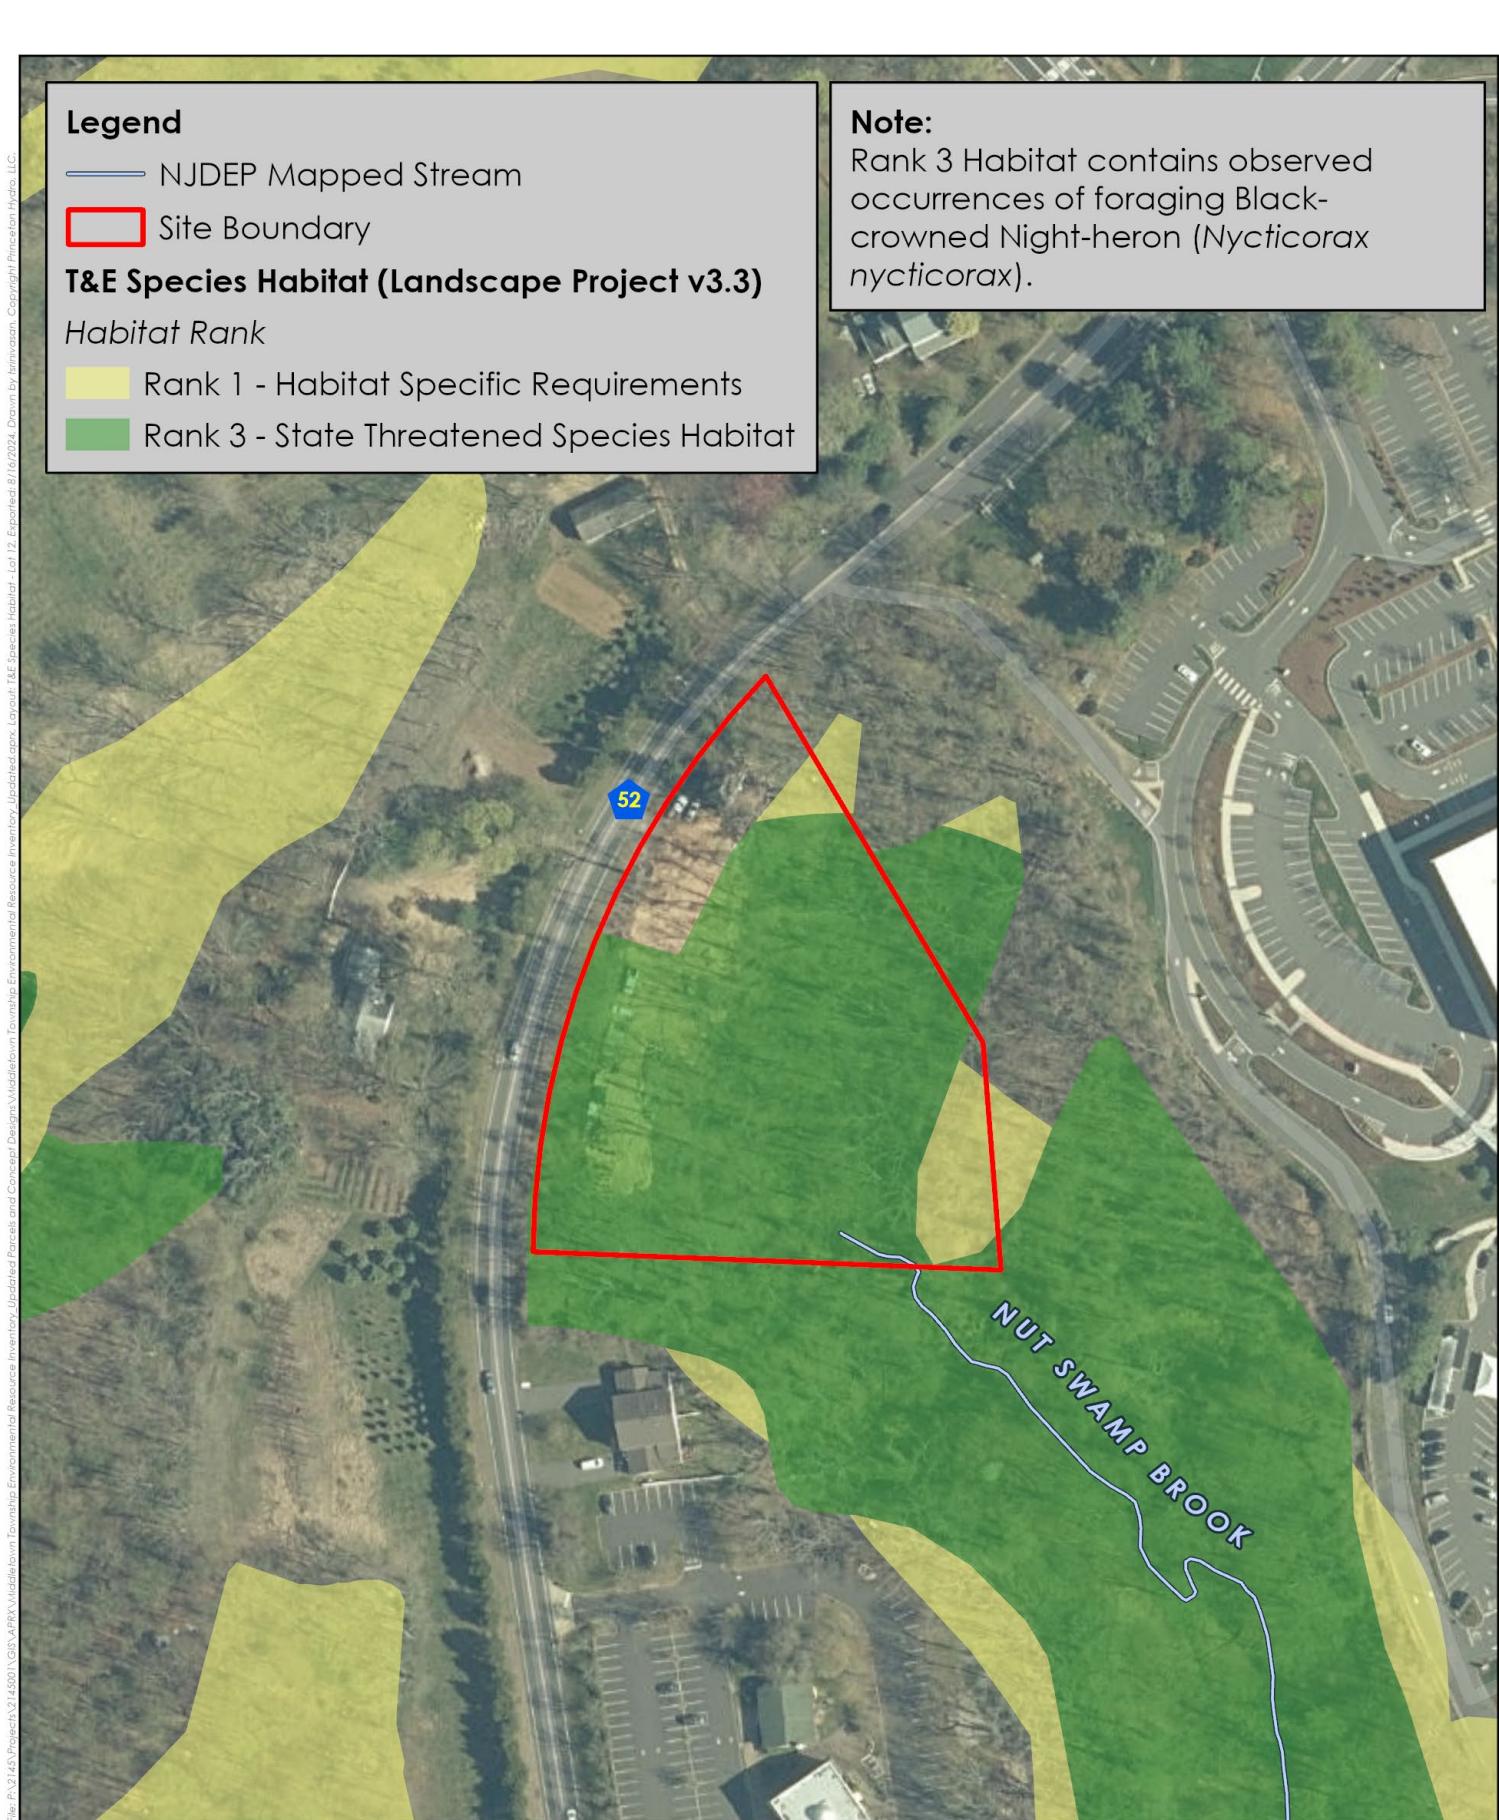
**T&E SPECIES
HABITAT MAP**
ENVIRONMENTAL RESOURCE INVENTORY
BLOCK 1045, LOT 12
MIDDLETOWN TOWNSHIP
MONMOUTH COUNTY, NEW JERSEY

Rank 1 habitats are those areas that meet one or more habitat specific requirements of T&E species, but where no observed occurrences of T&E species exist. Rank 1 habitats were identified on the Site along its northern and southeastern edges. The Site's Rank 1 habitats were ranked as being either wetlands or riparian corridors, which possess the potential to provide suitable habitat for T&E species.

Rank 3 habitats are those areas that meet one or more habitat specific requirements of T&E species and where there has been an observed occurrence of a species considered threatened by the State of New Jersey. Rank 3 habitats were identified throughout the majority of the Site with the exceptions being the extreme northwest and southeast portions. The Site's rank 3 habitats were comprised of wetlands and/or riparian corridors and by their proximity to an observed occurrence of Black-crowned Night Heron (*Nycticorax nycticorax*), a threatened species in New Jersey.

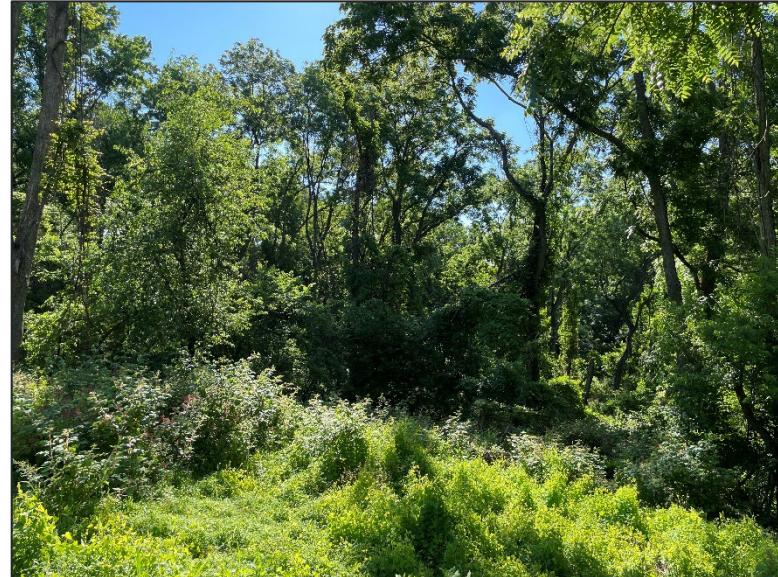
Figure 6: Photo of the Successional Hardwood Forest Community

The successional hardwood forest community was observed, primarily, within the eastern half of the Site, and comprised just over half of the Site (52.2%). This community generally aligned with the “other successional plant communities” as described in *Plant Communities of New Jersey* (Collins and Andrews 1994), and the “successional southern hardwoods” as described in *Ecological Communities of New York State* (Edinger et al. 2014). On-Site, this community generally had a mostly closed tree canopy, with some canopy gaps and clearings, and an understory layer that varied in density from moderate to dense (**Figure 6**).

The successional hardwood forest community understory contained mostly tree saplings, shrubs with sparse vines, and little to no herbaceous vegetation. The dominant shrub of the understory was northern spicebush (*Lindera benzoin*). Other characteristic shrub species included multiflora rose (*Rosa multiflora*), Morrow's honeysuckle (*Lonicera morrowii*), Japanese knotweed (*Polygonum cuspidatum*), and Japanese wineberry (*Rubus phoenicolasius*). The most common vine observed was poison ivy (*Toxicodendron radicans*). Other characteristic vine species included Japanese honeysuckle (*Lonicera japonica*), English ivy (*Hedera helix*), and an unidentified species of wild grape (*Vitis* sp.). Herbaceous species, where observed, were mostly ruderal and non-native species, including garlic mustard (*Alliaria petiolata*), purple dead-nettle (*Lamium purpureum*), and common reed (*Phragmites australis*).

Development of the Site would directly decrease the area of the Site’s extant ecological communities, namely the successional hardwood forest. In addition to reducing the overall area of ecological communities on-Site, development is also reasonably likely to degrade the quality and character of any ecological communities remaining after development due to habitat fragmentation. Fragmented habitat generally has a lower diversity of plant and animal species, lower tolerance to disturbance, and greater vulnerability to non-native and/or invasive species which typically outcompete native species in disturbed settings (NJDEP 2020).

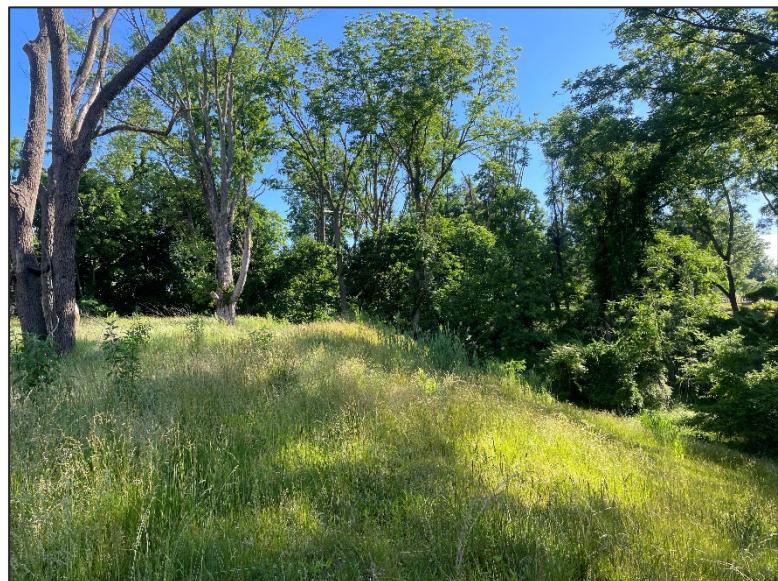
Figure 8: Photo of the Open Hillside Community

The open hillside was an area comprised of steep slopes, encompassing about 15% of the Site, between the cleared lot and successional hardwood forest. The area was primarily vegetated with herbaceous vegetation, with little to no woody vegetation (**Figure 8**) observed.

The Site’s anthropogenic communities (the cleared lot, open hillside, and ruderal wooded roadside) provide little ecological value due to their sparse vegetation and poor species diversity. These areas are likely to remain stable over time barring significant alteration of the Site, or abandonment of any management (e.g. occasional mowing, clearing, herbicide).

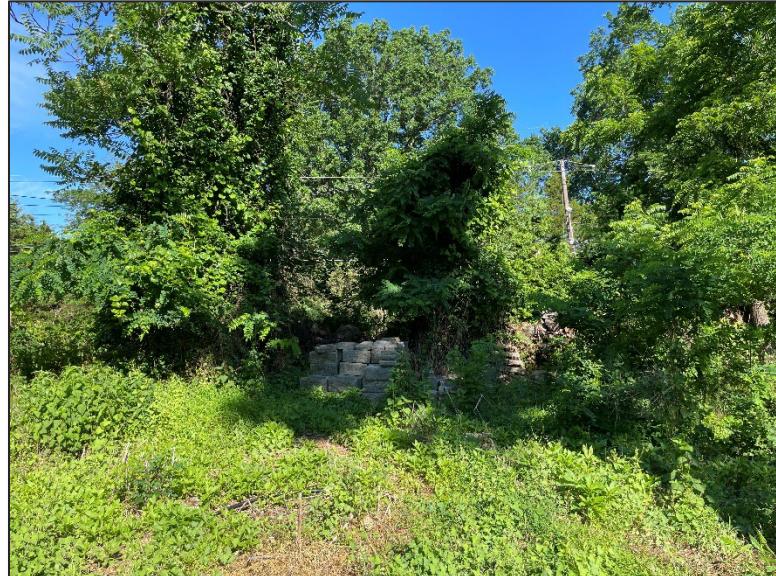
Figure 9: Photo of Ruderal Wooded Roadside Community

The ruderal wooded roadside community encompassed about 11% of the Site, along the narrow transition area between Red Hill Road and the cleared lot. This community generally aligned with the “urban vacant lot” as described in *Ecological Communities of New York State* (Edinger et al. 2014). The area contained a sparse mix of small trees, vines, and herbaceous plant species interspersed with piles of miscellaneous construction litter such as pallets, chopped wood, and cut stone (**Figure 9**).

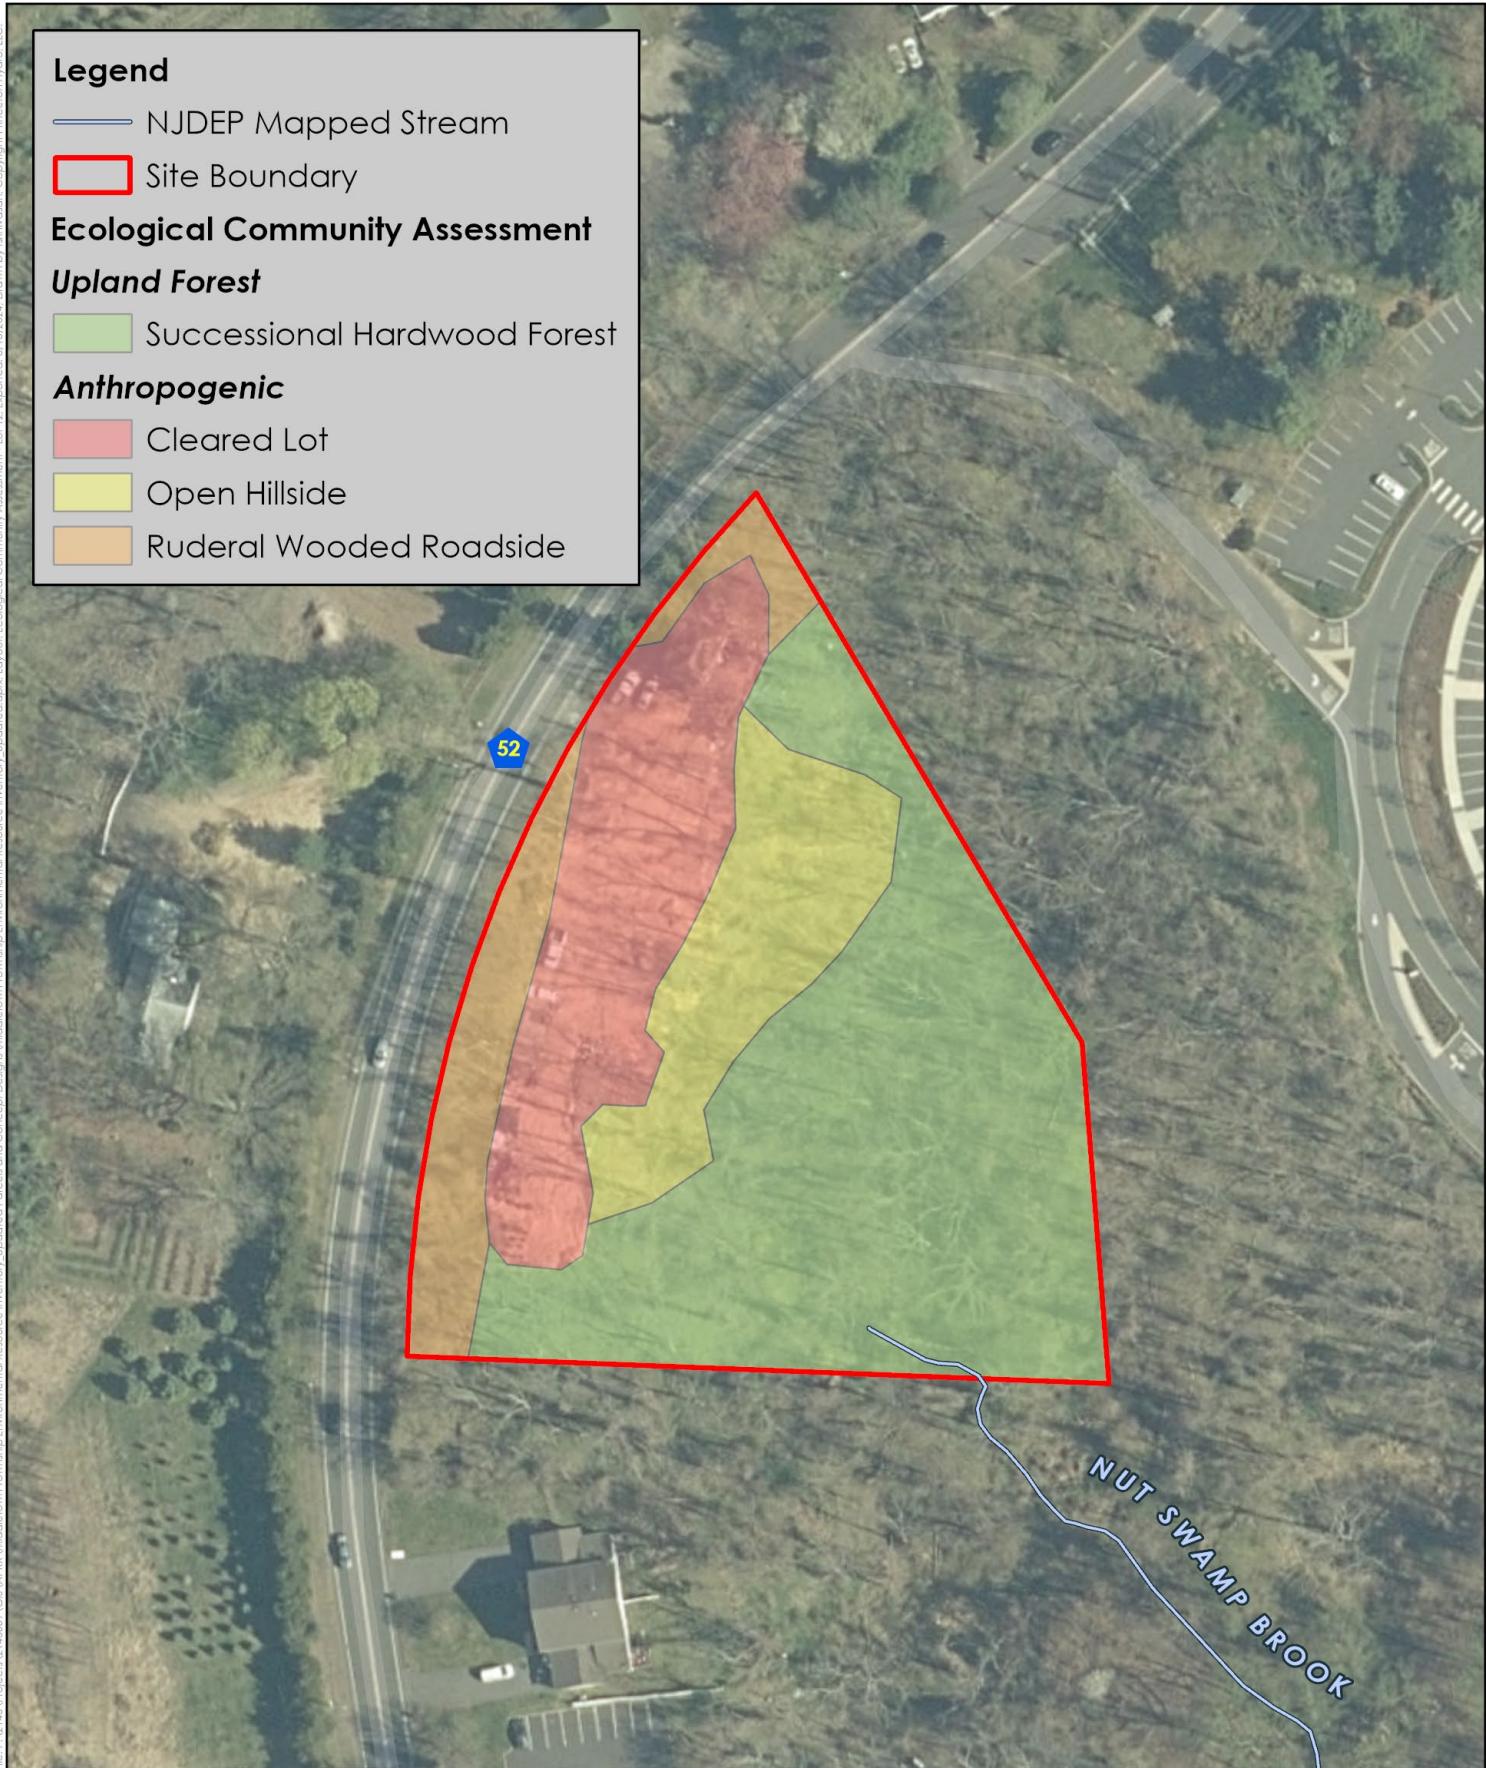
1. NJDEP mapped streams obtained from the NJDEP GIS website: www.state.nj.us/dep/gis/
2. Ecological community assessment performed by Princeton Hydro in March of 2024
3. 2020 orthoimagery obtained from the NJ Geographic Information Network (NJGIN) Open Data portal.
4. Site boundary provided by CPL Partnership, transmitted on 07/24/2024.
