Middletown Township
One Kings Highway
Middletown, New Jersey 07748

**REDEVELOPMENT
STUDY AND
PRELIMINARY
INVESTIGATION
REPORT**
Lunney's & Across
Town Towing
Block 70, Lots 1, 2 and 3

**T&M PROJECT NO. MIDD-10650/51
MARCH 6, 2013
REVISED AND RESTATED JULY 17, 2014**

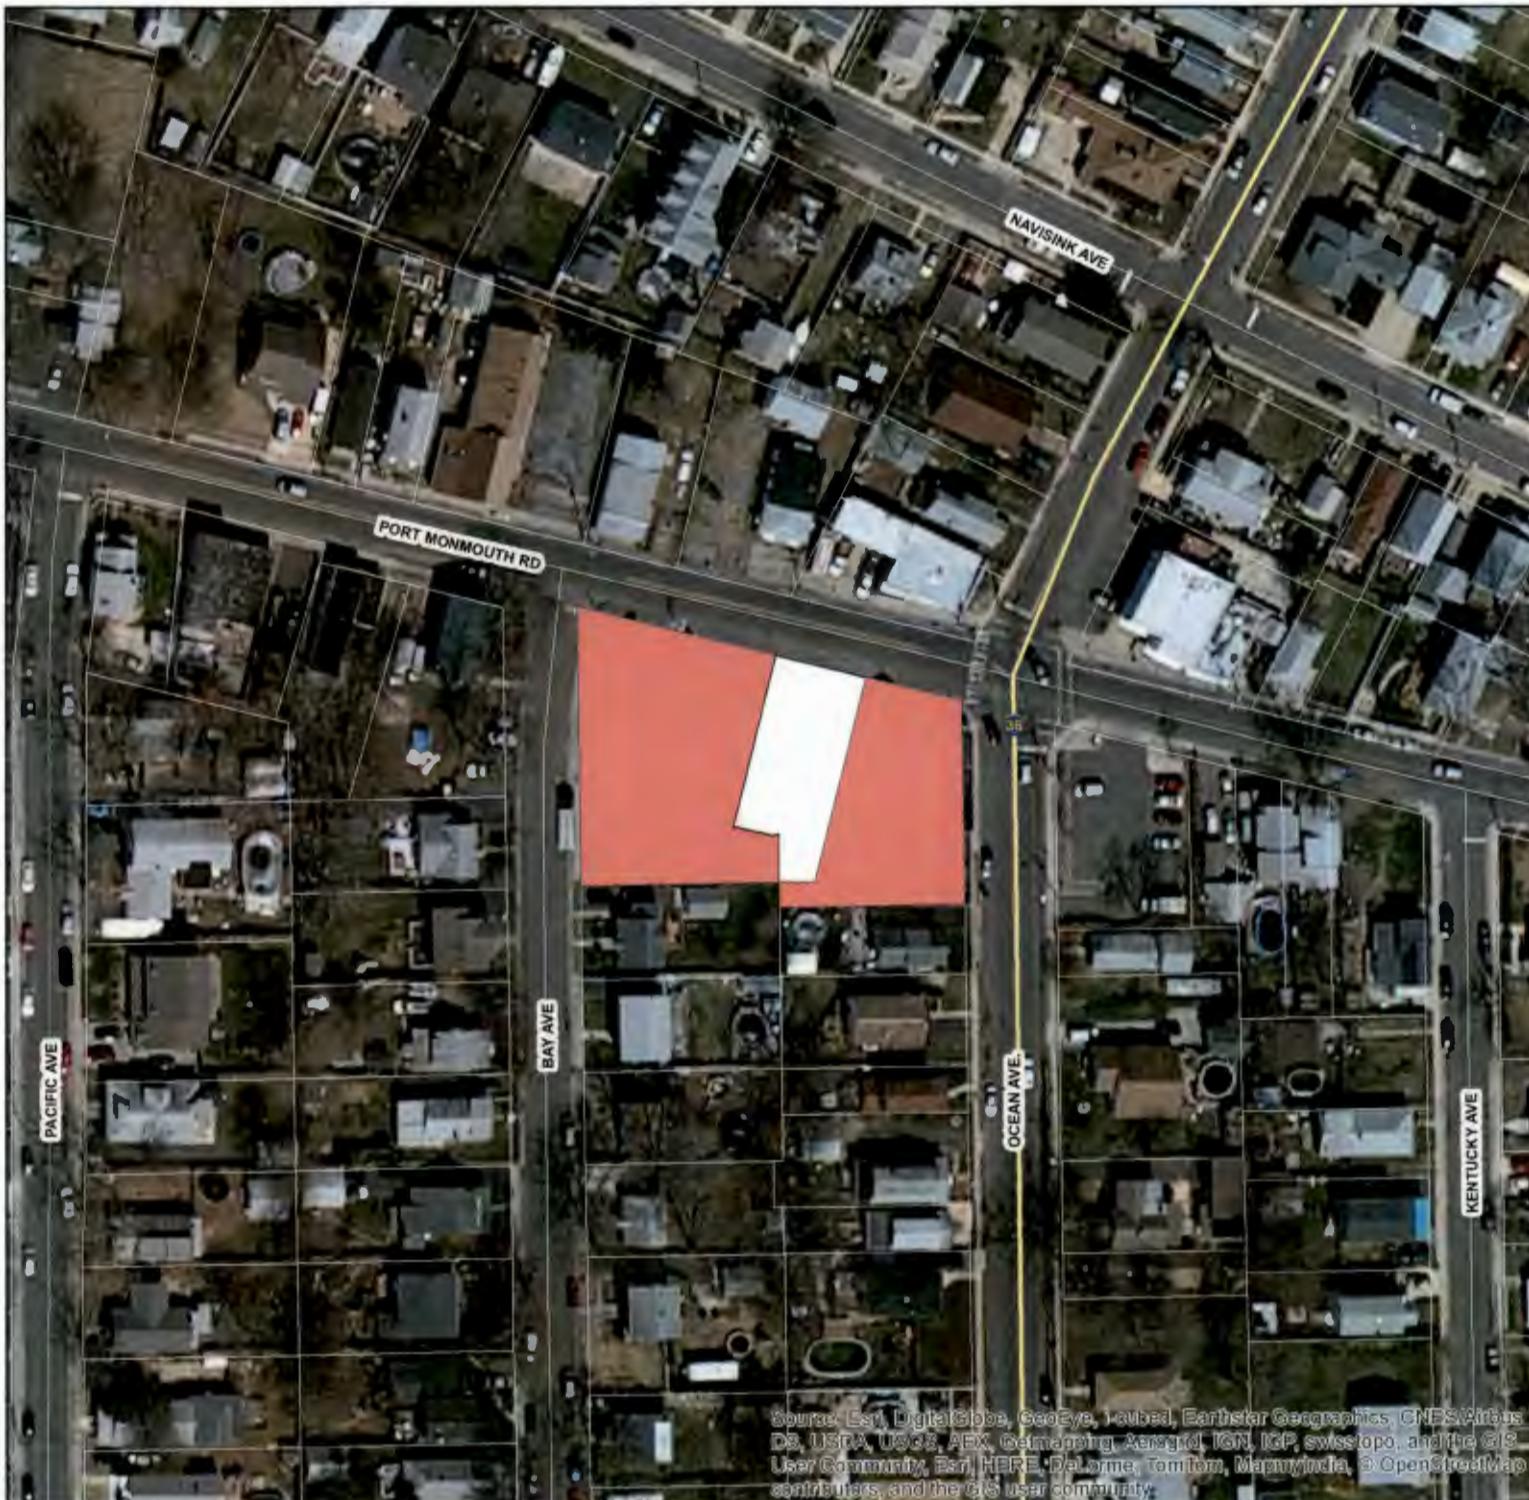
Figure 3
MOD-IV Data
Study Area
Block 70, Lots 1, 2 & 3
Township of Middletown
Monmouth County
New Jersey

Figure 3 depicts land use classifications in the study area based on MOD-IV data associated with tax assessment records. According to Township tax data, Lots 1 and 3 in Block 70 are classified as commercial properties, while Lot 2 is classified as vacant land. However, Lots 2 and 3 are in common ownership and are both associated with the former Lunney's commercial use on Lot 3. It should also be noted that the Lunney's building contains a formerly occupied residential use on the second story of the structure. A portion of the building on Lot 3 also extends into Lot 2, although that lot is classified as vacant in Township tax assessment records. Lunney's is abandoned and the building is currently unoccupied.

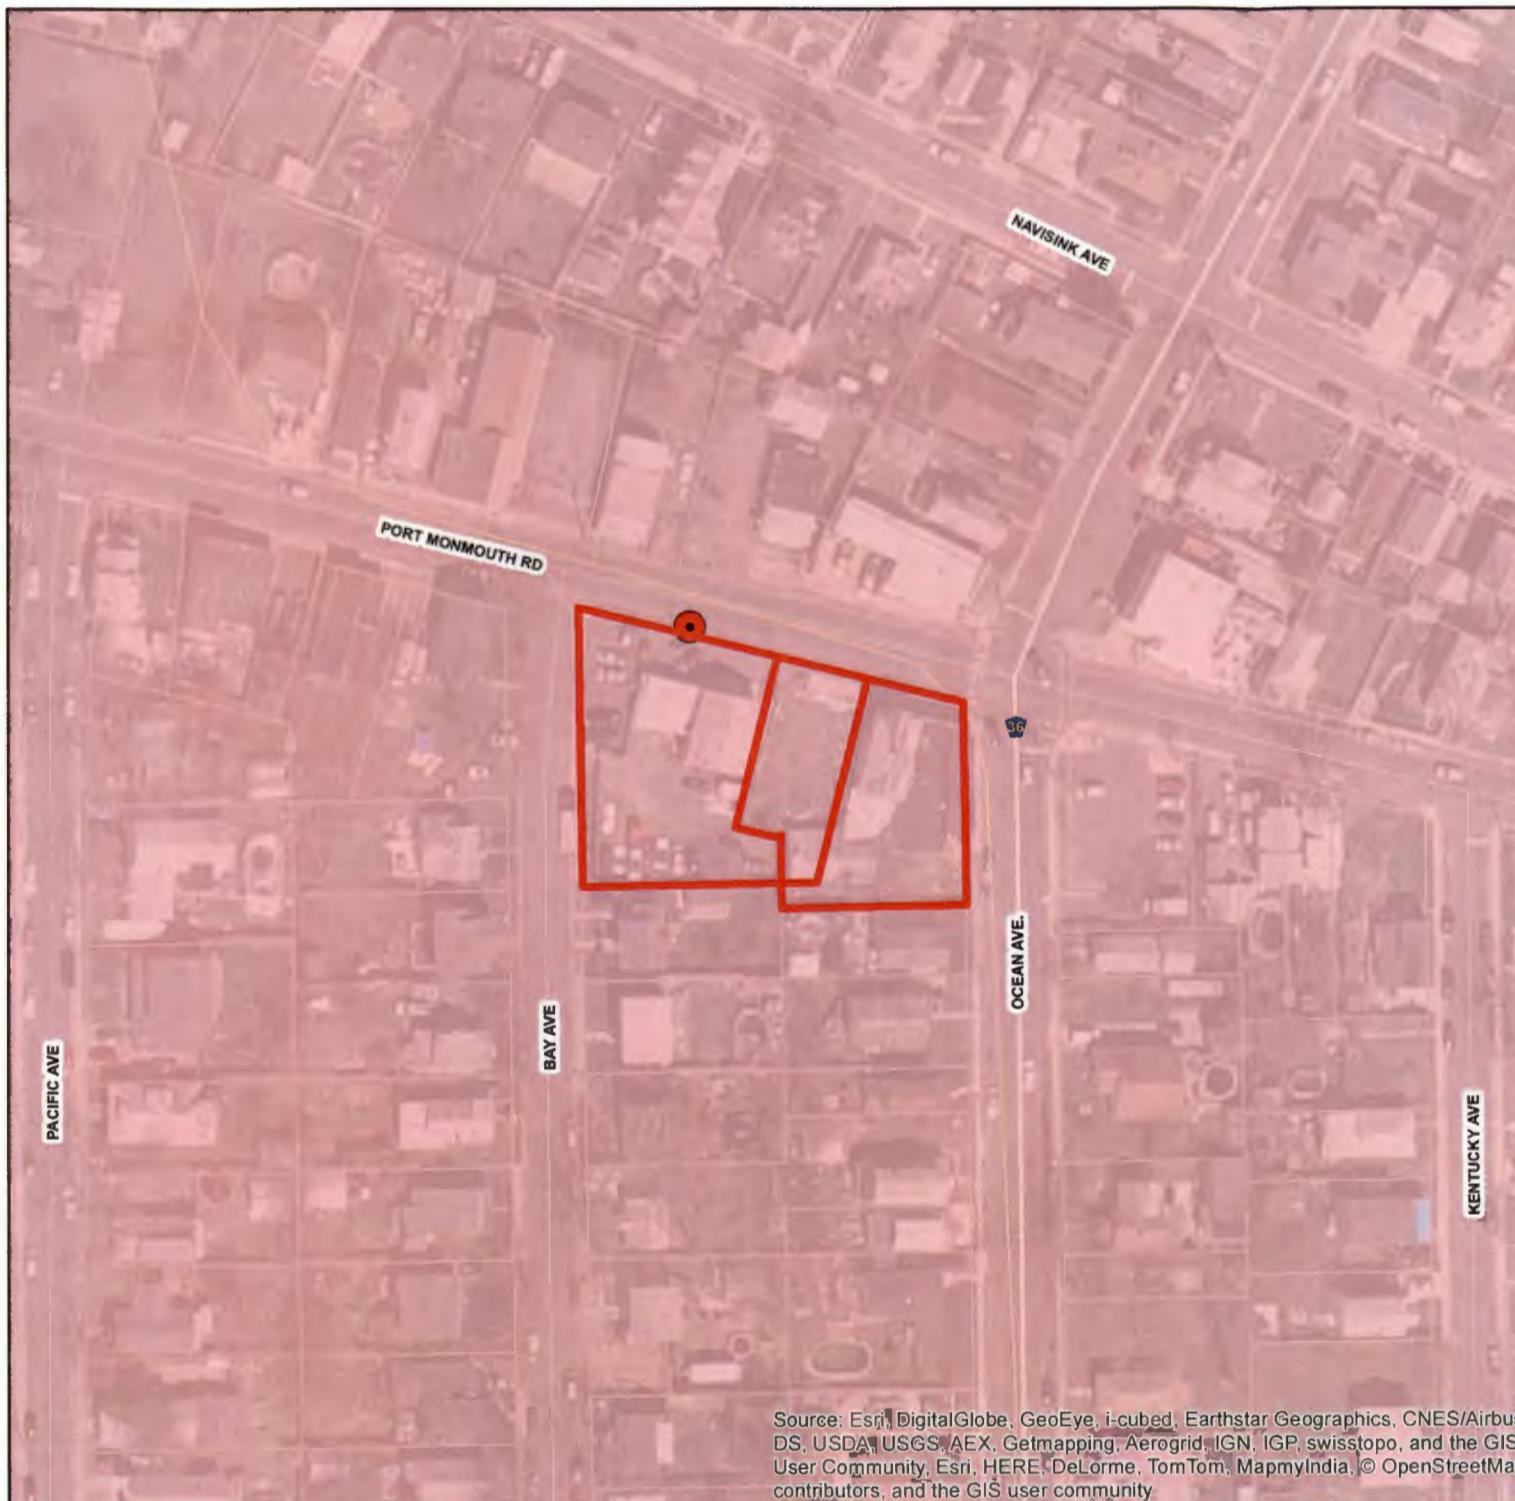
Figure 4
Environmental Constraints
Study Area
Block 70, Lots 1, 2 & 3
Township of Middletown
Monmouth County
New Jersey

As shown in Figure 5, the study area is devoid of any streams, watercourses and wetlands. However, the entire study area is located entirely within the AE Zone according to FEMA's Preliminary FIRM data released in January 2014. The AE Zone Designation within the study area carries with it a Base Flood Elevation of eleven (11) feet.

NJDEP data indicates that several remedial activities have taken place or are currently taking place on the site. In 2007, an underground storage tank was removed from the site and found to be in satisfactory condition.² At present, remedial activities are currently being conducted on the site in response to identified groundwater contamination that has migrated off-site. According to the Known Contaminated Sites List, the active case has a remedial level of "C2." The NJDEP Site Remediation Program's 1989 Case Assignment Manual notes that sites with a remedial level of "C2" are associated with more complicated contaminant discharges, multiple site spills and discharges, more than one contaminant, and impacts to both soil and groundwater.

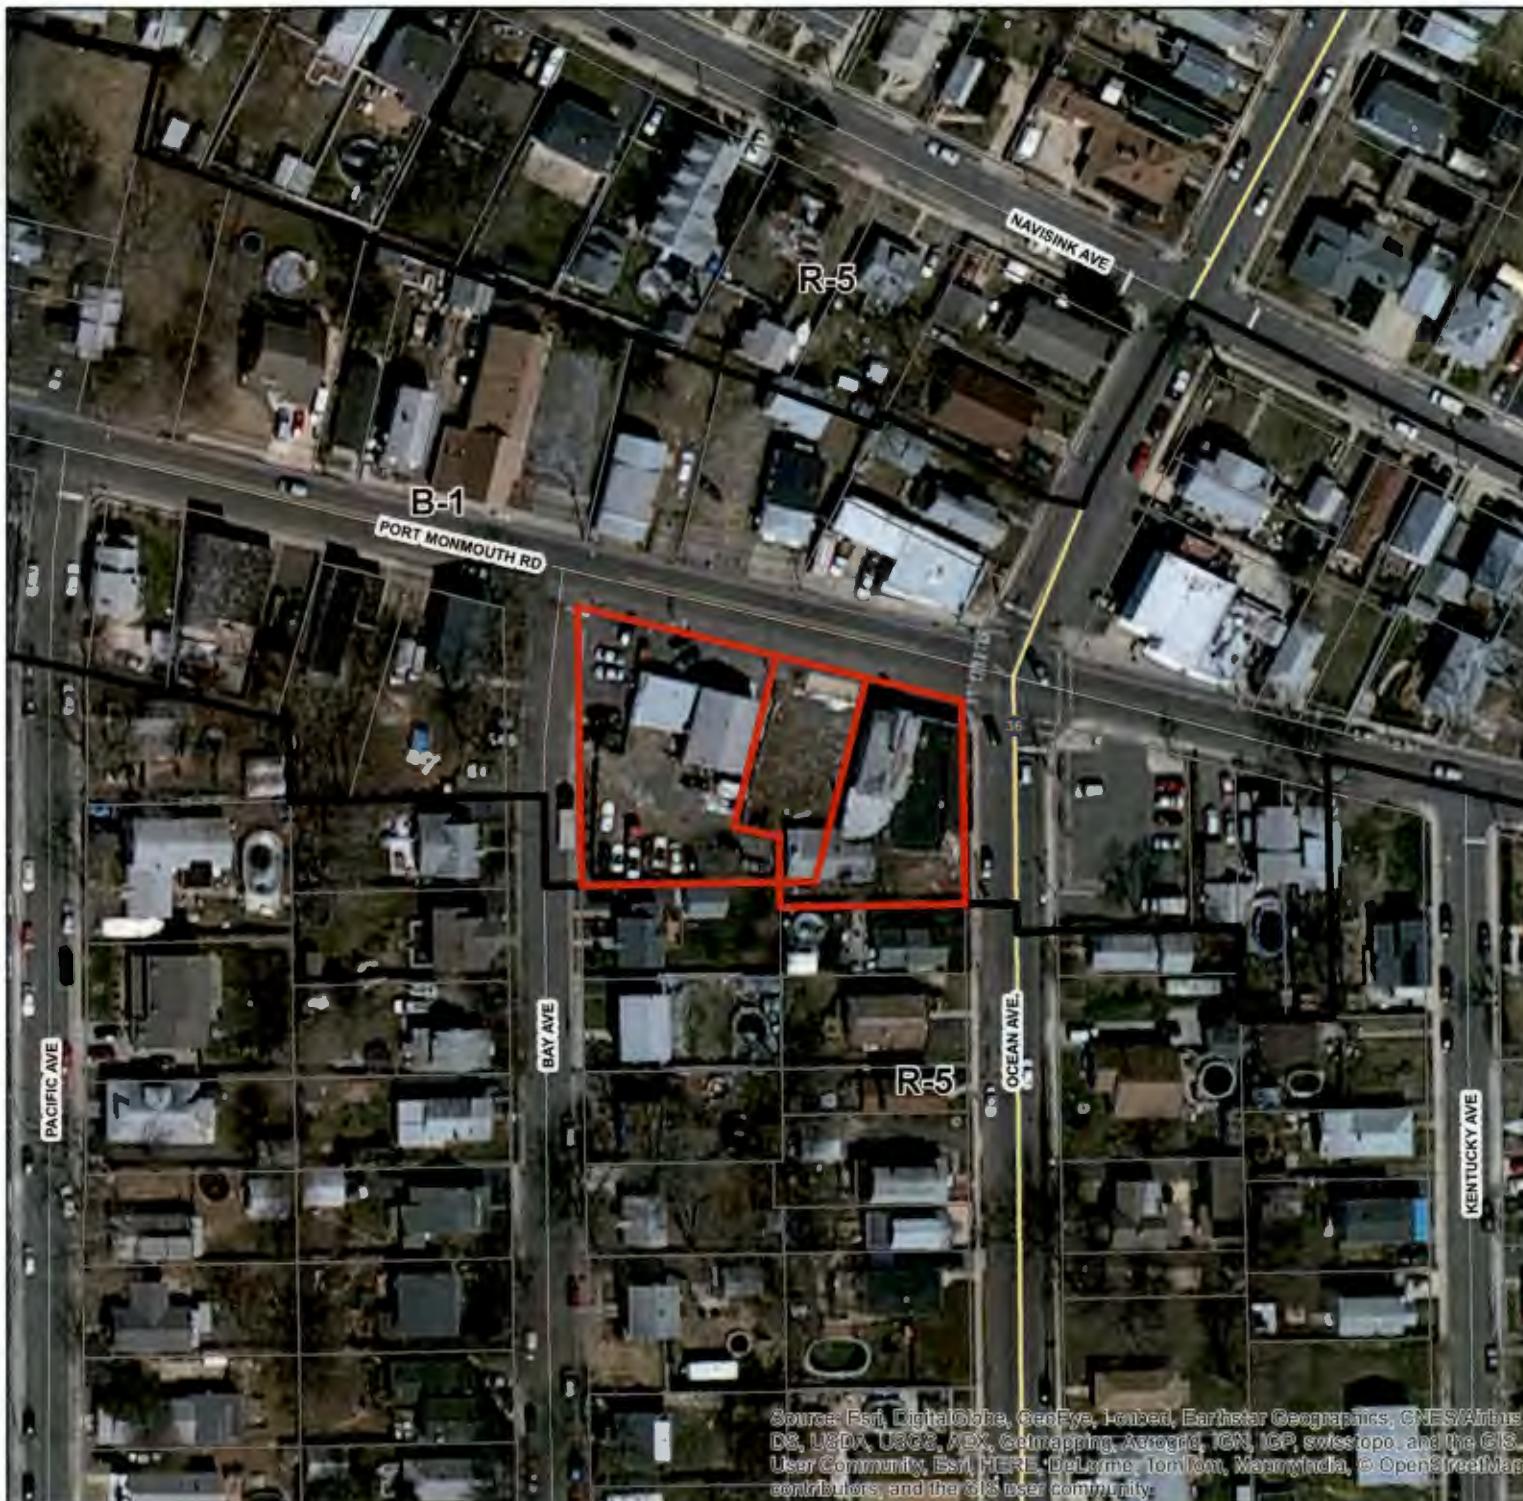
Figure 5
Current Zoning
Study Area
Block 70, Lots 1, 2 & 3
Township of Middletown
Monmouth County
New Jersey

The properties within the study area exhibit a number of existing non-conformities when compared to the required bulk and yard standards of the B-1 Business Zone. The properties within the study area exhibit insufficient yard setbacks, and Block 70, Lot 1 exceeds the maximum permitted lot coverage in the B-1 Zone.

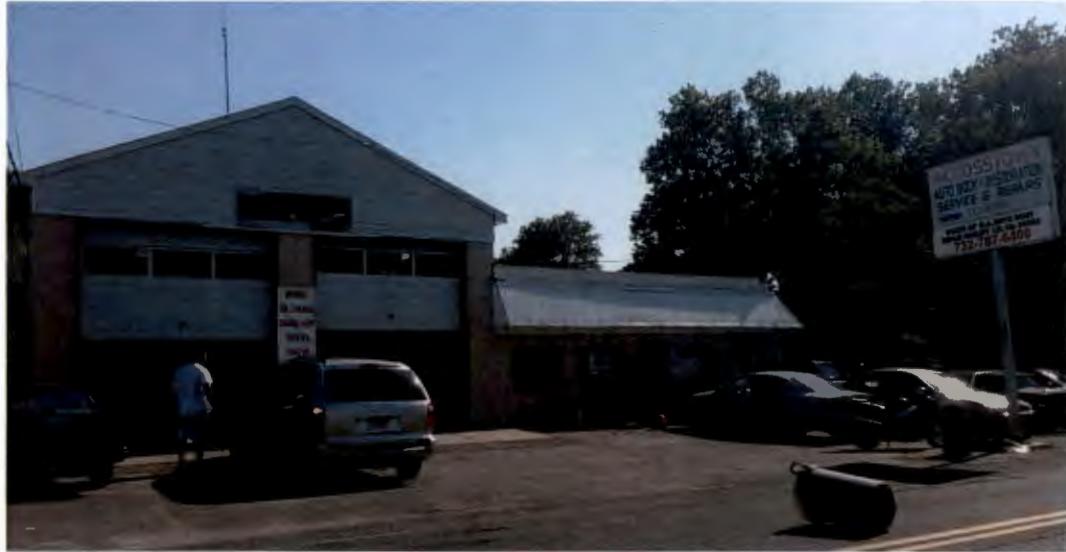
View of Block 70, Lot 1 from across Port Monmouth Road. There are a number of damaged vehicles parked along the property's frontage on Port Monmouth Road. A site investigation revealed that some of these vehicles appeared to be parked within an existing sewer easement.

Condition: Block 70, Lot 1 is a corner lot at the corner of Port Monmouth Road and Bay Avenue and has frontage on both streets. The property is the site of Across Town Towing, LLC, which operates a towing business and auto storage yard on site. The existing business offices front on Port Monmouth Road, while the entrance to the existing tow yard is located on Bay Avenue. Residential uses abut the site to the west and south. There is an existing sewer easement on the property along its frontage on Port Monmouth Road.

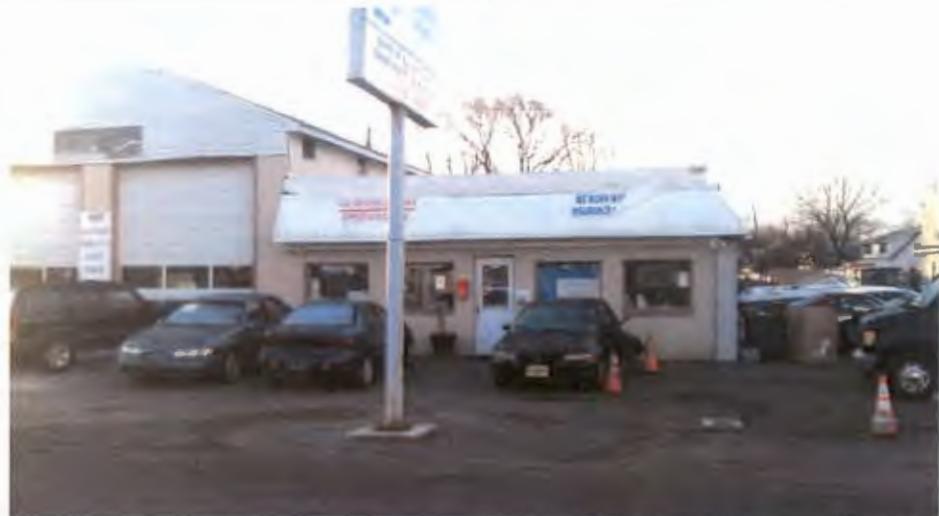
View looking south from Port Monmouth Road. The existing business utilizes traffic cones to mark potential on-site hazards including substantially damaged vehicles and potholes.

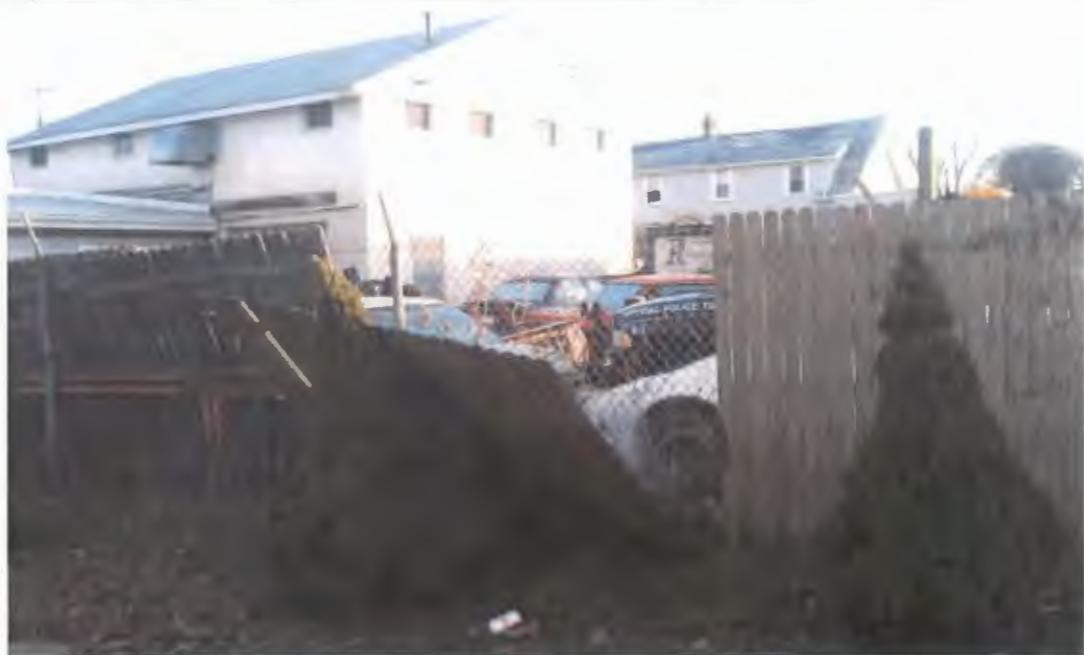
View of the rear of the existing building, including the existing tow yard. A site investigation revealed that segments of the existing privacy fence are damaged, which revealed haphazard storage of vehicles and outdoor storage of debris on-site.

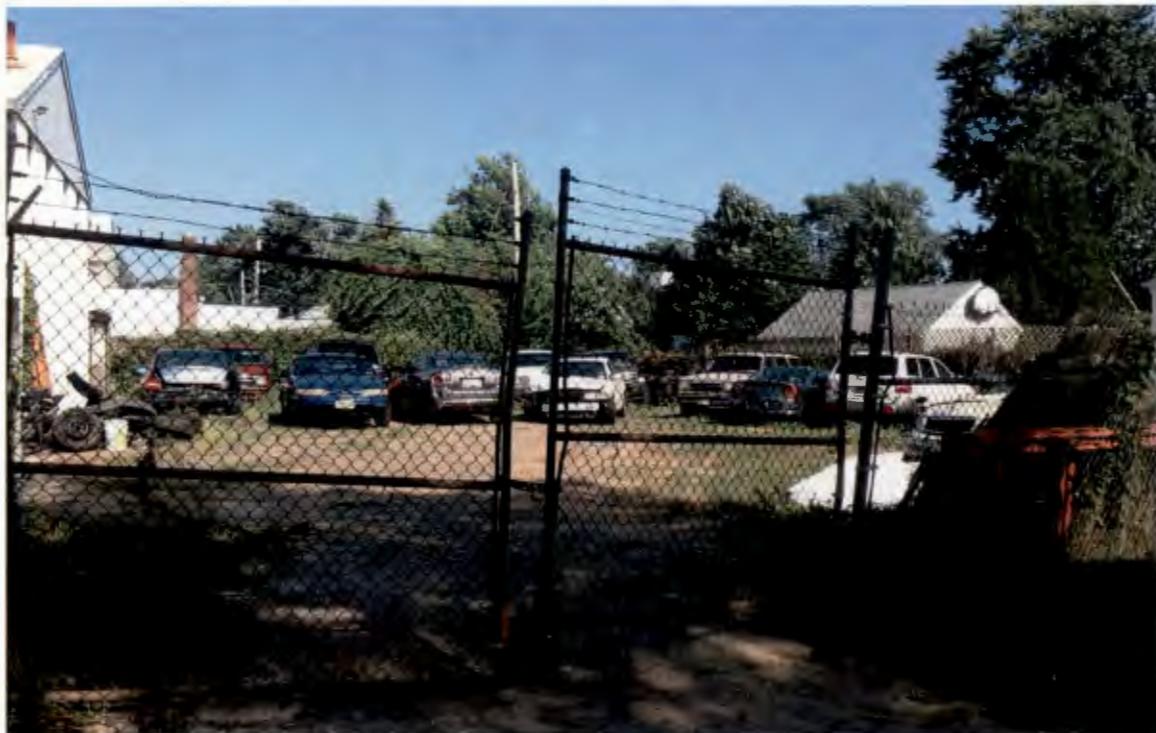
View of the existing tow yard. A pile of debris which includes spare auto parts is currently being stored in a hapazard fashion at the rear of the building. Piles of tires are also stored along the back fence line and there is some scattered debris throughout the site. The existing privacy fence is damaged and partially missing, and therefore provides insufficient buffering from adjacent residential uses.

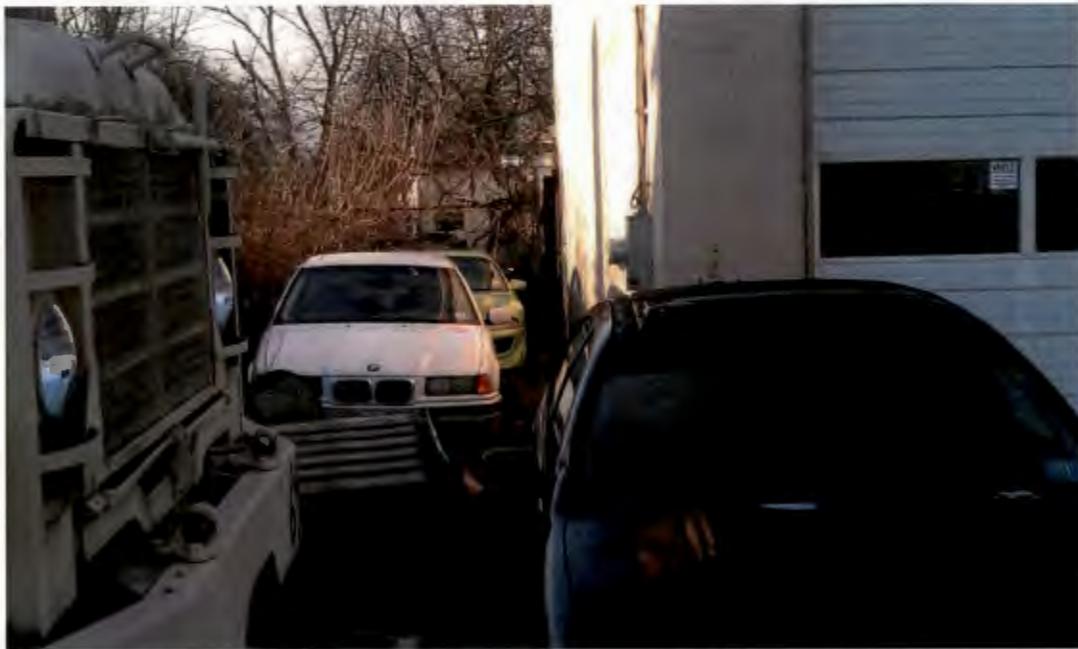
A view of the east side of the existing building on Block 70, Lot 1. Debris and disabled and damaged vehicles are being stored haphazardly on the side of the existing building.

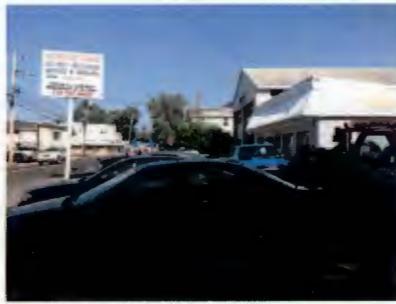
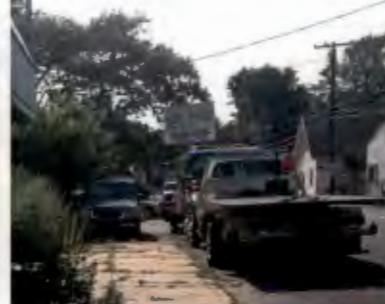
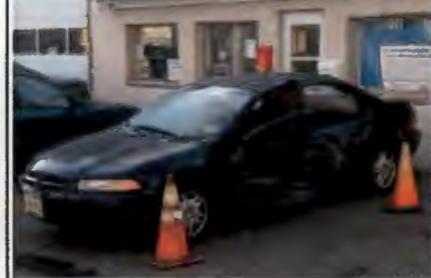
View of existing vehicle storage practices on the property. In the left and center photos, existing vehicle storage patterns encroach onto existing sidewalks, thereby preventing safe pedestrian movement. In the photo on the right, a substantially damaged vehicle is stored on the property's frontage with Port Monmouth Road.

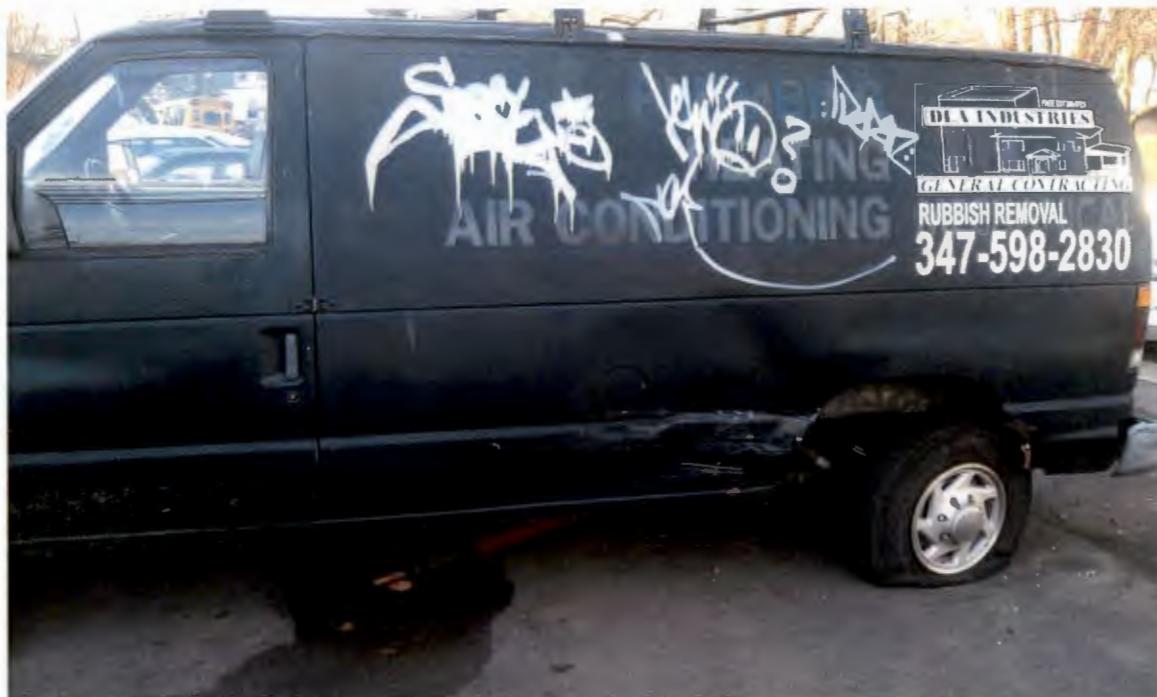
A disabled vehicle stored on Block 70, Lot 1, along the property's frontage on Port Monmouth Road. This vehicle is leaking fluid as seen above, which may be hazardous and may further contribute to contamination on site and on adjacent properties.

Redevelopment Criteria Summary:	
<input type="checkbox"/>	A: Substandard, unsafe, unsanitary, dilapidated, or obsolete buildings The site is currently developed with a building that appears to be in generally good condition from an exterior view of the building. Therefore, this criterion does not apply.
<input type="checkbox"/>	B: Discontinuance/abandonment of commercial or industrial buildings The site is currently being used for commercial and industrial purposes and is not abandoned. Therefore this criterion does not apply.
<input type="checkbox"/>	C: Privately-owned vacant land/publicly-owned land The land is neither vacant nor publicly owned. Therefore, the 'c' criterion does not apply.
<input checked="" type="checkbox"/>	D: Areas with dilapidation, overcrowding, faulty arrangement or design, obsolete layout, deleterious land use The site may be designated in need of redevelopment due pursuant to the 'd' criterion. The operation of the existing business has a negative impact on surrounding properties as evidenced by the groundwater contamination present on Block 70, Lots 2 and 3 as described in the Limited Site Investigation Report prepared by French & Parrello Associates, P.A. In addition, the layout of the site is haphazard and disorderly. Existing fencing on the site is in a state of disrepair, damaged and disabled vehicles are stored haphazardly on the site, debris is scattered throughout the site and stored haphazardly in a pile at the rear of the existing building, some vehicles encroach upon or completely block the sidewalk along Port Monmouth Road, there is inadequate on-site parking and loading areas due to vehicle storage practices, and ingress and egress to the site is not clearly defined, leading to poor on-site circulation. In addition, at least one disabled vehicle is leaking fluids on site, which may further contribute to on-site and off-site contamination of soil and groundwater.

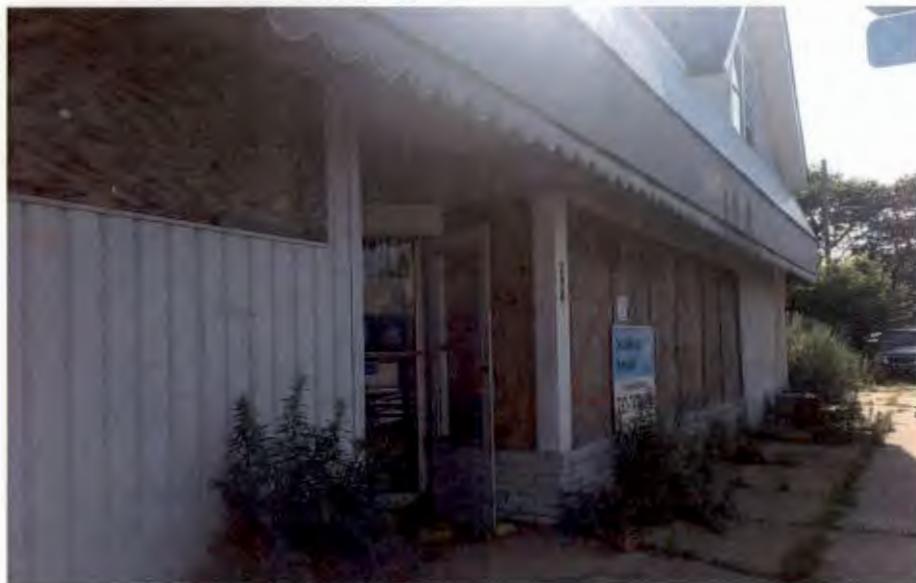
A view of the front of the existing Lunney's building on Block 70, Lots 2 and 3. The windows are boarded up and the property is overgrown. The uses on the site have been discontinued and the site is unproductive.

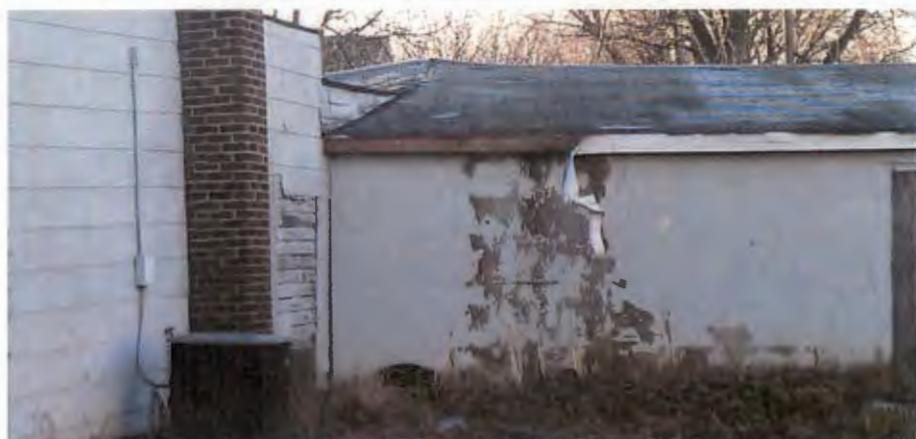
A view of the west side of the existing Lunney's building on Block 70, Lots 2 and 3. The exterior walls of the building exhibit peeling paint and overall lack of maintenance. In addition, the roof is dilapidated and partially collapsed. The roof section seen here exhibits deteriorated and detached fascia, missing roof shingles and bowing.

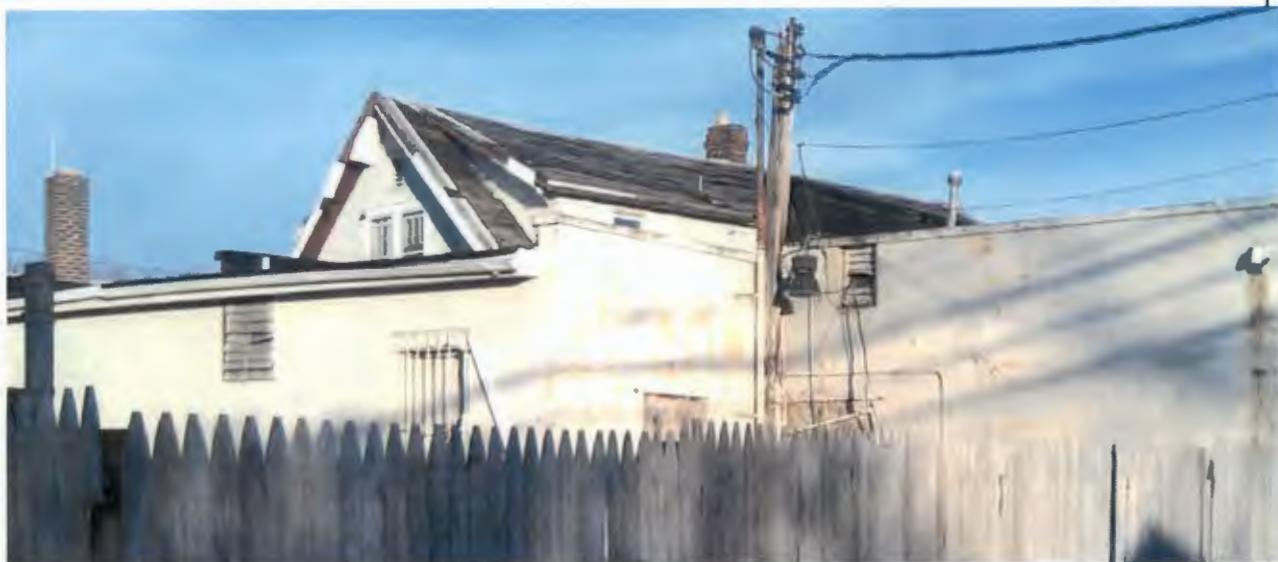
View of the existing Lunney's building from Ocean Avenue, looking northwest. The use of the existing building has been discontinued and the building now exhibits signs of dilapidation. This photo depicts peeling and missing exterior paint, boarded up windows, haphazardly organized wiring and damaged exterior ventilation grilles. The roof section seen here exhibits significant deterioration including deteriorating fascia and soffits and swaths of missing shingles.

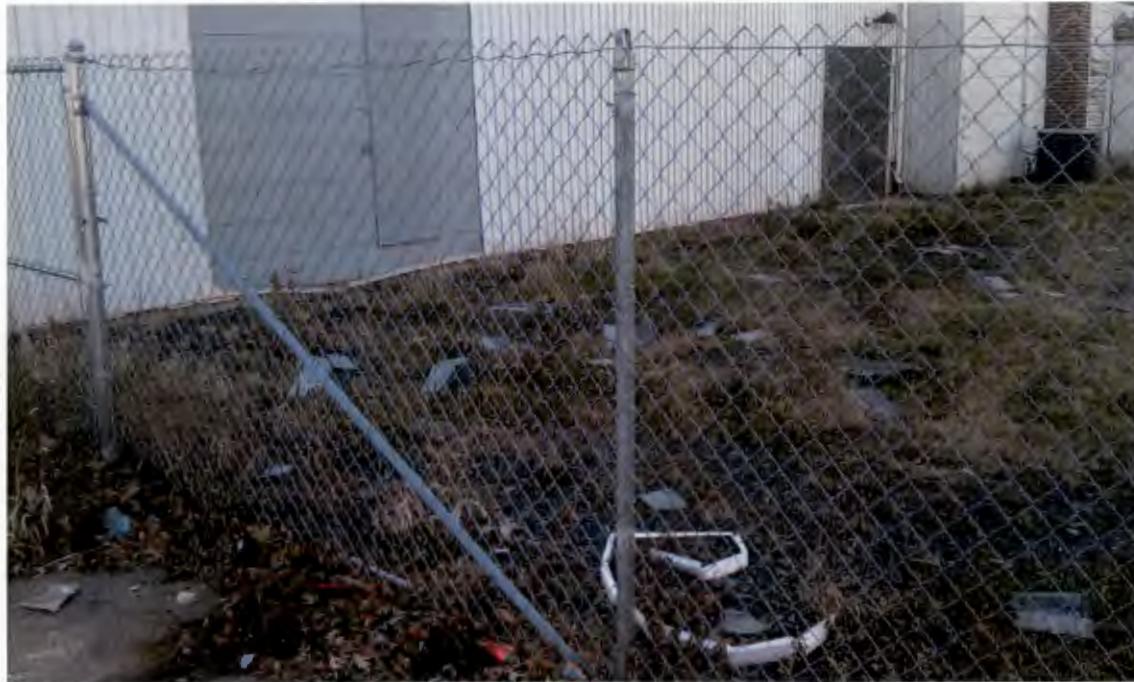
View of the undeveloped area of Block 70, Lot 2 along the property's frontage with Port Monmouth Road. The property and existing building have been neglected for an extended period and the property is in disrepair. There is a substantial amount of debris on the property, including roof shingles and fascia as seen here. In addition, vegetation on the property is overgrown and trash is strewn throughout the property.

It should also be noted that undeveloped areas of the site are overgrown and strewn with debris including roof shingles and fascia. There is a significant amount of trash and debris along the sidewalk at the front of the building.

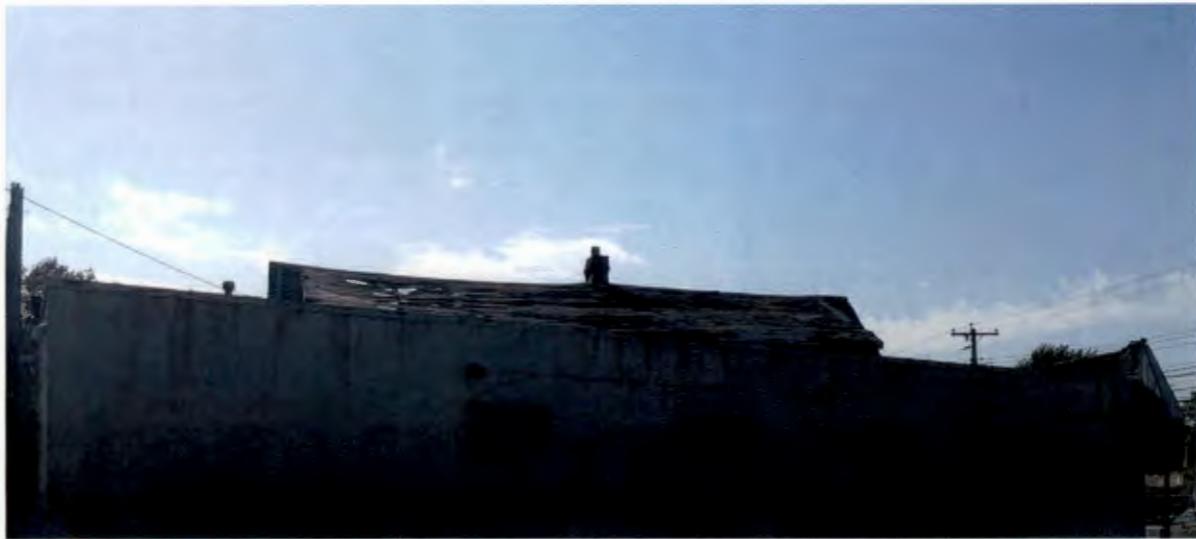
A view of the eastern portion of the roof of the Lunney's building, Block 70, Lots 2 and 3. The building exhibits significant signs of dilapidation. Many of the shingles on the existing roof are missing revealing the plywood sheathing and felt underlayment of the existing roof. In other areas, the roof is completely rotted and partially collapsed.

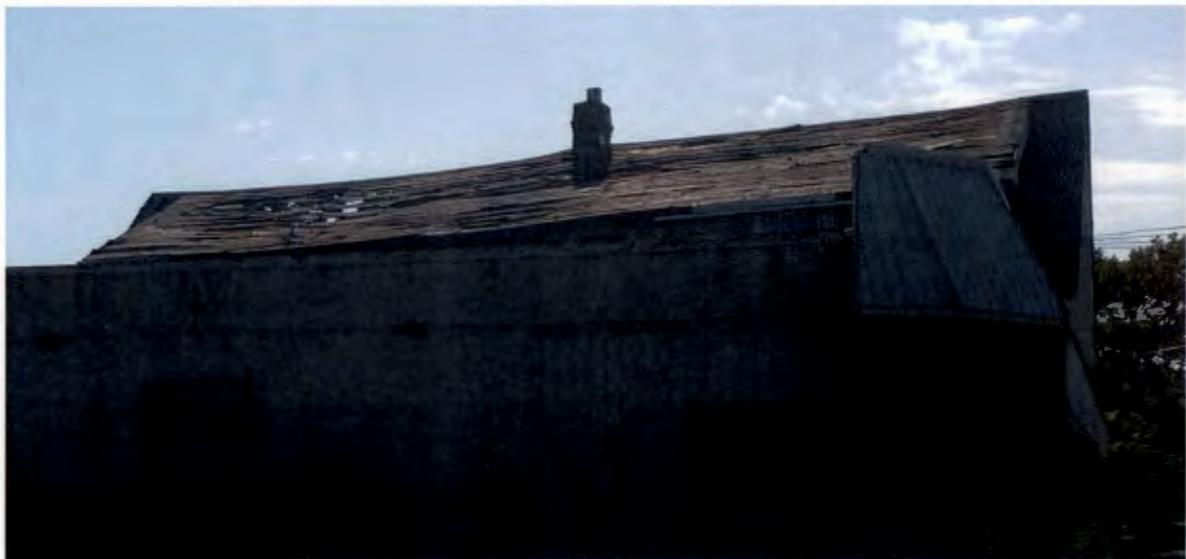
A second photo of the existing condition of the roof of the existing Lunney's building. The roof is partially collapsed.

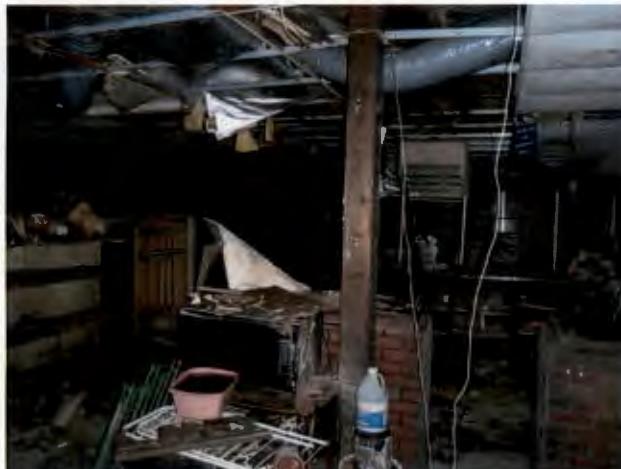
First floor interior of the Lunney's building. The interior of the building is unsanitary, represents unwholesome working conditions and exhibits significant neglect and disrepair. This photo depicts a damaged ceiling, trash and other debris, and what appears to be chemical waste. *(Photo courtesy of Middletown Township)*

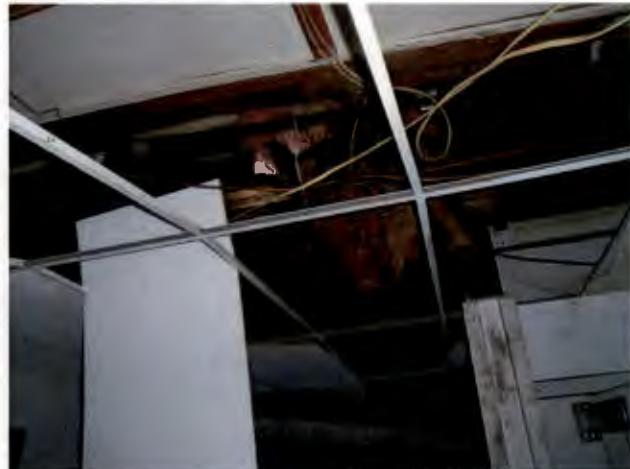
View of the first floor ceiling of the Lunney's building. This photo depicts exposed insulation and wiring and missing ceiling tiles due to overall neglect. The building's interior is dilapidated and represents unwholesome working conditions, and the building is untenantable in its current state. *(Photo courtesy of Middletown Township)*

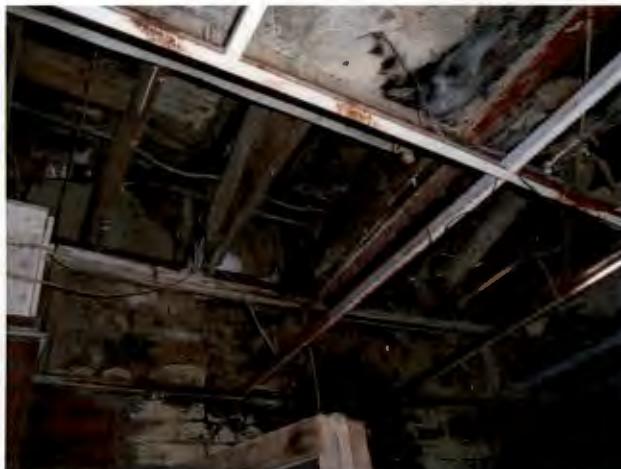
A second photo of the first floor ceiling of Lunney's. Depicted here are exposed water pipes, missing ceiling tiles, and rusting drop ceiling framework. *(Photo courtesy of Middletown Township)*

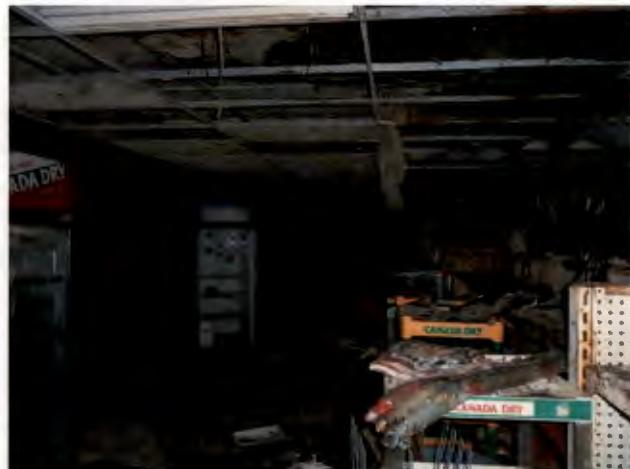
Interior view of the first floor of Lunney's. There are significant amounts of trash and debris in the building, including old refrigerators, shelving, and other materials. *(Photo courtesy of Middletown Township)*

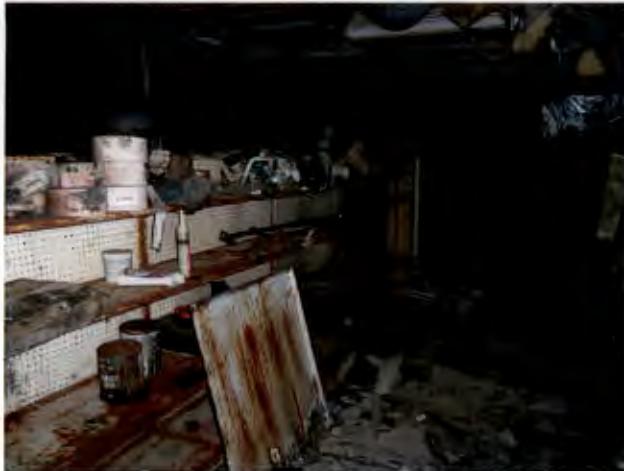
Interior view of the first floor of Lunney's, depicting old paint cans, caulking and other building materials. The uses on the property have been abandoned and the building has fallen into a state of dilapidation.

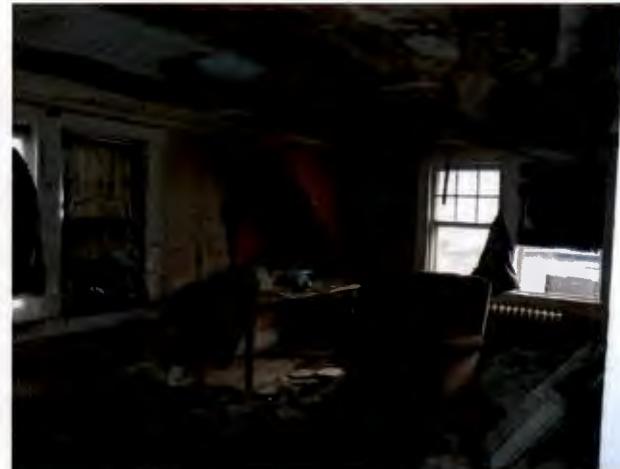
A view of the second floor apartment of the Lunney's building. Seen here is piled trash and debris, a leaking roof and deteriorated ceiling, broken and taped windows, and deteriorated wall coverings. The building represents unwholesome living and working conditions in its current condition.

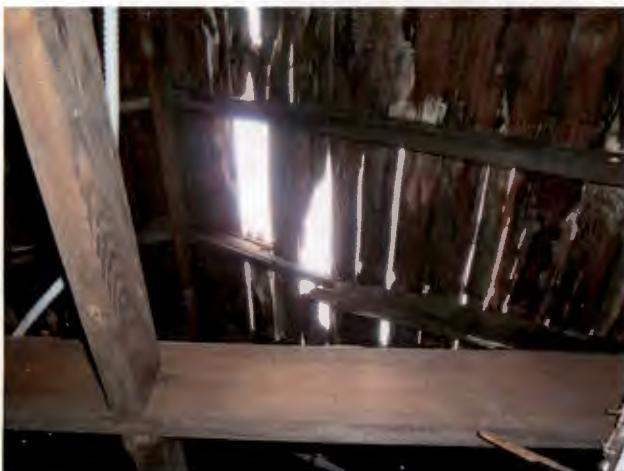
A view of the roof of the Lunney's building. The roof exhibits rotting wood, significant holes, and missing shingles, plywood sheathing, and felt underlayment.

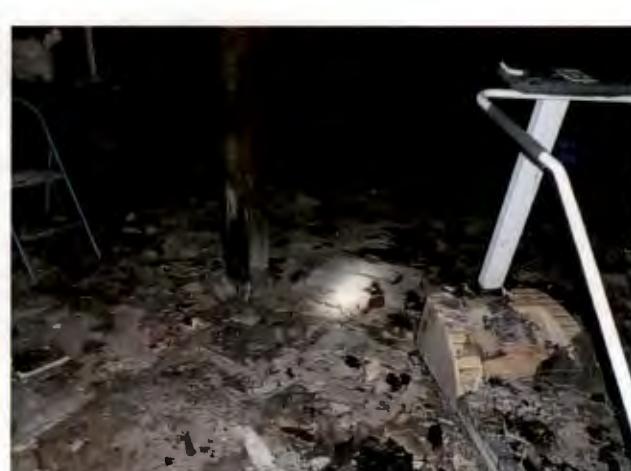
A view of the first floor of the Lunney's building. There is significant trash and debris in the building.

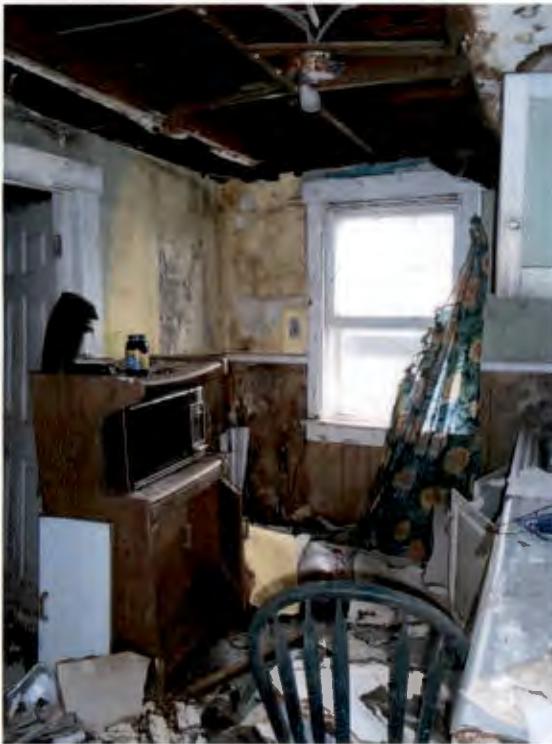
Kitchen area of the second floor apartment in the Lunney's building. All uses on site have been abandoned and the building exists in a dilapidated state.

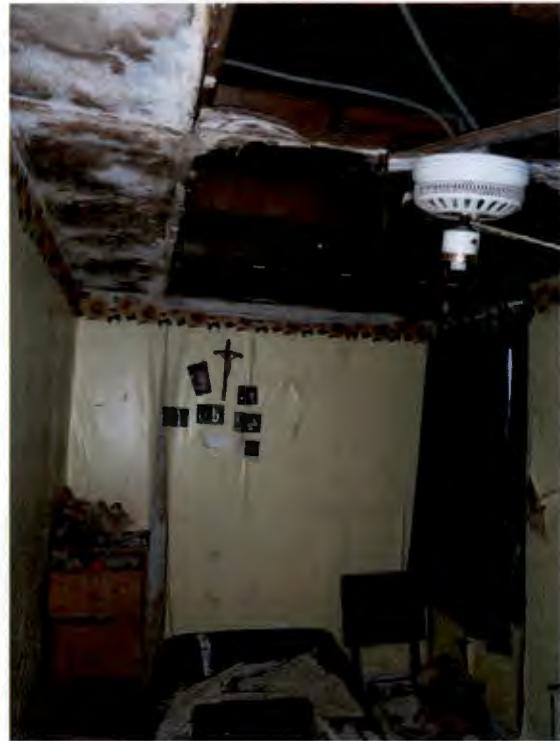
Bedroom area of the second floor apartment in the Lunney's building. Significant portions of the ceiling are missing, exposing the roof structure of the building. There is debris throughout the building, and the building is uninhabitable in its current state.

The existing building is currently vacant and is in a dilapidated state. The building exhibits substantial evidence of neglect, is substandard in its existing condition, and would require significant repairs in order to become tenantable. The building's roof is in a significant state of disrepair, is partially rotted/collapsed and appears to be bowed in several places, especially at the rear of the building. Most of the roof is missing shingles, causing the plywood sheathing and felt underlayment to be exposed, much of the fascia is missing, and many of the soffits are damaged. The first floor windows are boarded up and the building's exterior paint is peeling and the walls are dirty, suggesting that the building has not been maintained due to lack of use. The ventilation grills at the rear of the building are damaged, and there is exterior wiring that has been detached from the building and arranged haphazardly. The interior of the building represents unwholesome, unsanitary conditions, and exhibits significant neglect and disrepair.
