Report of
**Preliminary Investigation for
Determination of an Area in Need of Redevelopment**

Block 825, Lots: 53, 54, 55, 56, 57, 58, 59, 60, 61, 62, 63, 64, 65, 66, 67, 68, 69.01, 70, 72, 73, 74, 75, 76, 77, 78, 79, 80, and 81 (Mountain Hill), Block 638, Lot 31.01, Block 870, Lot 1 and 2, Block 871, Lot 3 and 7.02

DMR Architects
Francis Reiner, LLA - PP
License #: LI00616700

Township of Middletown
Monmouth County, New Jersey
December, 2017

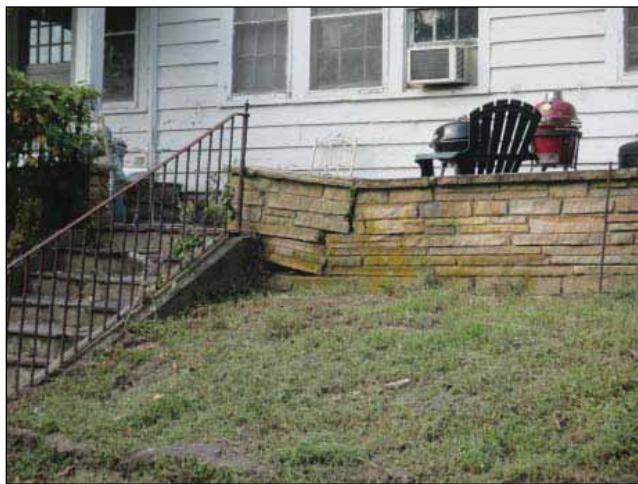
Image 2: Rear yard retaining wall collapsing

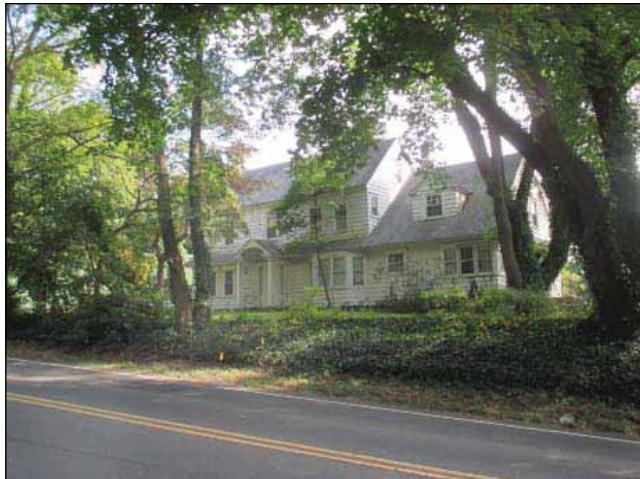
Image 4: Two story residential building on Kings Highway East

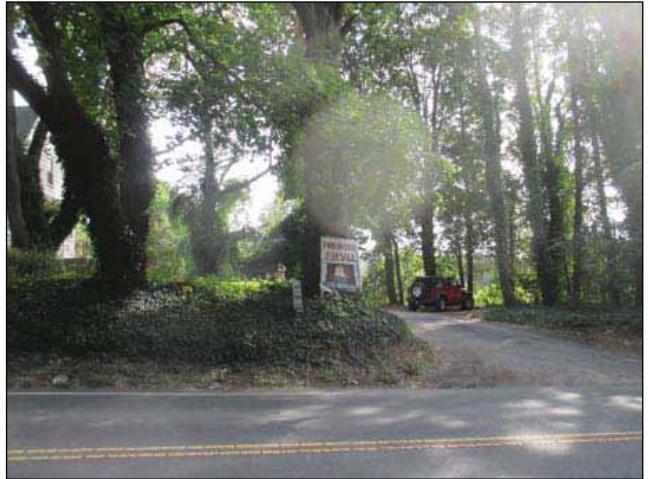
Image 5: Single driveway entrance to residential and commercial uses on the property

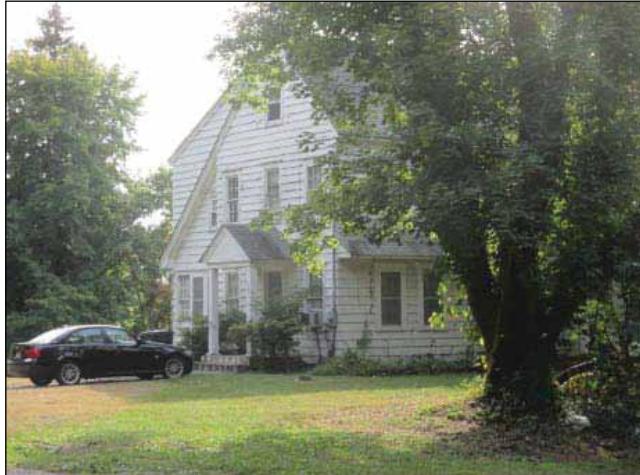
Image 6: North entrance of two story residential

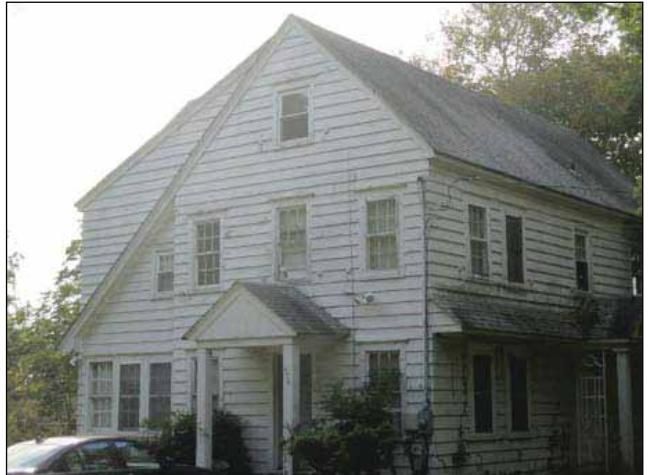
Image 7: Peeling of siding along north side of the building

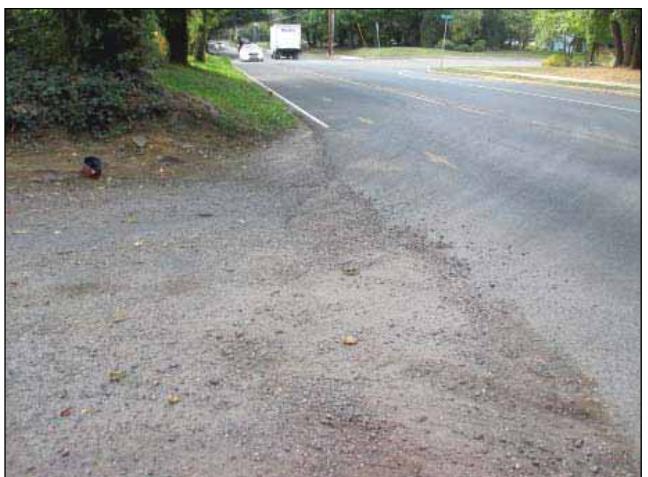
Image 9: Driveway entrance depicting a lack of sidewalks and drainage from the driveway into the road.

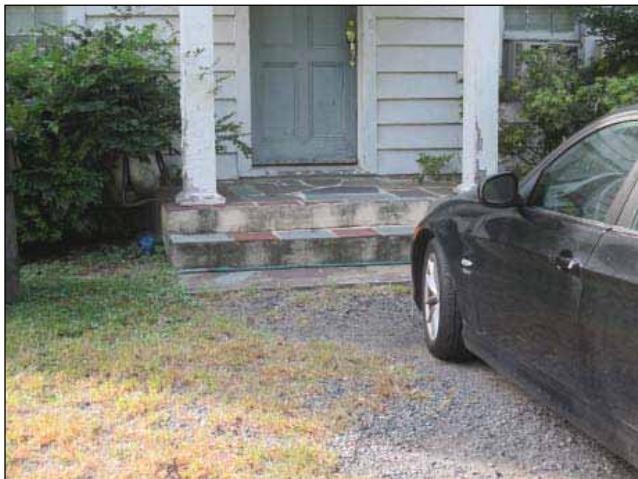
Image 10: Damage to front stoop and pillars of two story residential building.

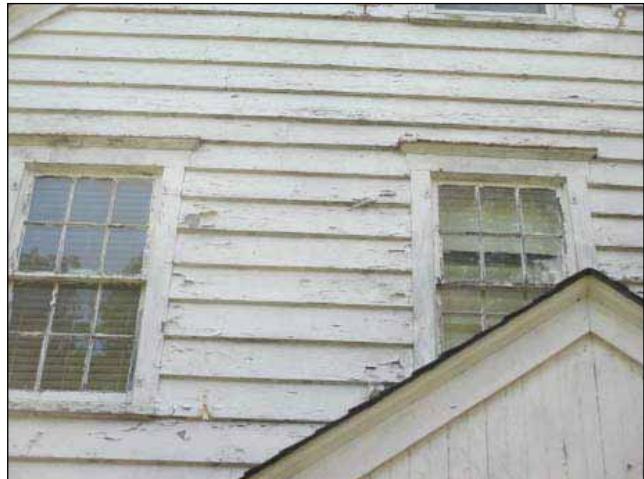
Image 11: Siding damage on two story residential building.

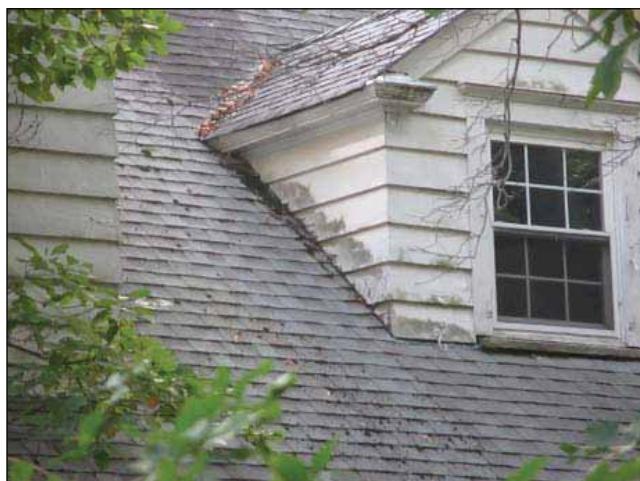
Image 12: Damage to the roof and eaves at the rear of the building.

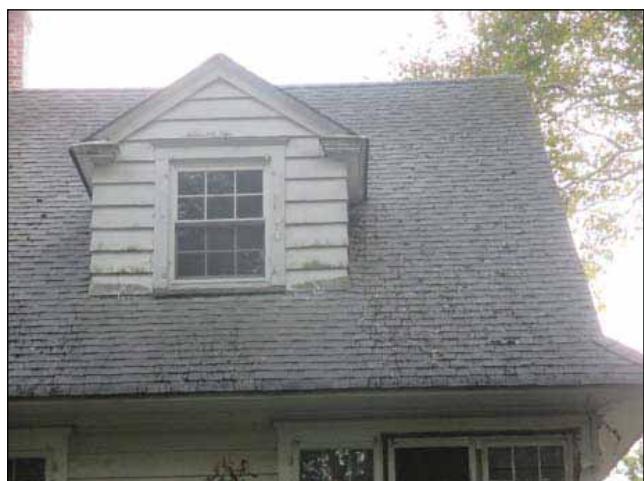
Image 13: Damage to the roof and eaves at the rear of the building.

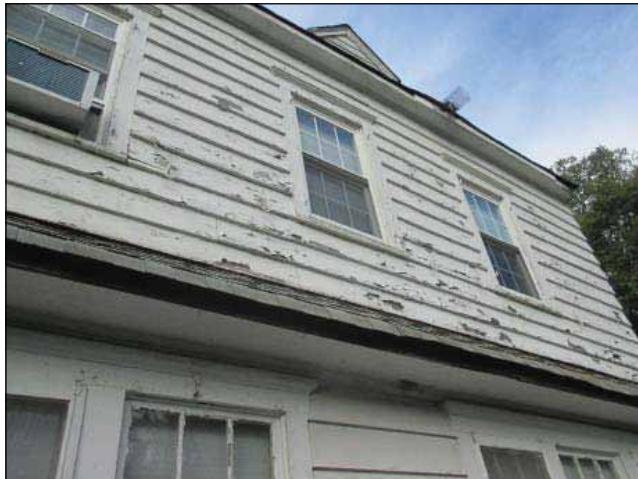
Image 16: Rear facade with damage.

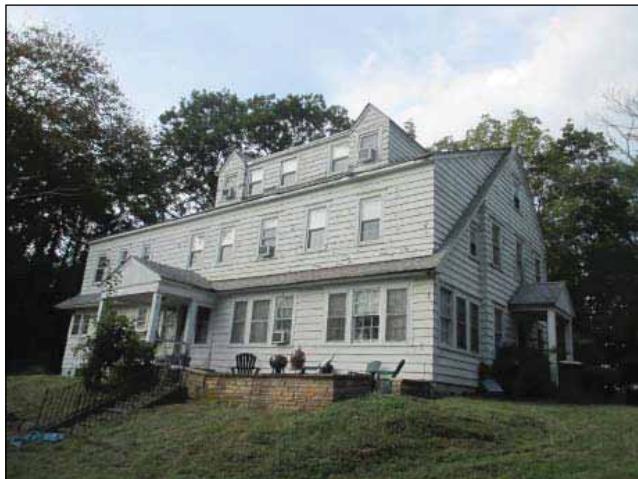
Image 18: Rear two story residential.

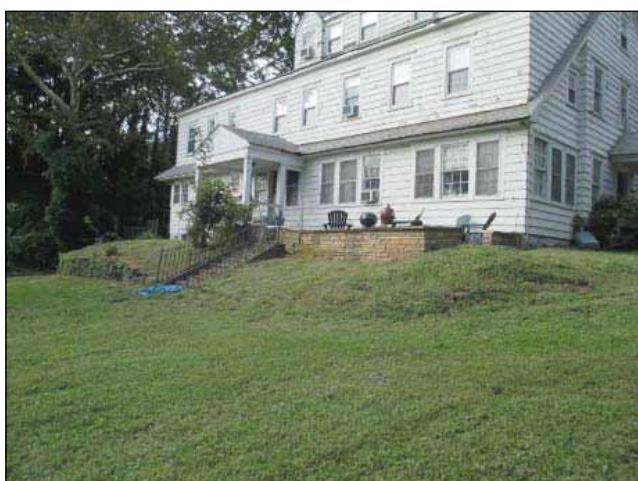
Image 20: Rear yard

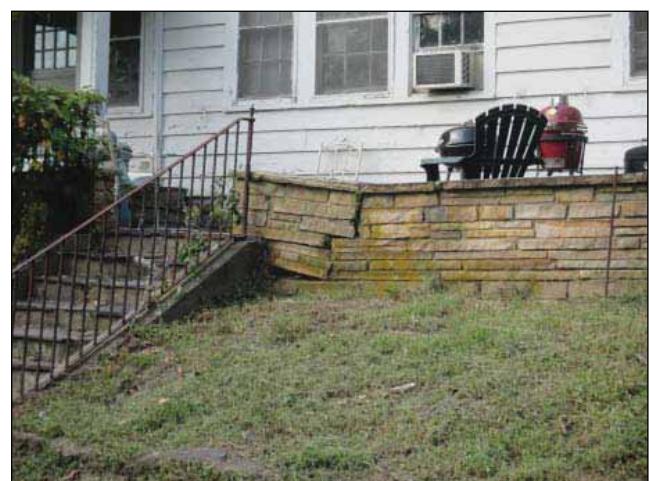
Image 21: Rear yard retaining wall collapsing

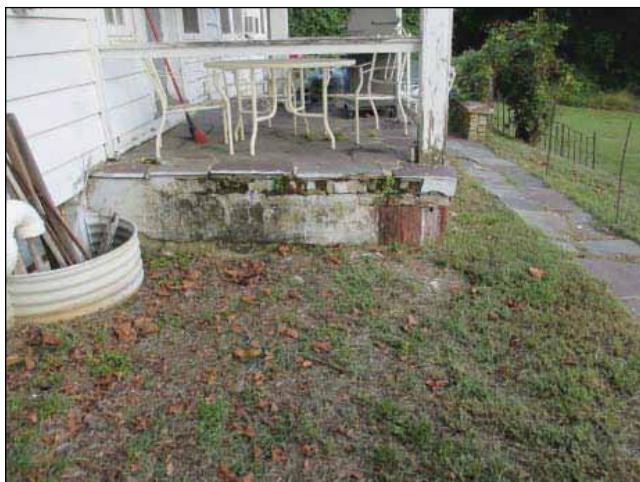
Image 22: Rear port with damage to concrete.

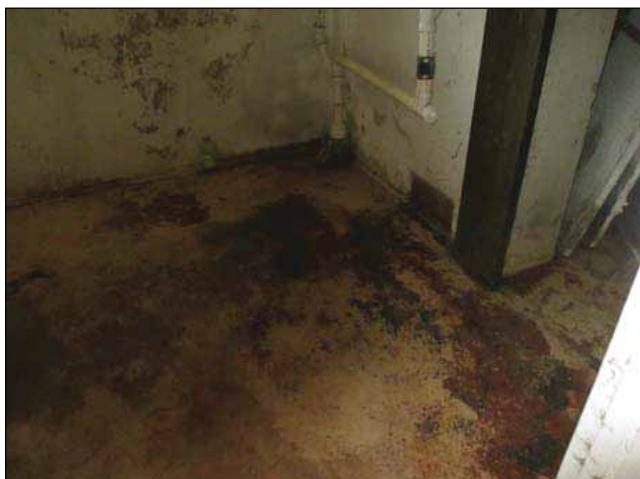
Image 24: Basement floor with water damage.

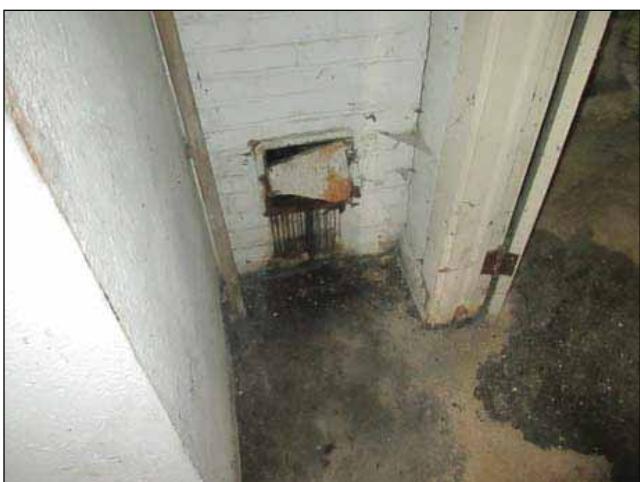
Image 26: Basement floor with water damage.

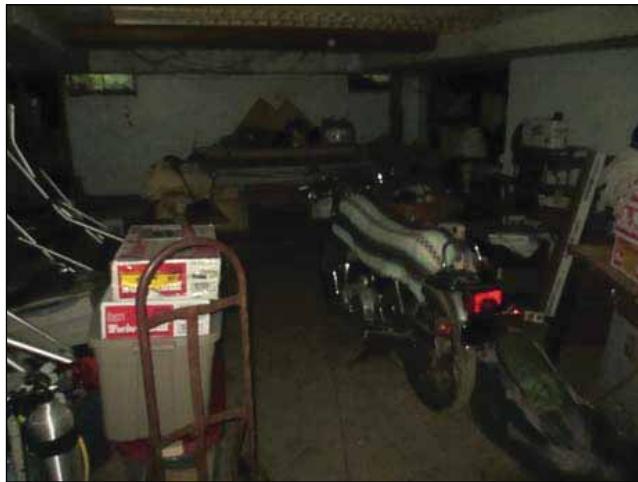
Image 28: Basement cluttered.

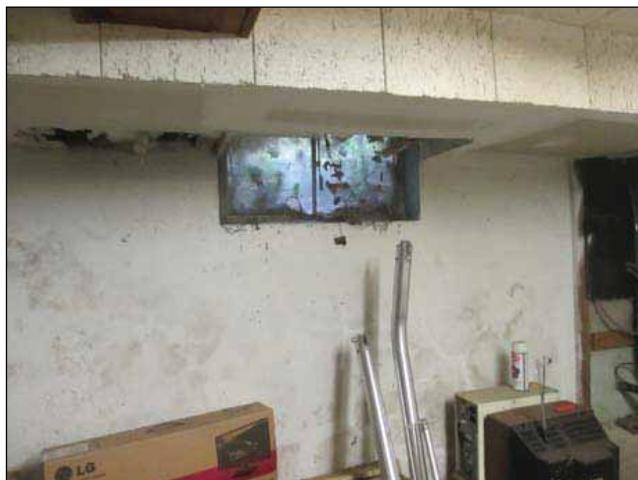
Image 30: Damage along basement window.

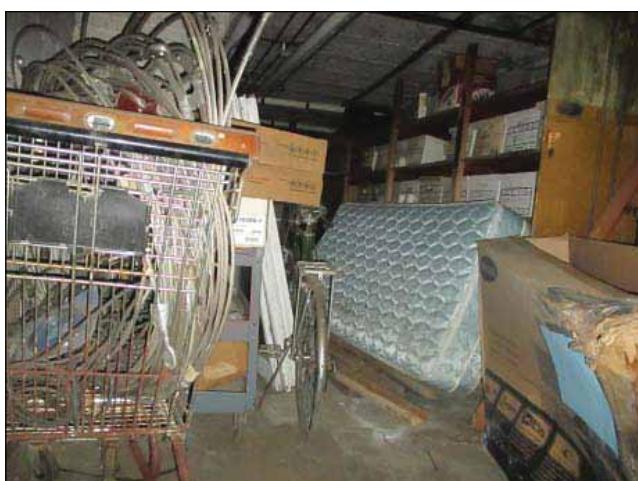
Image 32: Basement with debris

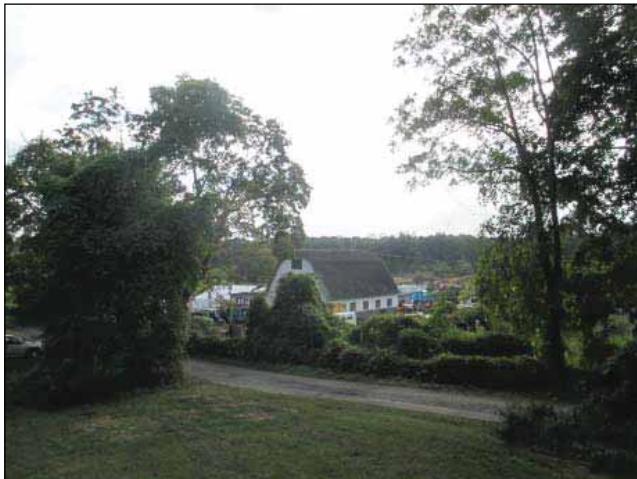
Image 34: View from two story house to commercial barn structure.

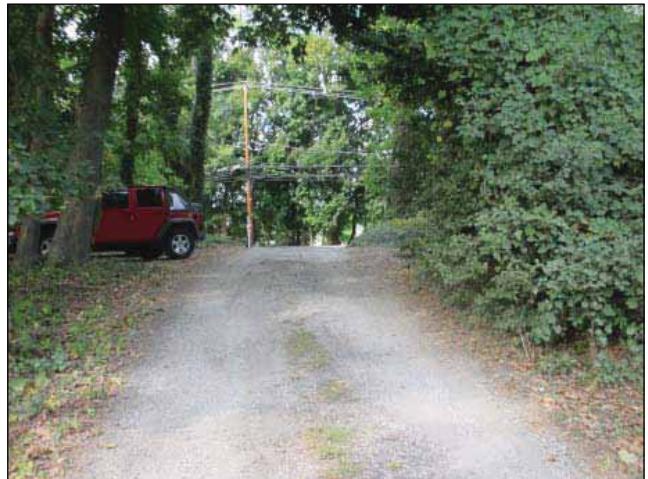
Image 35: Access from Kings Highway through the two story house

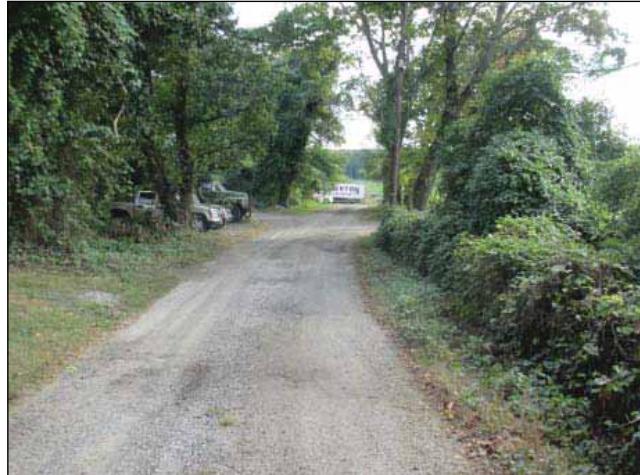
Image 36: Driveway to commercial barn structure.

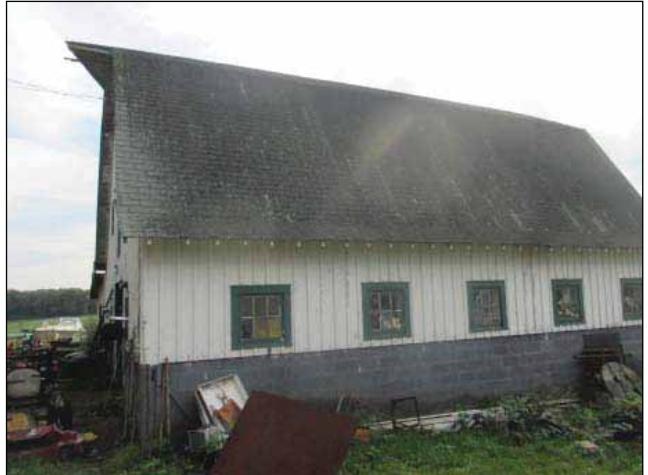
Image 37: Commercial barn structure with debris.

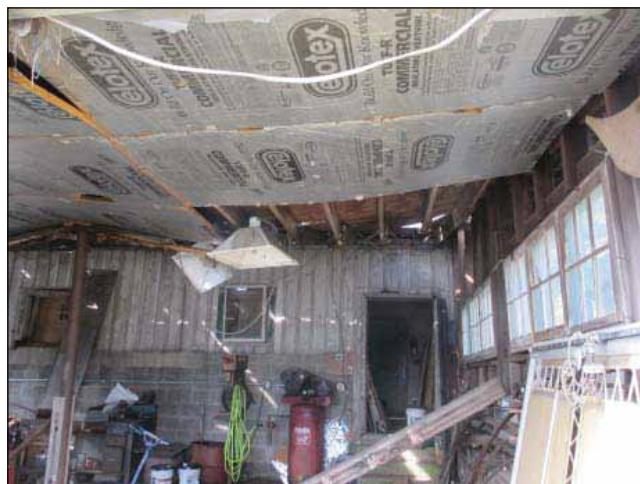
Image 38: Collapsing barn structure on the side of the building.

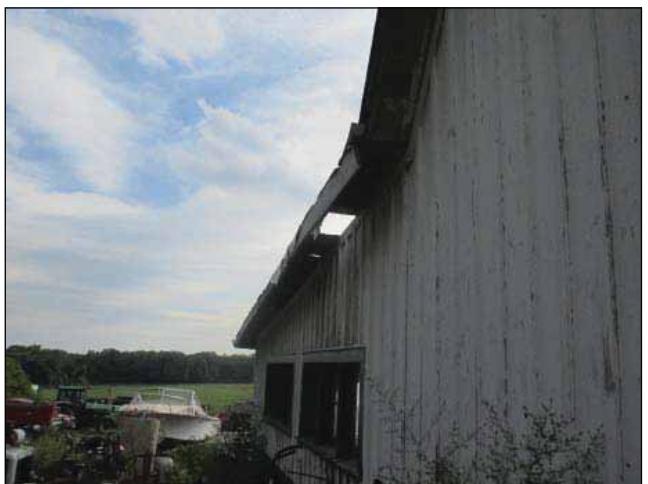
Image 39: View of side structure that is collapsing.

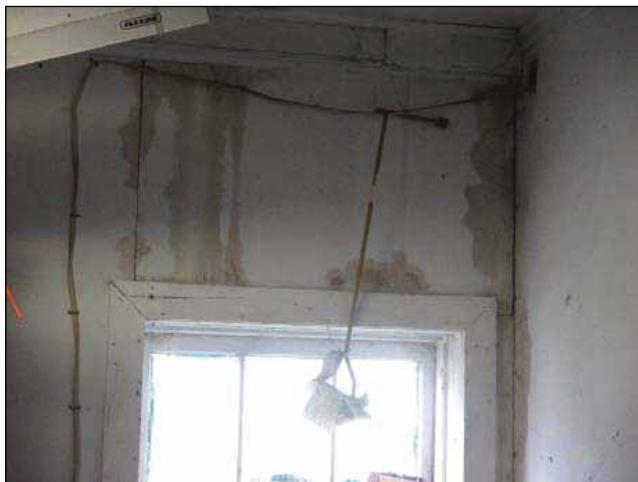
Image 40: Water damage along interior wall in barn structure.

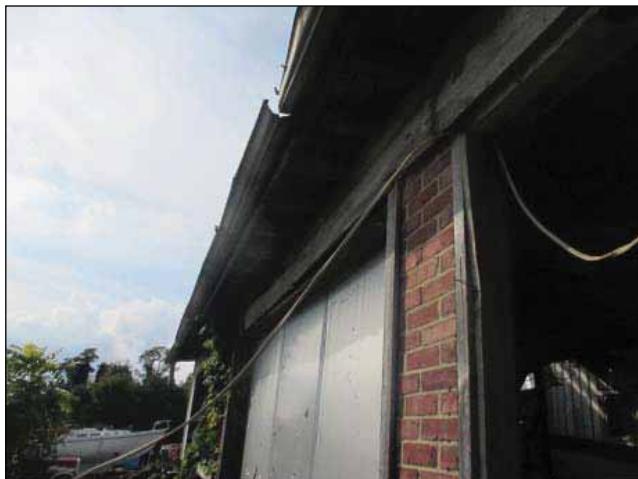
Image 42: Barn structure roof damage.

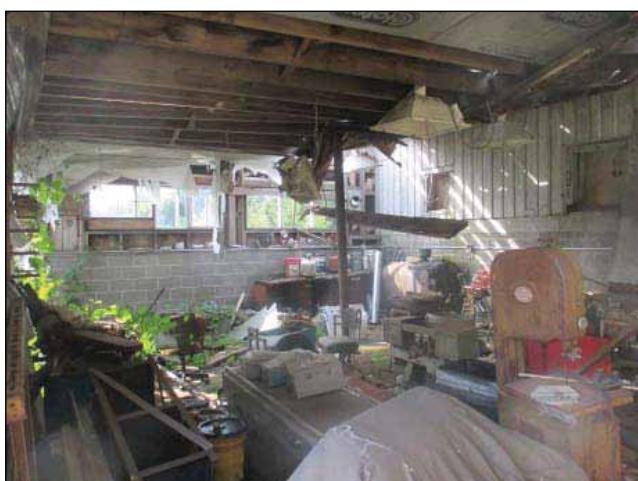
Image 44: Collapsing roof of barn structure side.

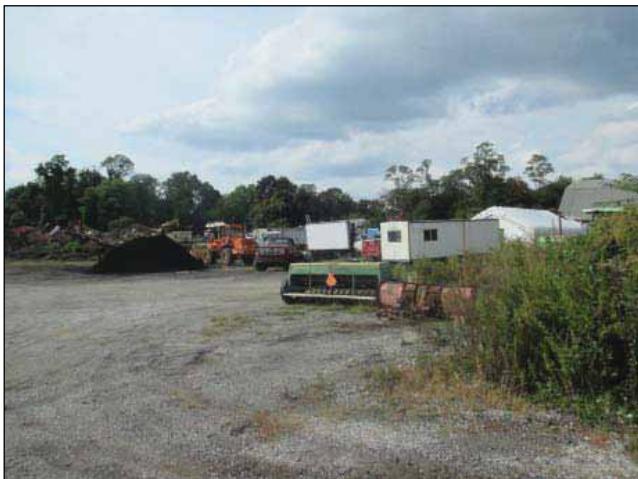
Image 46: Debris / vehicles on site adjacent to barn structure.

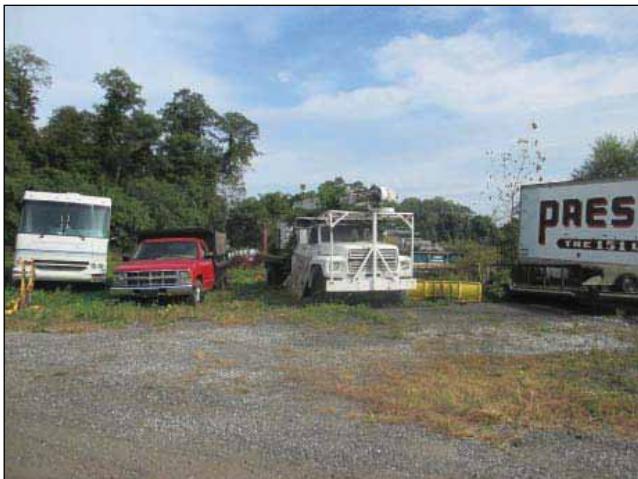
Image 48: Debris / vehicles on site adjacent to barn structure.

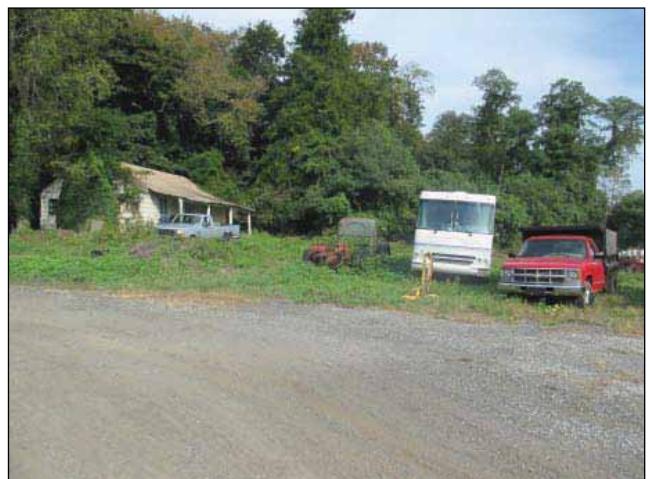
Image 49: Debris / vehicles on site adjacent to barn structure.

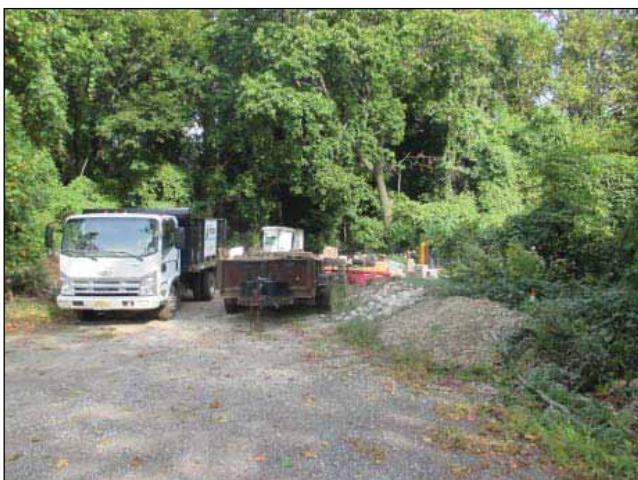
Image 50: Debris / vehicles on site adjacent to barn structure.

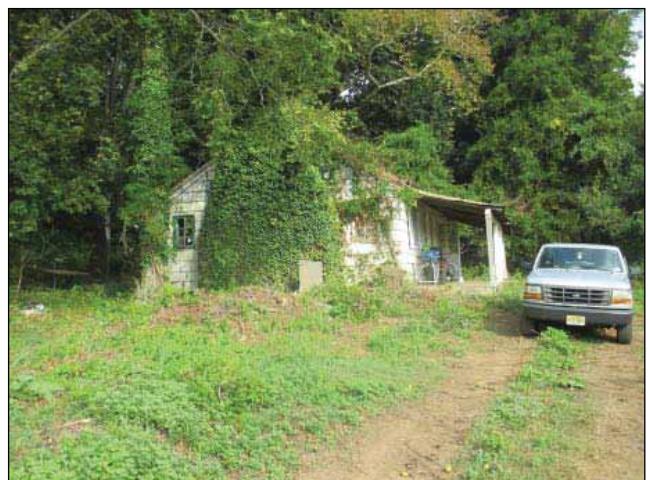
Image 51: One story cabin collapsing with vegetation.

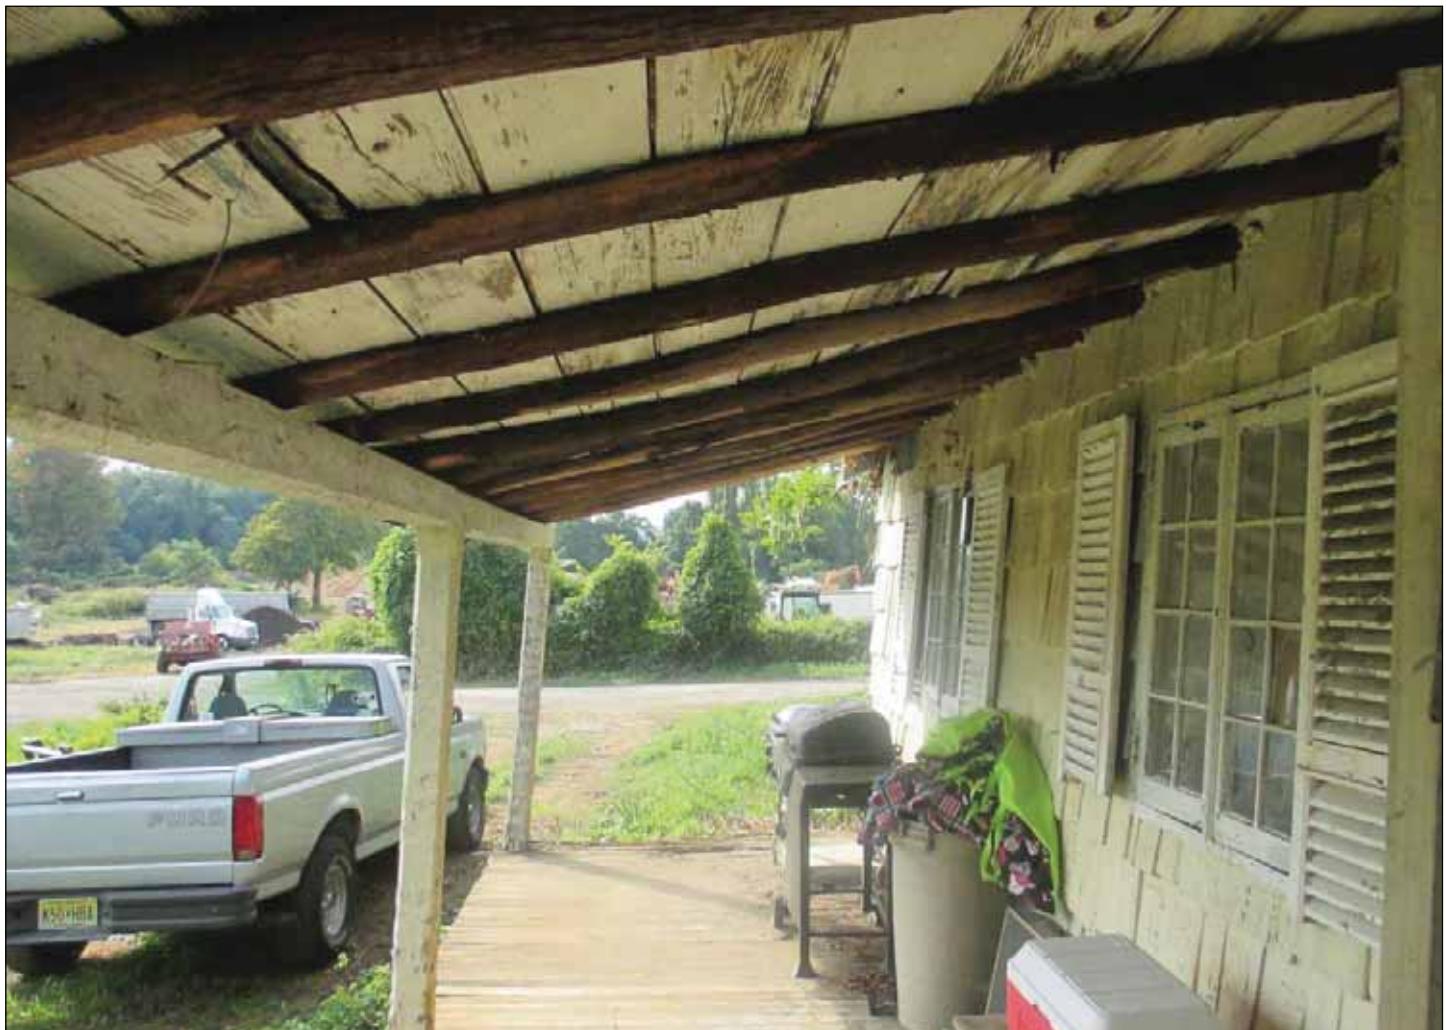
Image 52: Porch of cabin bowing.

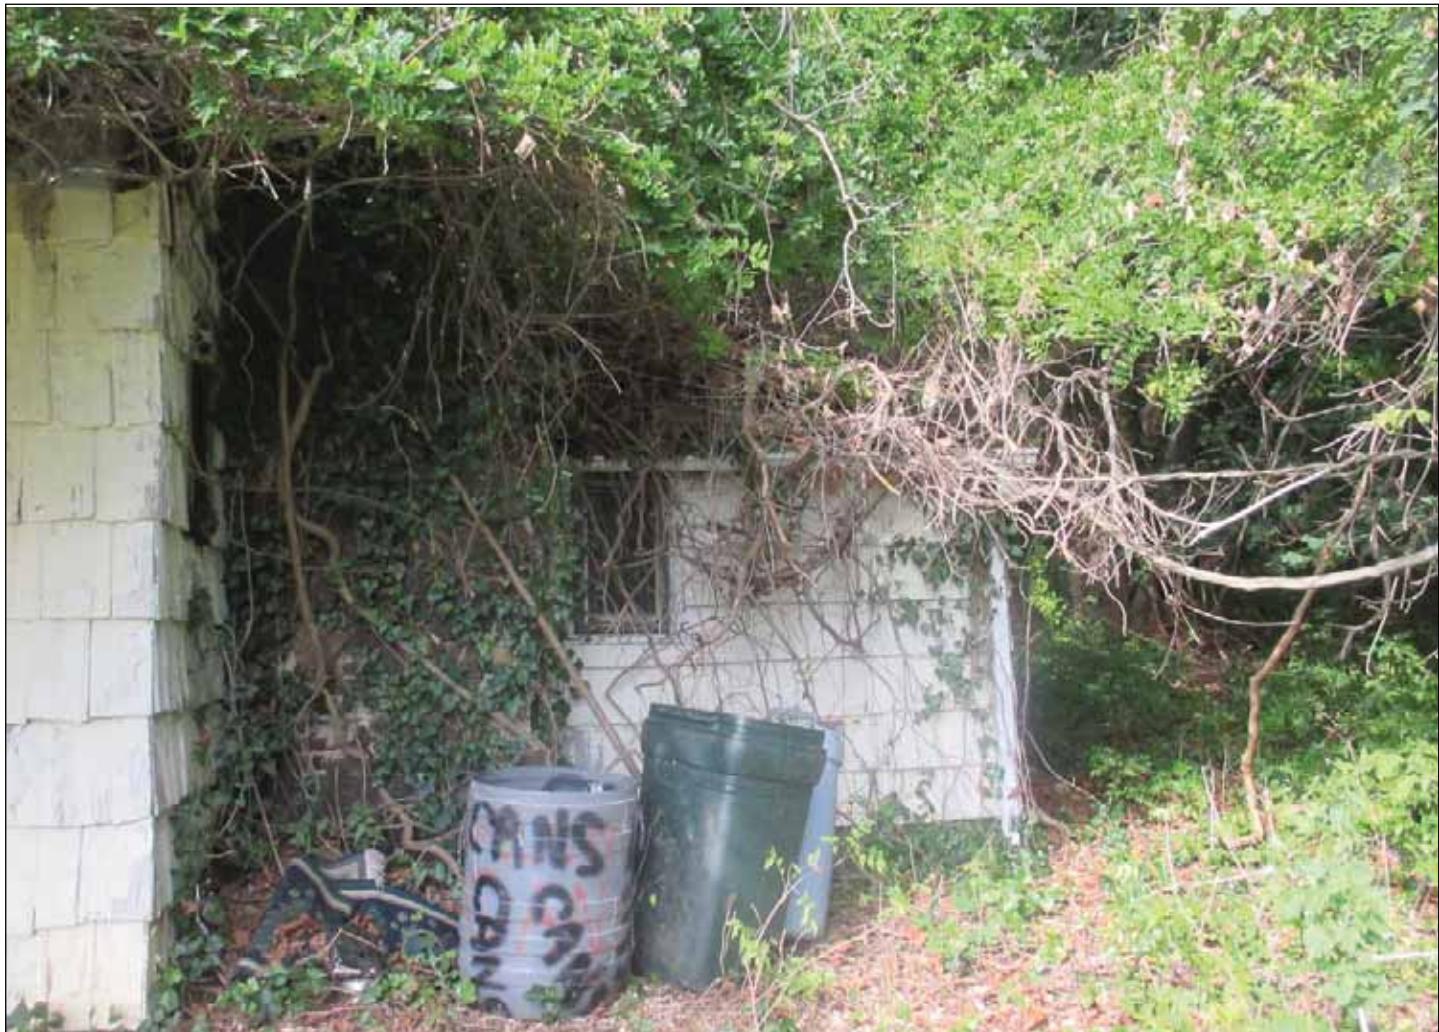
Image 54: Collapsing side of cabin.

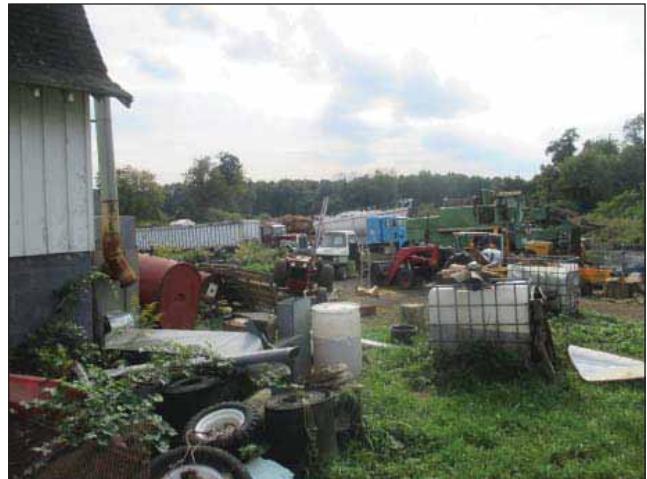
Image 2: Debris adjacent to the barn area.

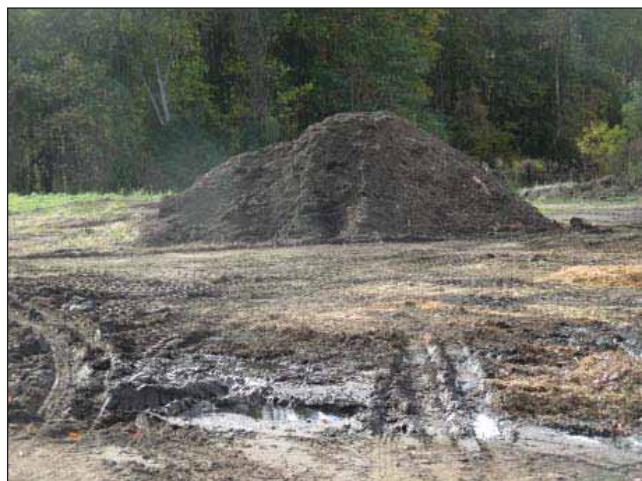
Image 3: Piled landscape with gravel and dirt roads.

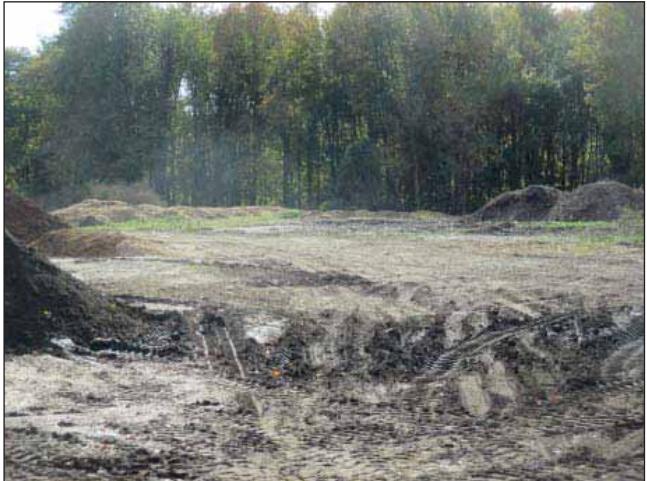
Image 4: Piled landscape with gravel and dirt roads.

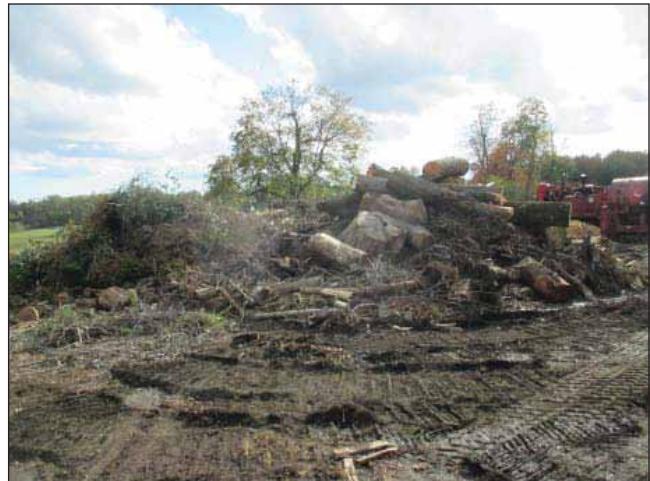
Image 8: Landscape materials, logs, debris.

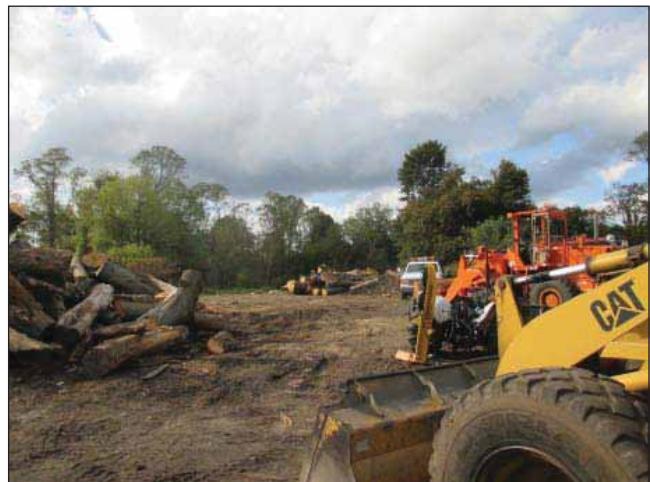
Image 10: Landscape materials, logs, debris.

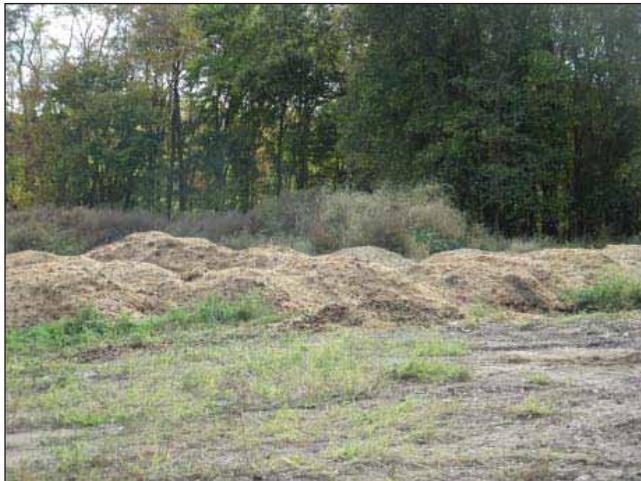
Image 1: Piles of dirt and debris.

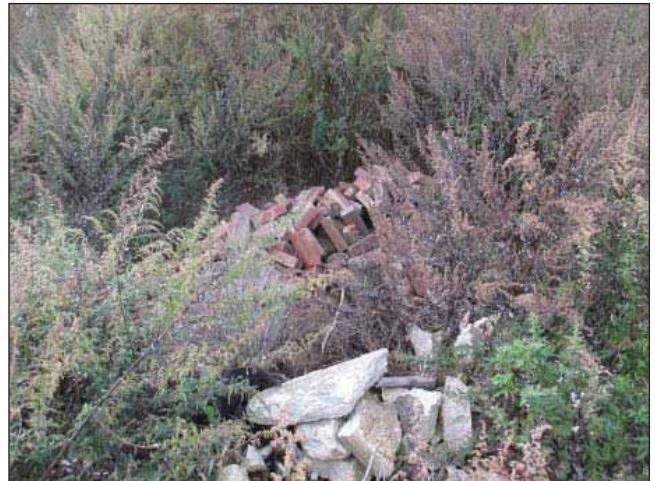
Image 2: Piles of stone and brick dumped on the site.

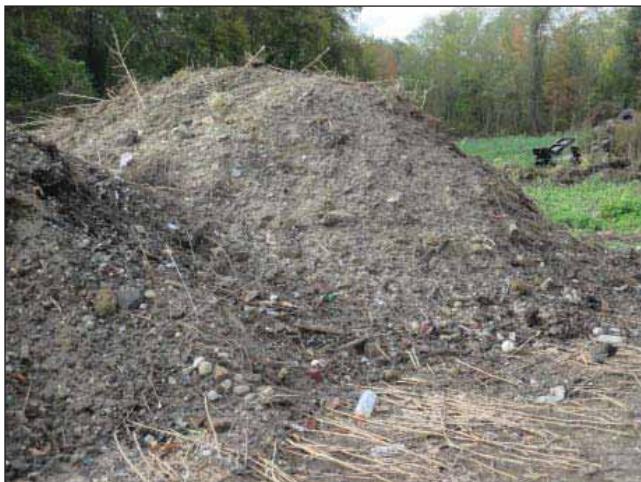
Image 3: Pile of debris and garbage on site.

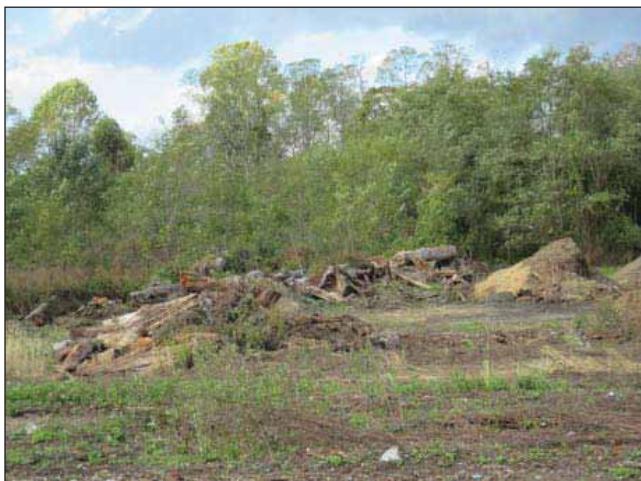
Image 5: Pile of materials including logs.

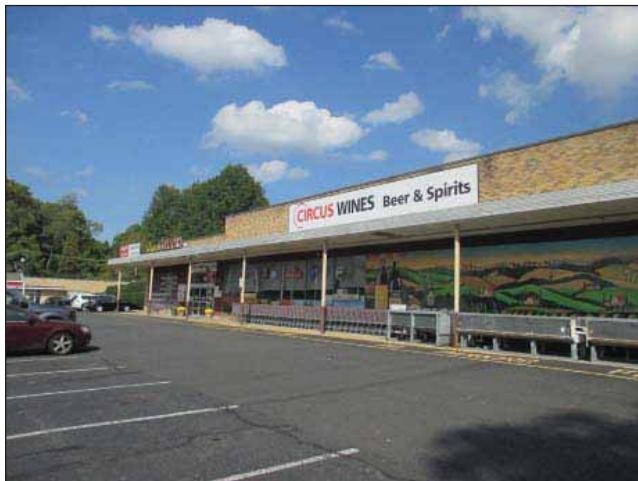
The parking lot lacks lighting and sidewalks and does not provide any pedestrian safety measures from the parking lot to the front entrance. Further, the property includes a significant amount of impervious area between the building and the parking lot, which does not allow for the absorption of surface runoff into the ground, but rather sends surface runoff directly into the Route 35 public right of way. This creates dangerous situations during peak storm events and freezing conditions and represents a faulty arrangement and design that is dangerous to the safety, health and welfare of the community (Criterion 'd').

Image 2: Front entrance with no lighting in the parking lot.

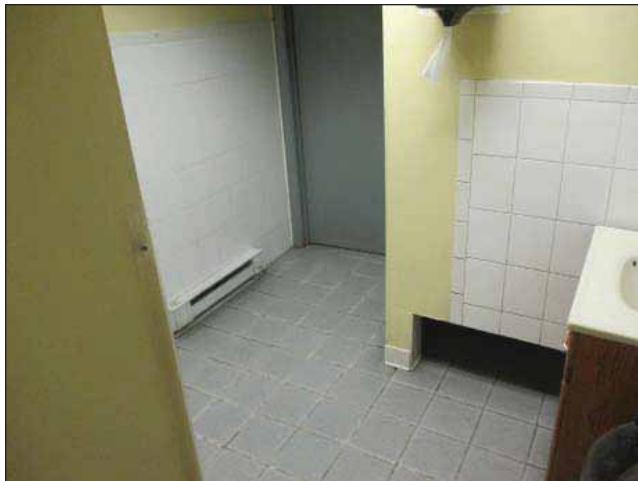
Image 4: Existing bathroom that are not ADA compliant.

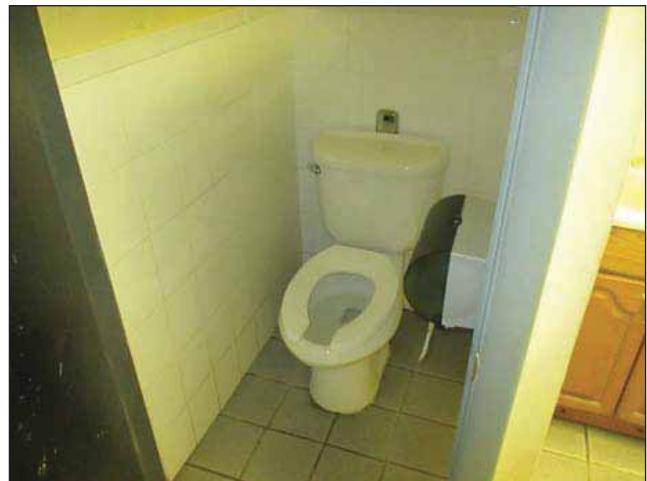
Image 5: Existing bathroom that are not ADA compliant.

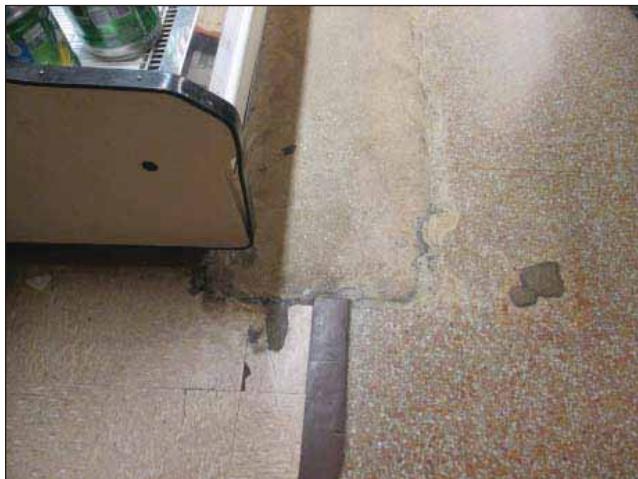
The interior of the building includes evidence of water damage in both the public portion as well as in the rear office and storage spaces evidenced by damage to both the ceiling and floor as well as damage to the interior walls within the storage areas (See images 2-15). The building is not currently ADA compliant in that it does not include an elevator. The combination of the interior and exterior conditions represent a faulty arrangement with an obsolete layout of the building and property.

Image 8: Water damage and repair on the retail store floor.

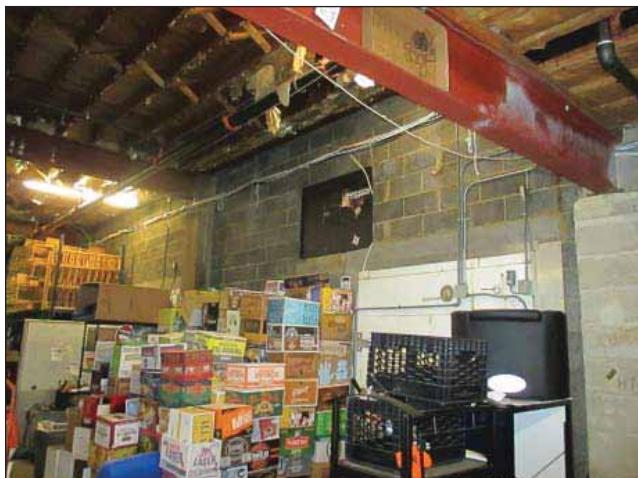
Image 9: Storage area.

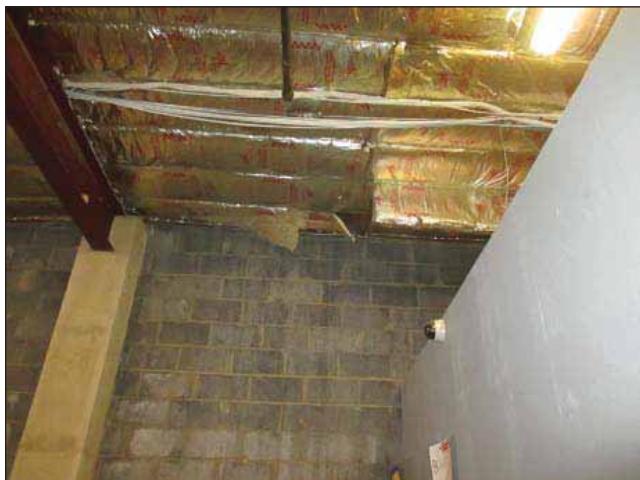
Image 15: Ceiling insulation falling down in storage area.

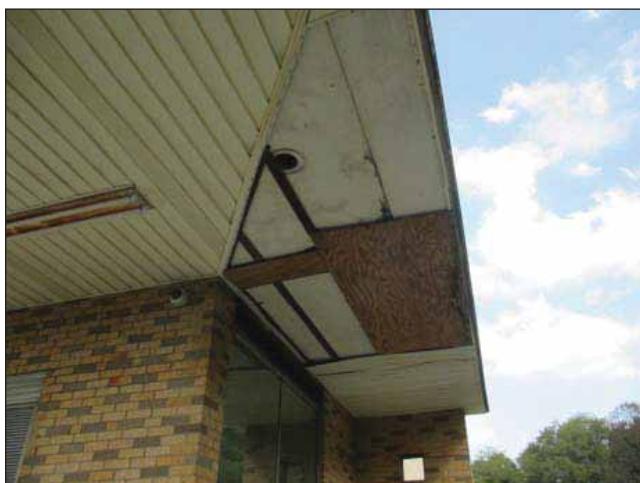
Image 17: Exterior overhang with missing ceiling panels

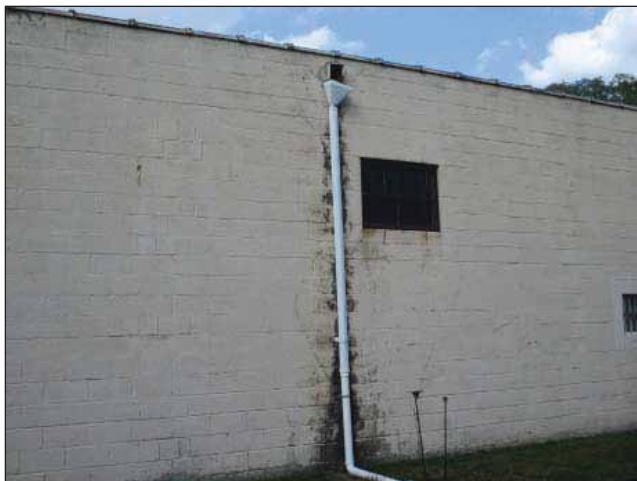
Image 19: Side elevation of building.

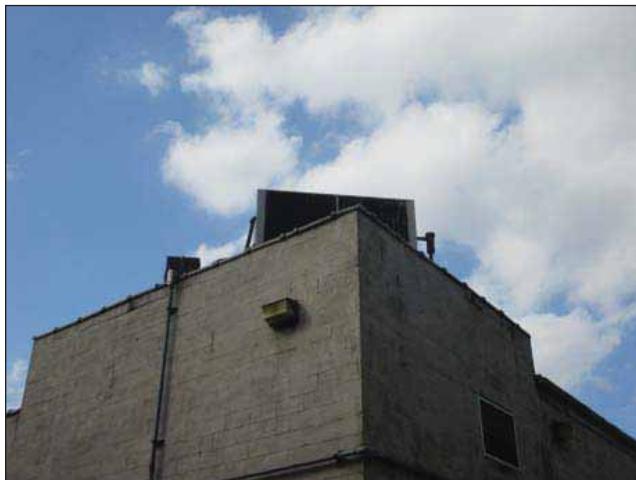
Image 21: Side elevation.

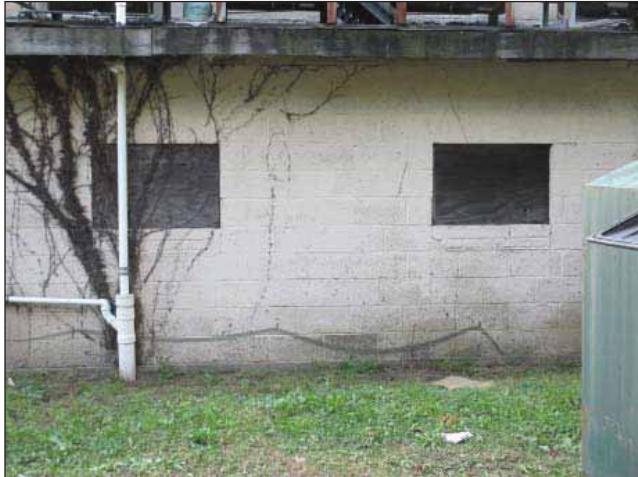
Image 25: Rear elevation with windows boarded and roof bowing.

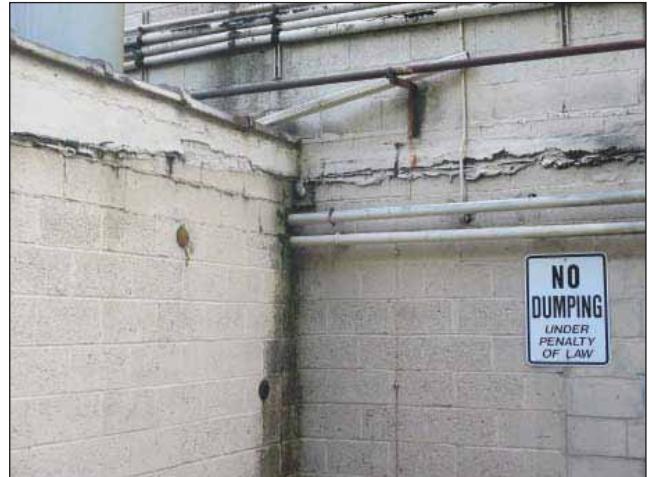
Image 26: Rear elevation with windows boarded.

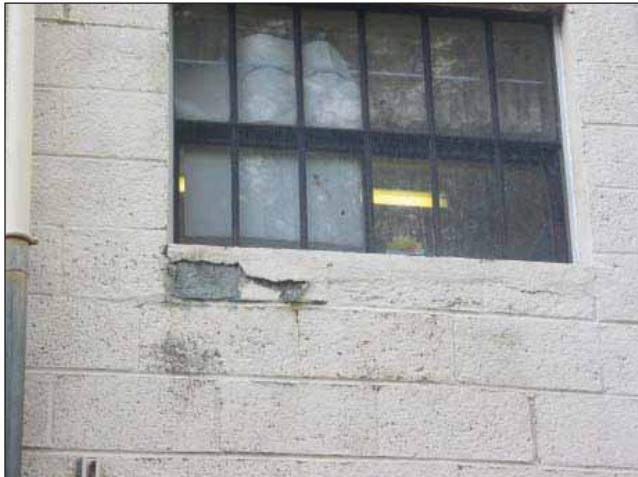
Image 27: Rear elevation depicting water damage along joint between buildings.

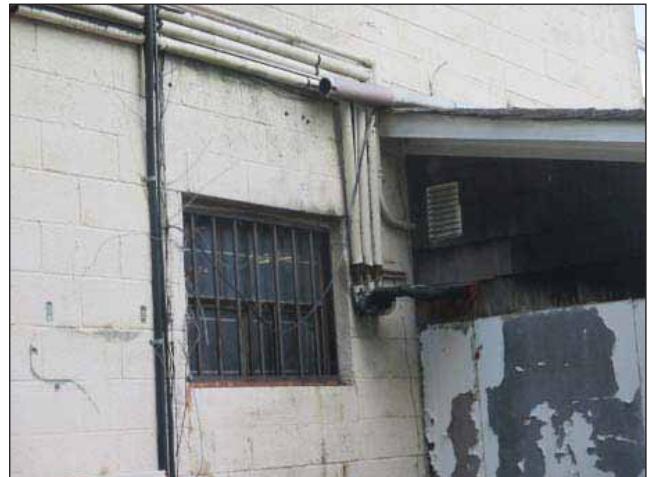
Image 28: Rear elevation.

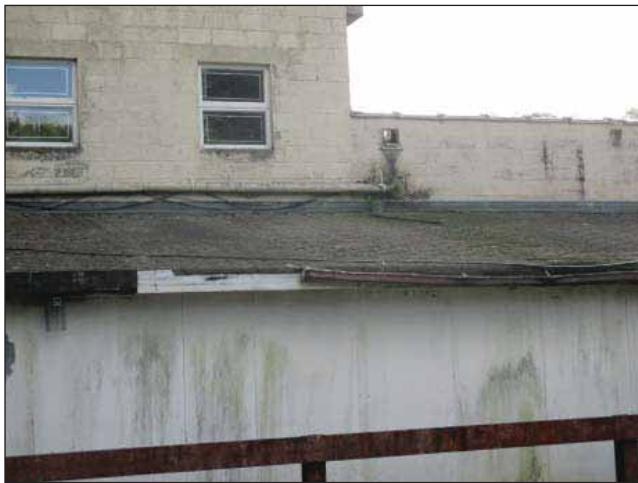
Image 29: Side elevation depicting degradation.

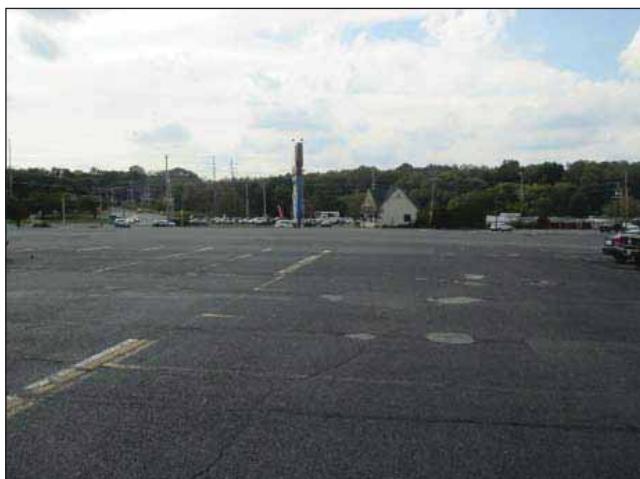
Image 33: Parking area with no lighting or sidewalks.

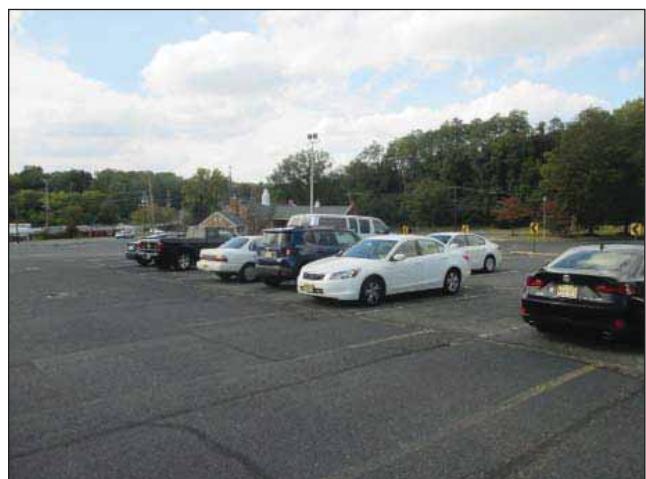
Image 34: Parking area with no lighting or sidewalks

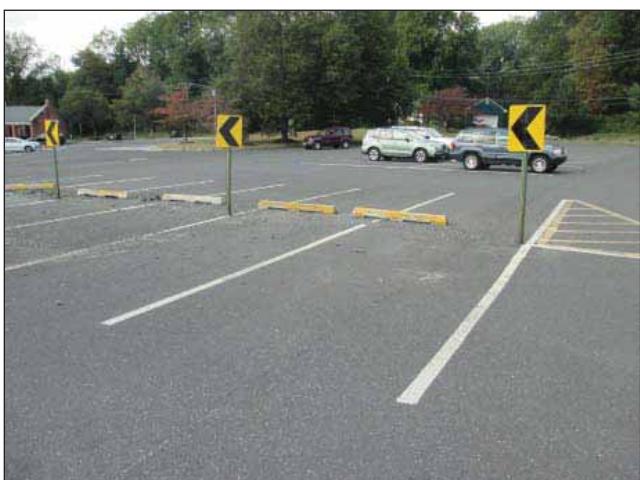
Image 35: Parking area with no lighting or sidewalks

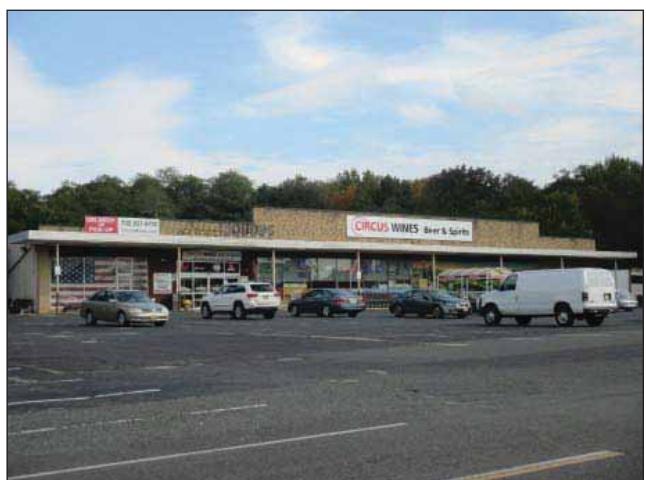
Image 36: Parking area with no lighting or sidewalks
