Report of
**Preliminary Investigation for
Determination of an Area in Need of Redevelopment**

Block 825, Lots: 53, 54, 55, 56, 57, 58, 59, 60, 61, 62, 63, 64, 65, 66, 67, 68, 69.01, 70, 72, 73, 74, 75, 76, 77, 78, 79, 80, and 81 (Mountain Hill), Block 638, Lot 31.01, Block 870, Lot 1 and 2, Block 871, Lot 3 and 7.02

DMR Architects
Francis Reiner, LLA - PP
License #: LI00616700

Township of Middletown
Monmouth County, New Jersey
December, 2017

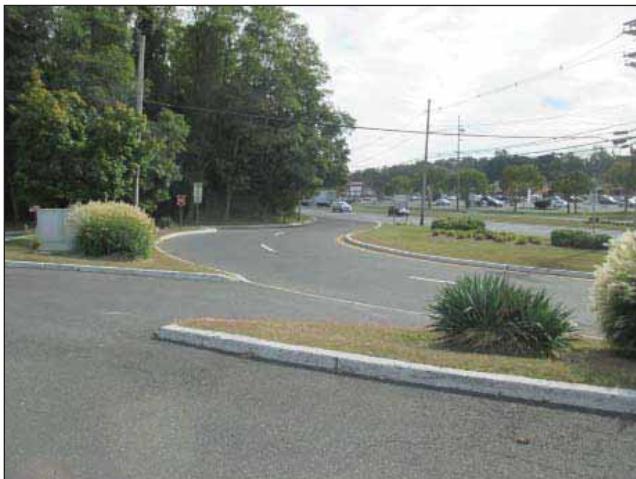
Image 37: Parking area with no lighting or sidewalks.

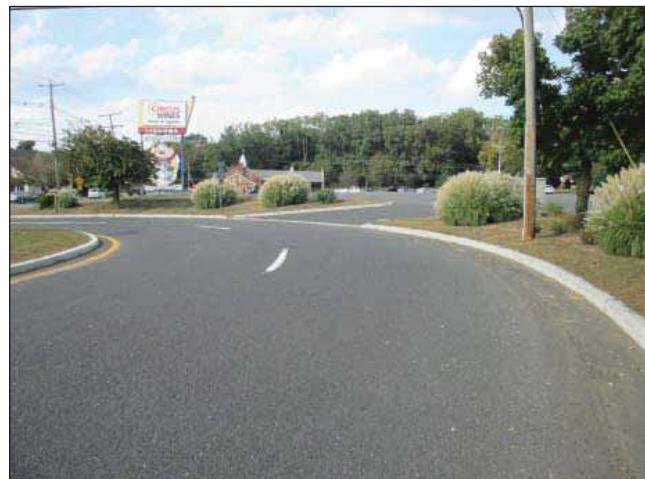
Image 38: Parking egress along Route 35 jug handle depicting grading from parking to the right of way.

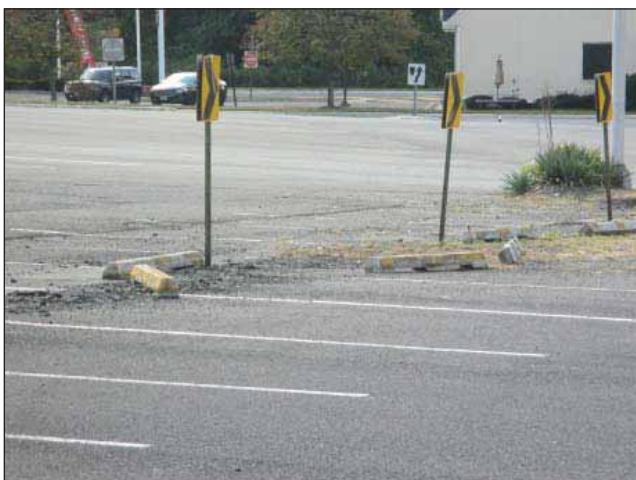
Image 39: View of parking egress along Route 35 jug handle depicting grading from parking to the right of way.

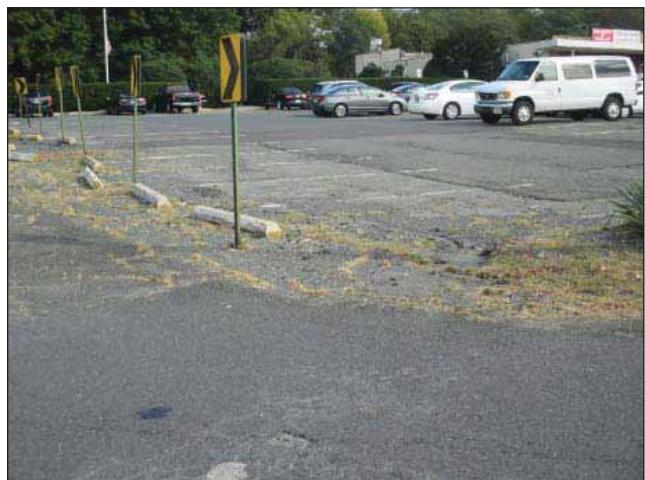
Image 40: Erosion of existing parking area depicting run-off damage toward Route 35.

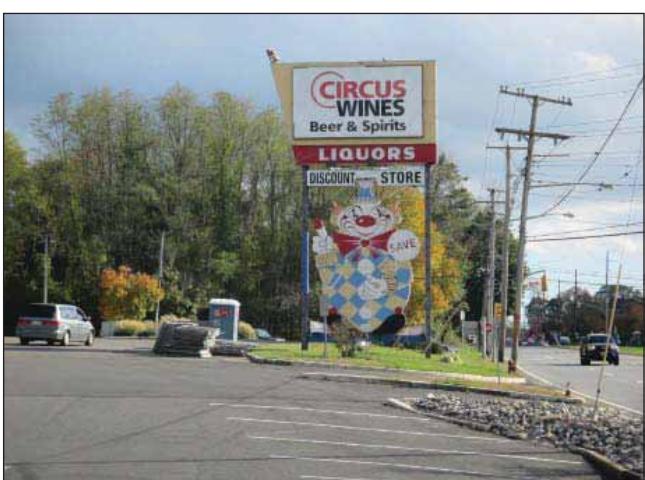
Image 42: Slope from existing parking lot to Highway 35.

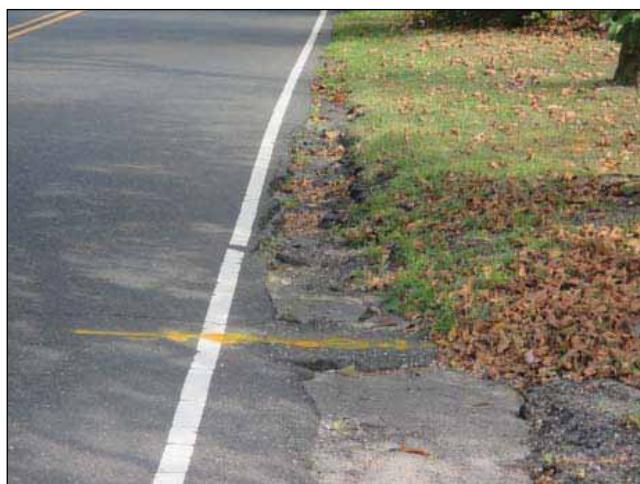
Image 2: Erosion along Kings Highway with no curb and gutter

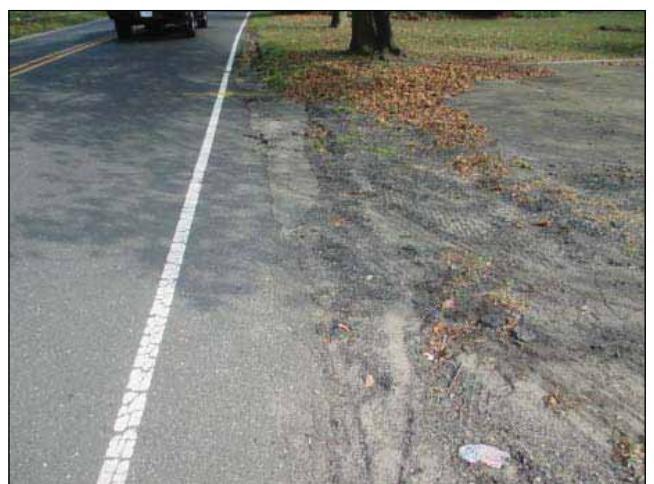
Image 3: Erosion along Kings Highway with no curb and gutter

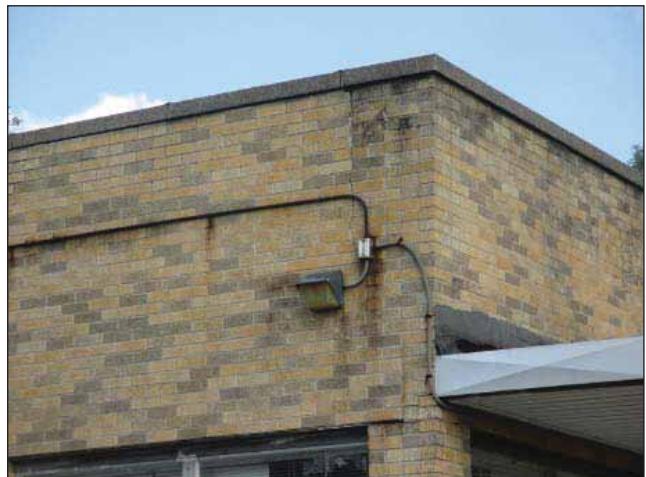
Image 5: Water damage along vertical bricks at roof line.

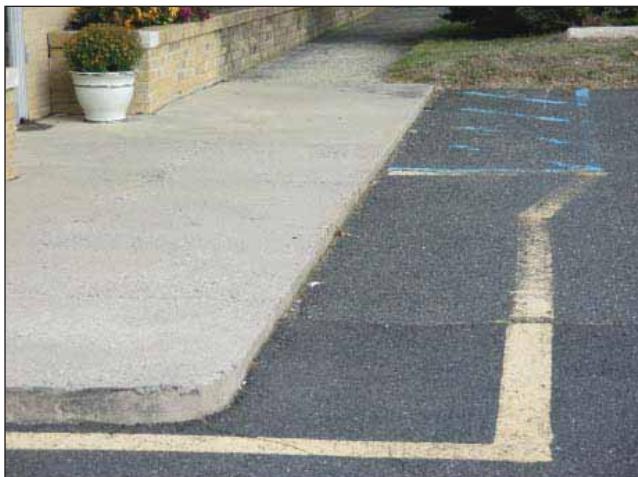
Image 6: Sidewalk at front entrance with handicap spaces which lack proper striping.

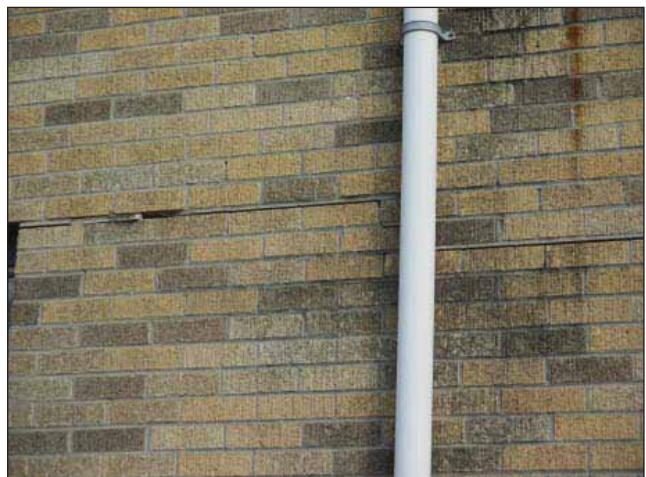
Image 7: Separation of bricks along building facade.

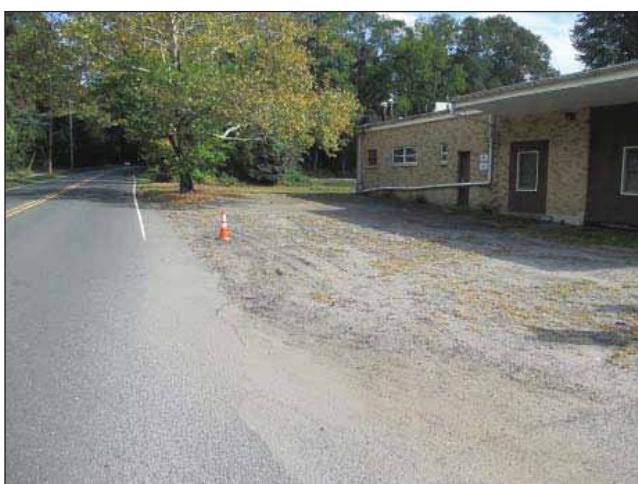
Image 8: Side view of building with asphalt and gravel depicting erosion caused by storm water run off along Kings Highway East.

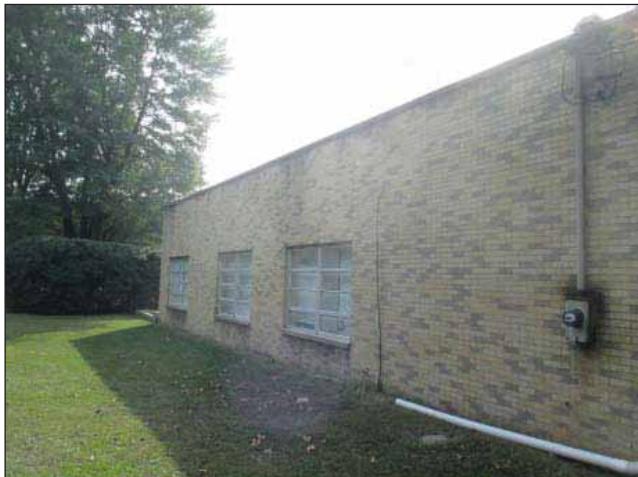
Image 9: Rear of the building facade.

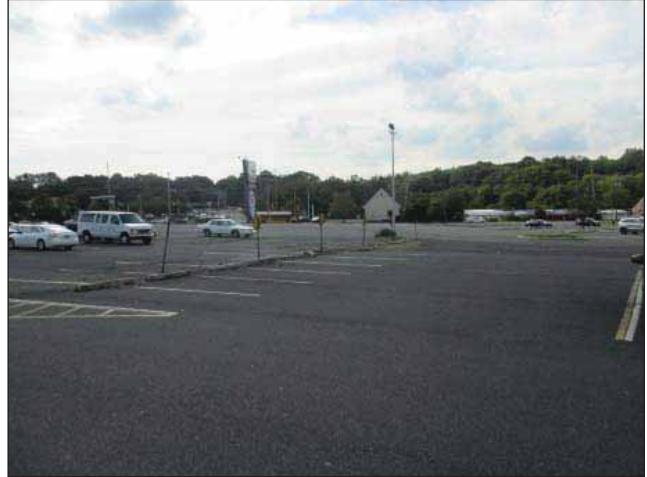
Image 10: Erosion of existing parking area depicting run-off damage toward Route 35.

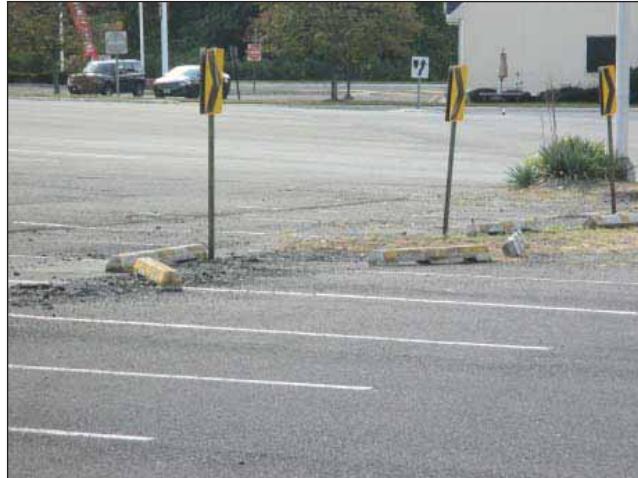
Image 11: Erosion of existing parking area depicting run-off damage toward Route 35.

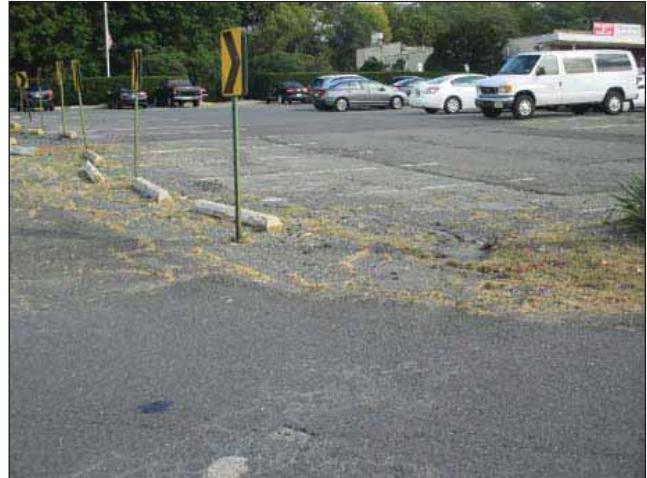
Image 12: Erosion of existing parking area depicting run-off damage toward Route 35.

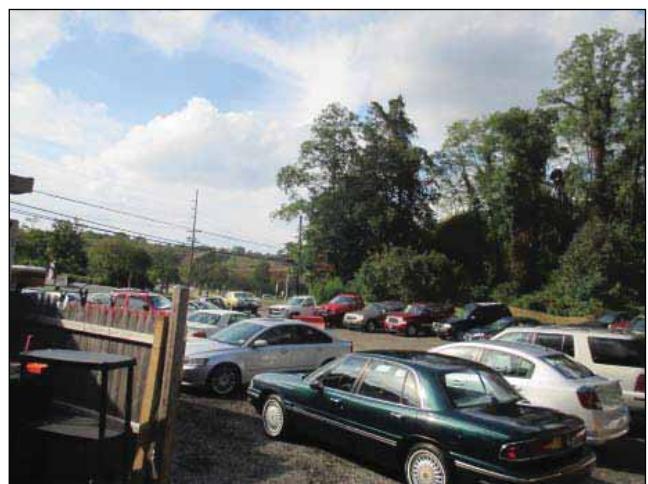
Image 3: Vehicles parked throughout the site in ad hoc manner.

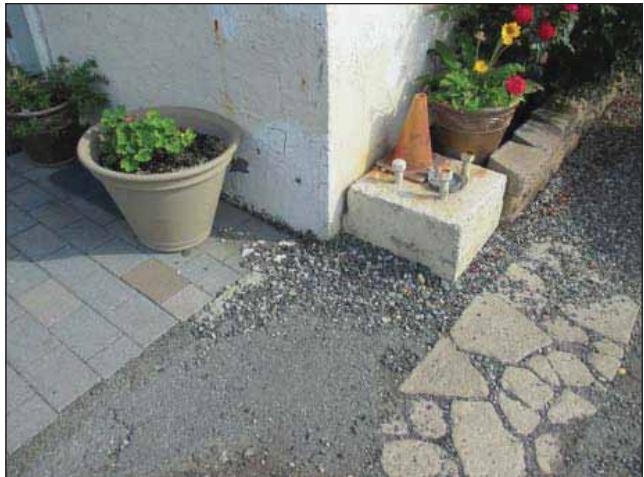
Image 5: Erosion and sediment from rain and run off.

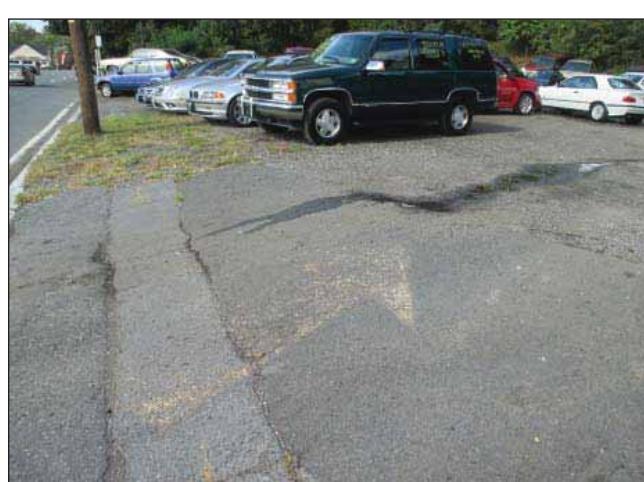
Image 9: Grades along front entrance going from the property to Highway 35 without any storm water management controls.

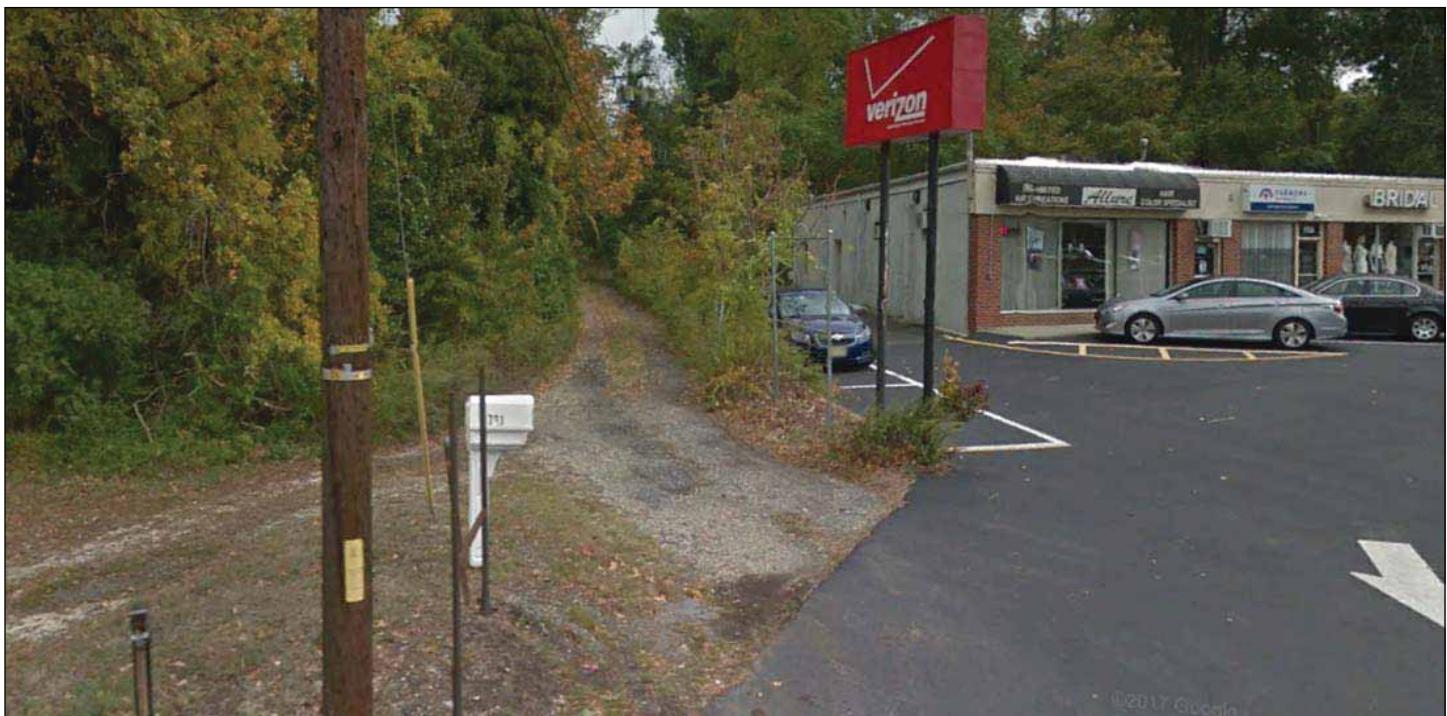
Image 1: Entrance to Highland Place off Highway 35. Approximately 14'-0" wide dirt road with acute angle entrance. Appear vehicles accessing Highland Place are illegally cutting across the exit drive aisle for the strip retail center.

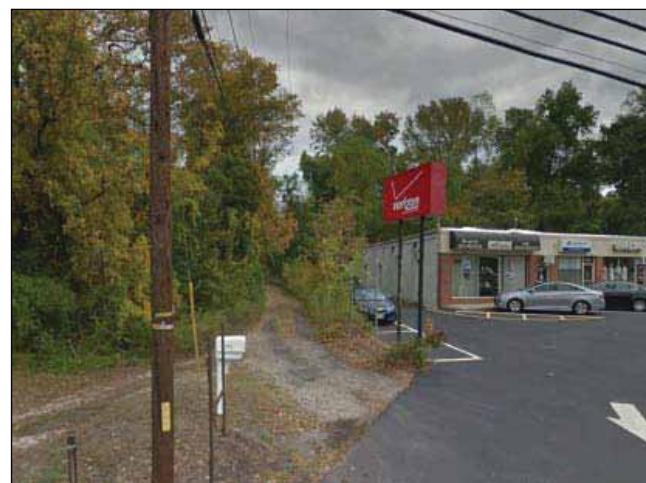
Image 3: Highland Place 14'-0" dirt road with acute angle from Highway 35.

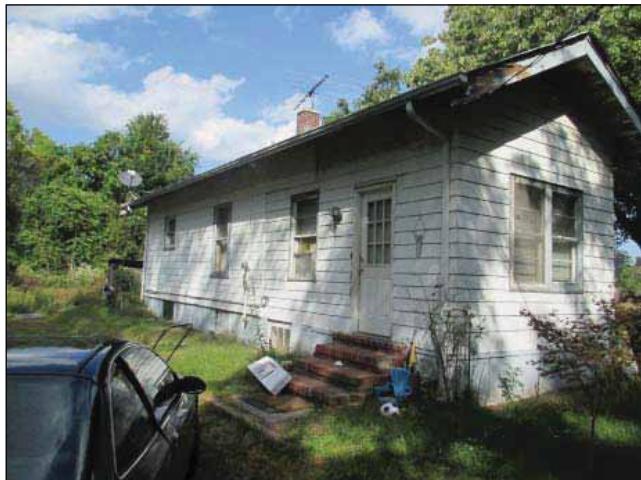
Image 3: Front steps missing hand rails.

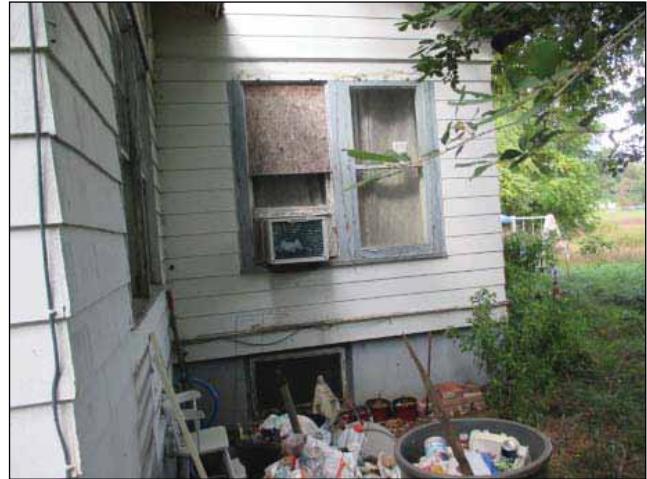
Image 4: Window boarded on rear side.

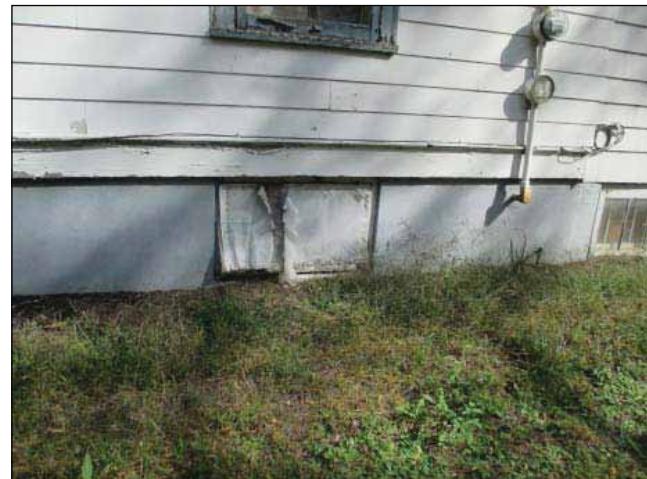
Image 6: Boarded up windows to the basement.

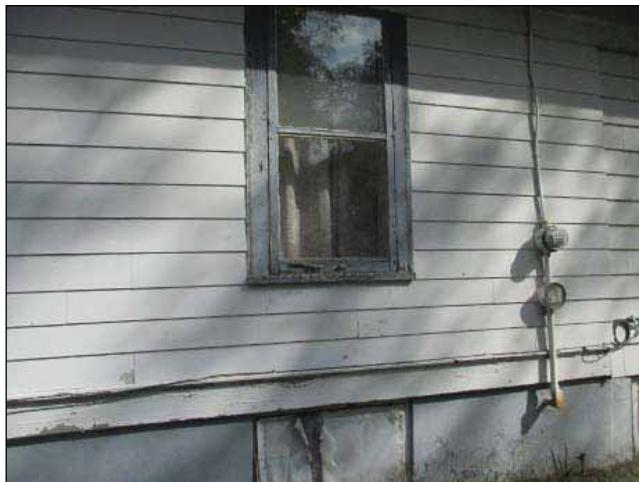
Image 6: Rotting wood framing at windows.

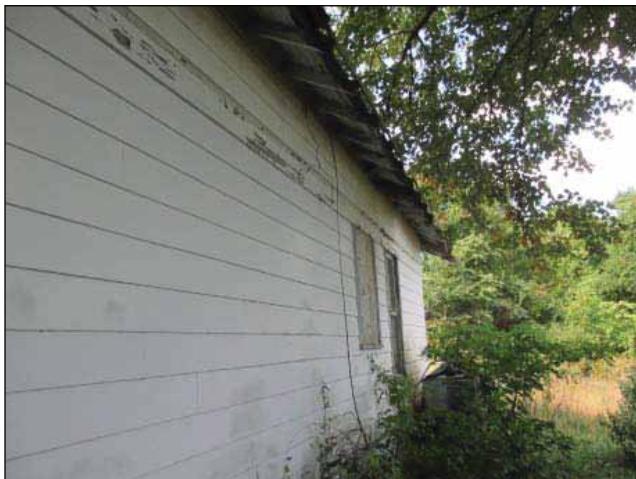
Image 10: Roof completely deteriorated at rear of house.

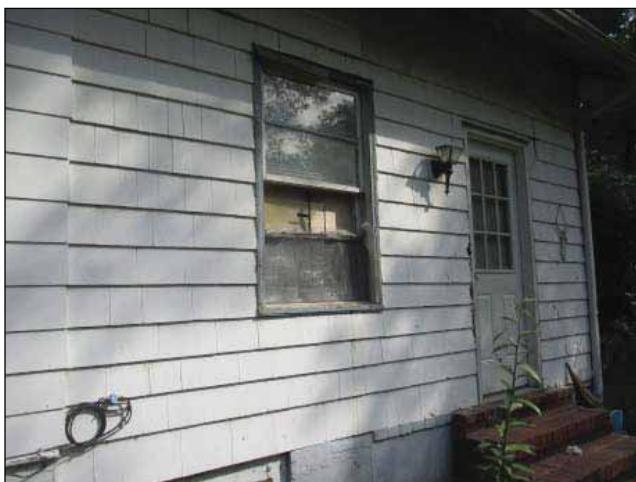
Image 12: Windows boarded on front of house.

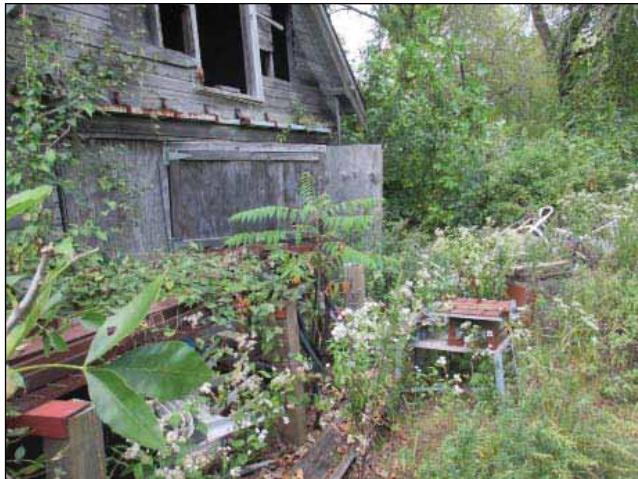
Image 14: Collapsing barns adjacent to house.

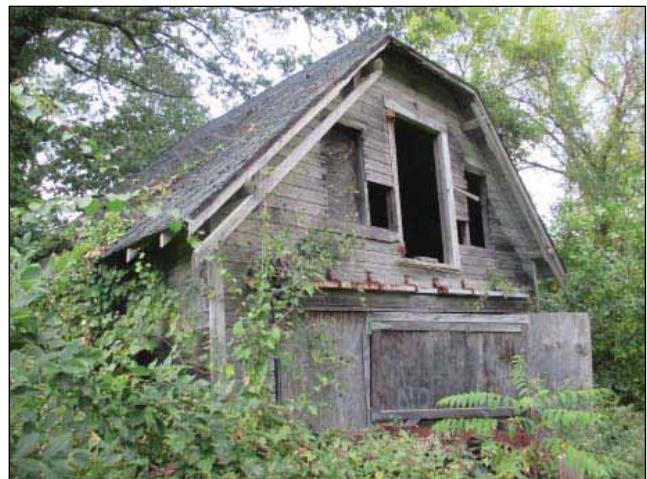
Image 15: Collapsing barns adjacent to house.

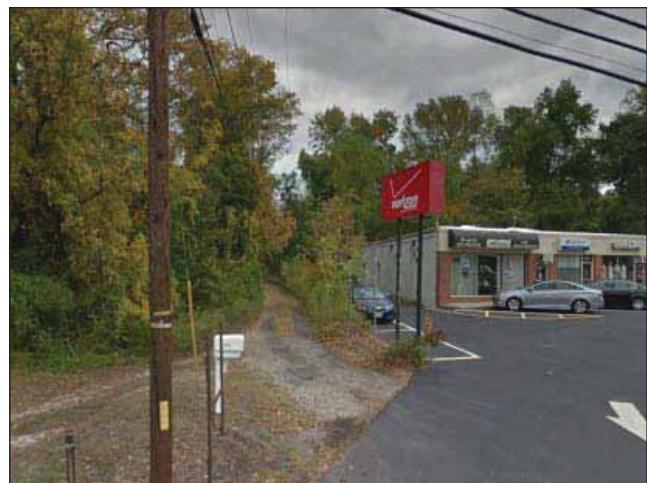
Image 3: Highland Place 14'-0" dirt road with acute angle from Highway 35.

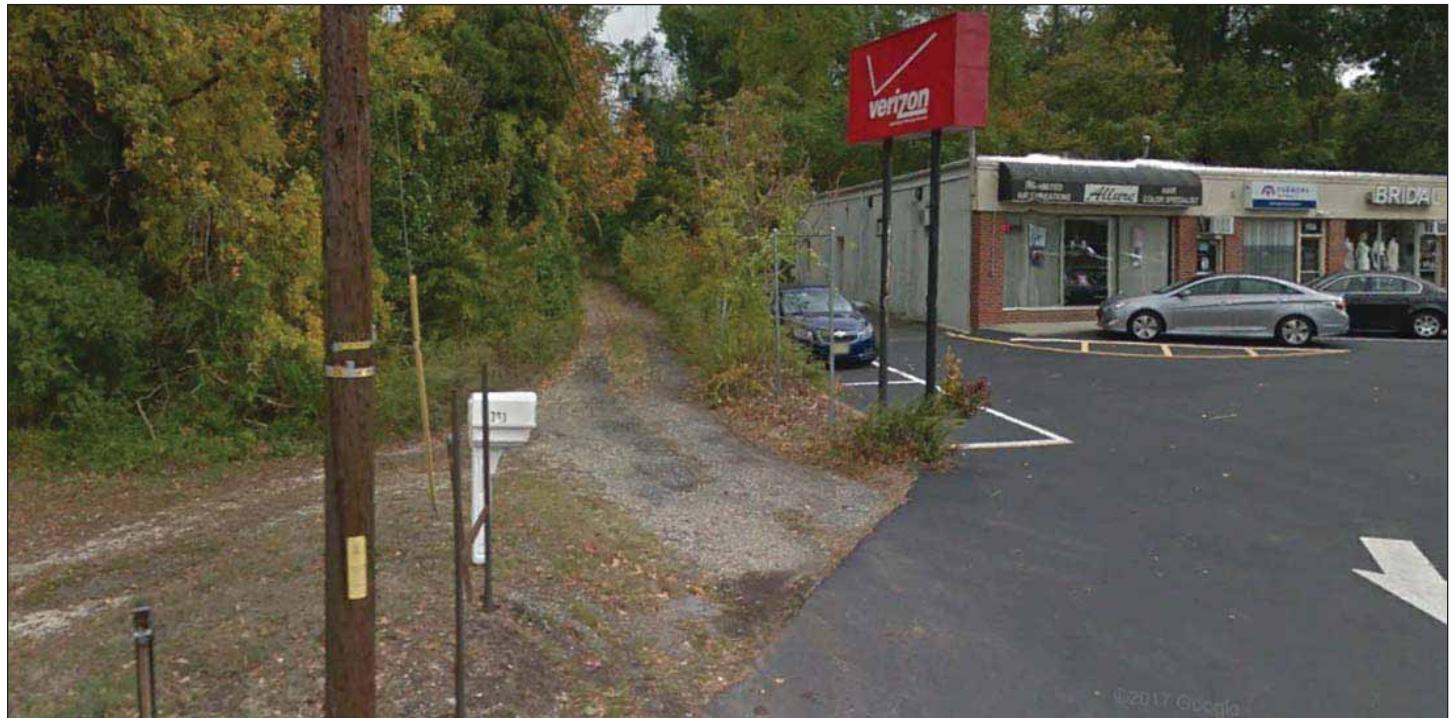
Image 1: Entrance to Highland Place off Highway 35. Approximately 14'-0" wide dirt road with acute angle entrance. Appear vehicles accessing Highland Place are illegally cutting across the exit drive aisle for the strip retail center.

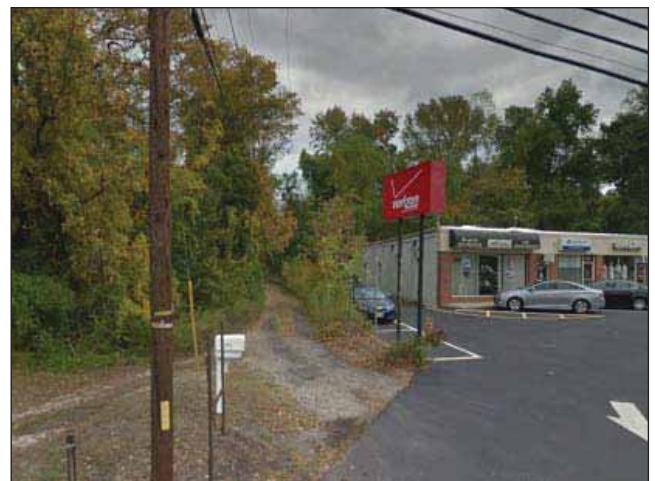
Image 3: Highland Place 14'-0" dirt road with acute angle from Highway 35.

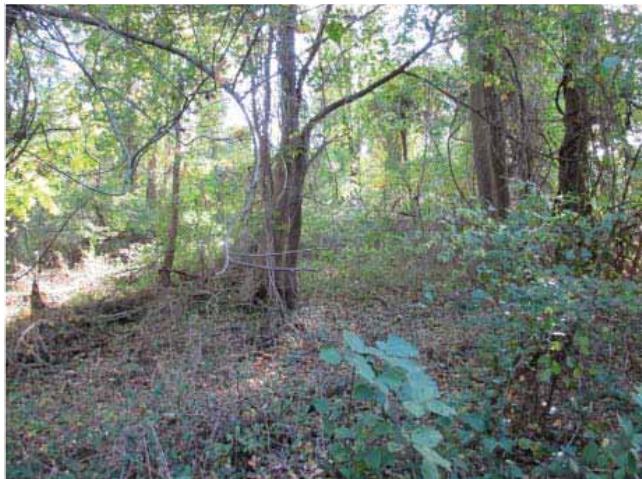
Image 4: Dirt road with no lighting or sidewalks off Highway 35.

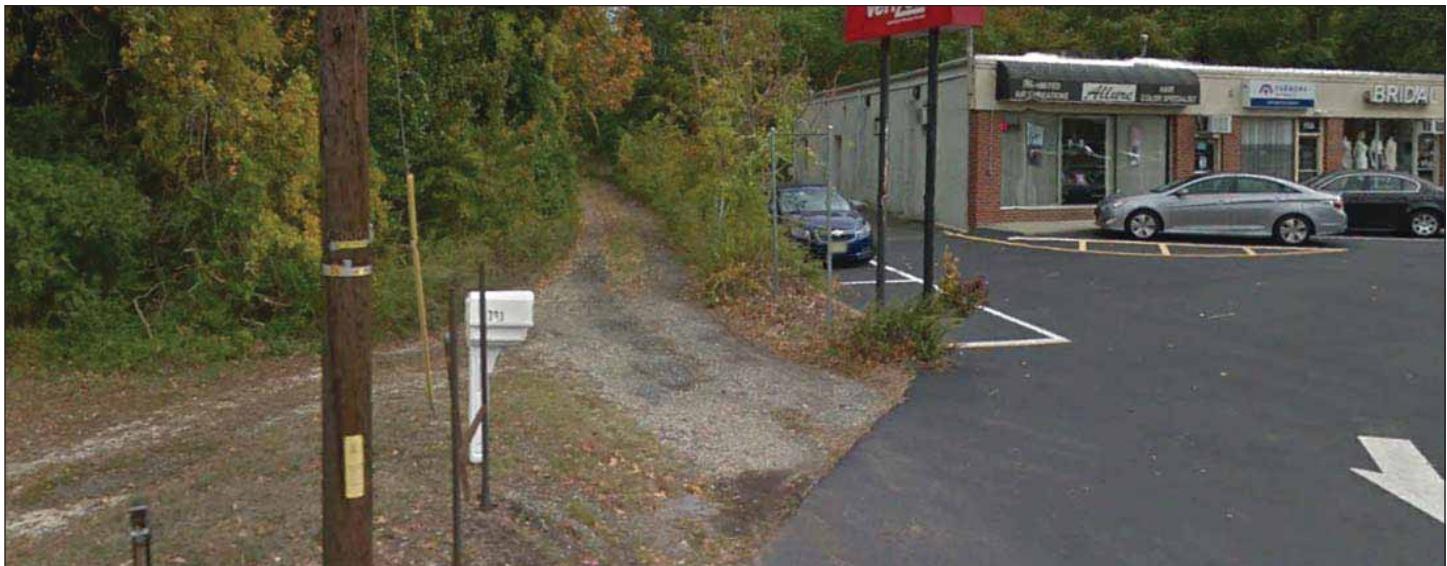
Image 1: Entrance to Highland Place off Highway 35. Approximately 14'-0" wide dirt road with acute angle entrance. Appear vehicles accessing Highland Place are illegally cutting across the exit drive aisle for the strip retail center.

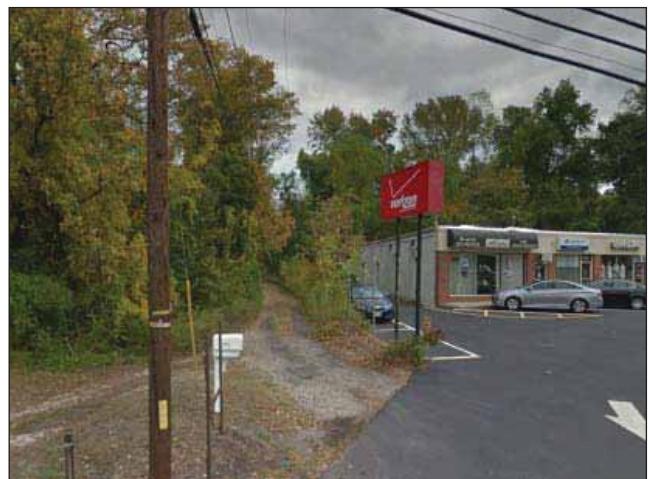
Image 3: Highland Place 14'-0" dirt road with acute angle from Highway 35.

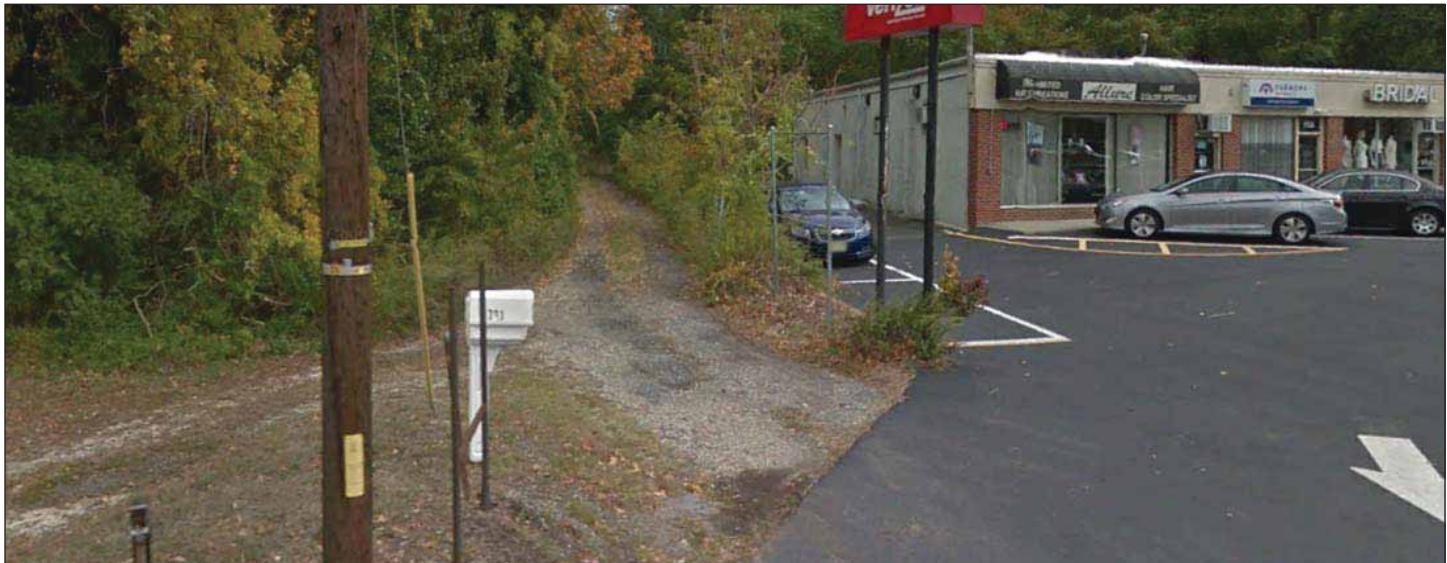
Image 1: Entrance to Highland Place off Highway 35. Approximately 14'-0" wide dirt road with acute angle entrance. Appear vehicles accessing Highland Place are illegally cutting across the exit drive aisle for the strip retail center.

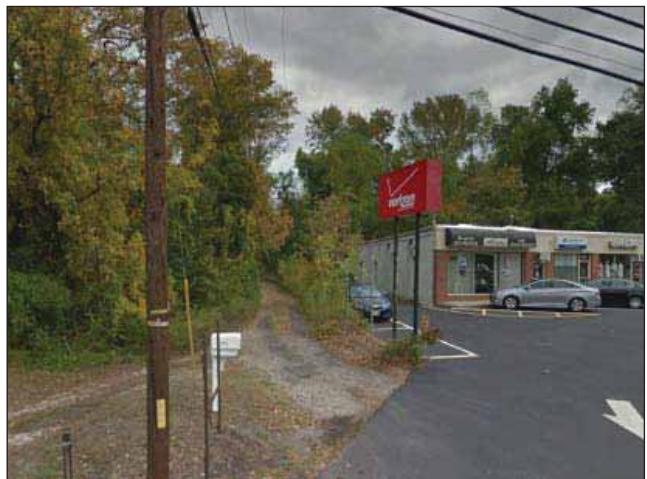
Image 3: Highland Place 14'-0" dirt road with acute angle from Highway 35.

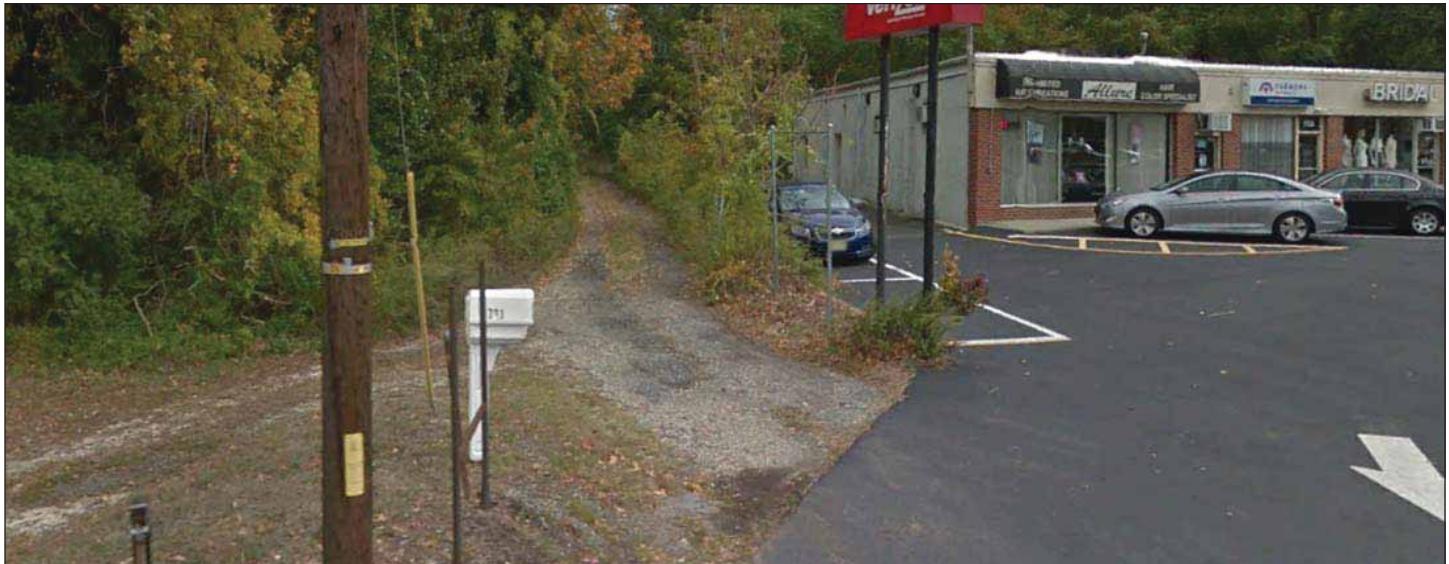
Image 1: Entrance to Highland Place off Highway 35. Approximately 14'-0" wide dirt road with acute angle entrance. Appear vehicles accessing Highland Place are illegally cutting across the exit drive aisle for the strip retail center.

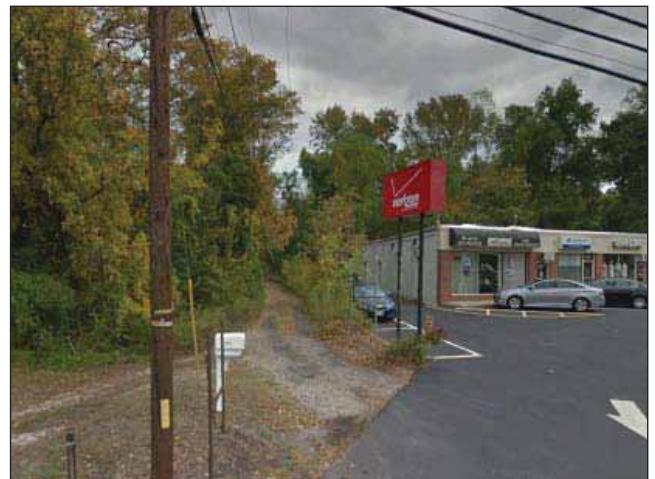
Image 3: Highland Place 14'-0" dirt road with acute angle from Highway 35.

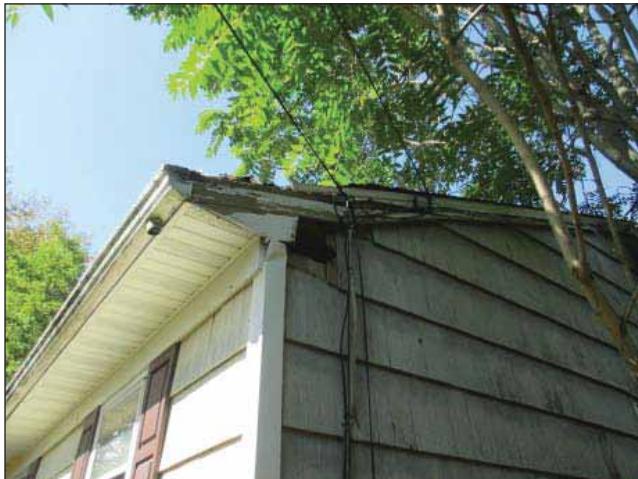
Image 1: Hole in siding to attic space. Rotting wood at roof.

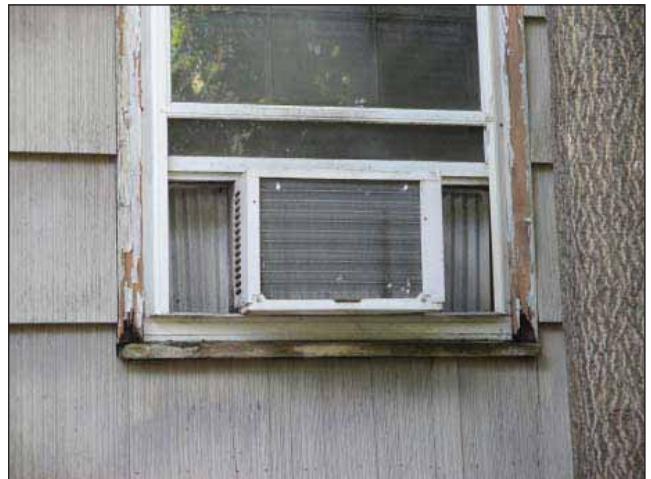
Image 2: Rotting wood along window frame.

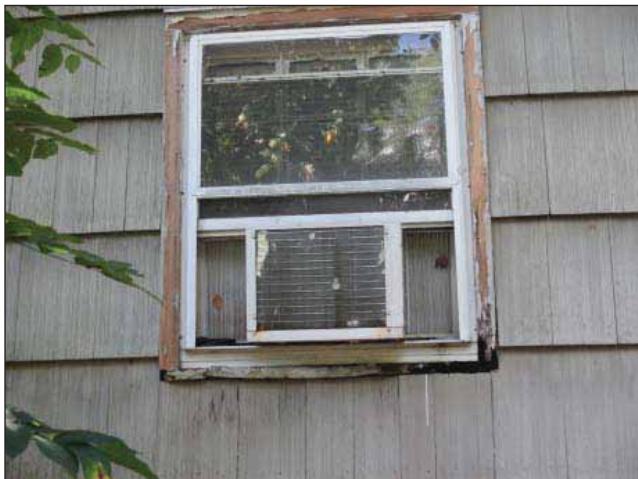
Image 3: Rotting wood along window frame.

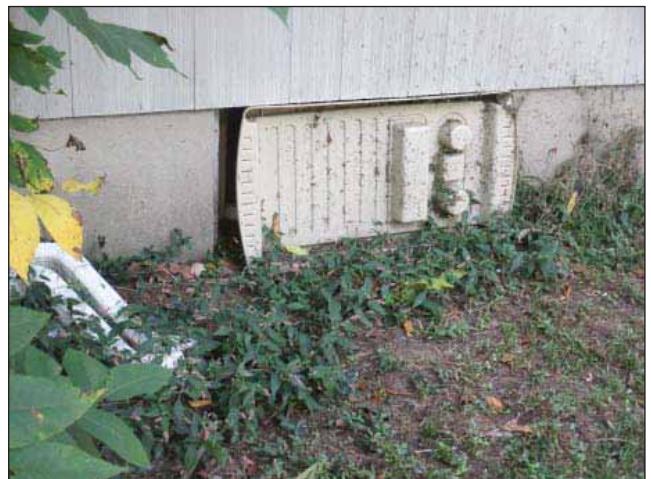
Image 4: Temporary plastic covering over opening to basement.

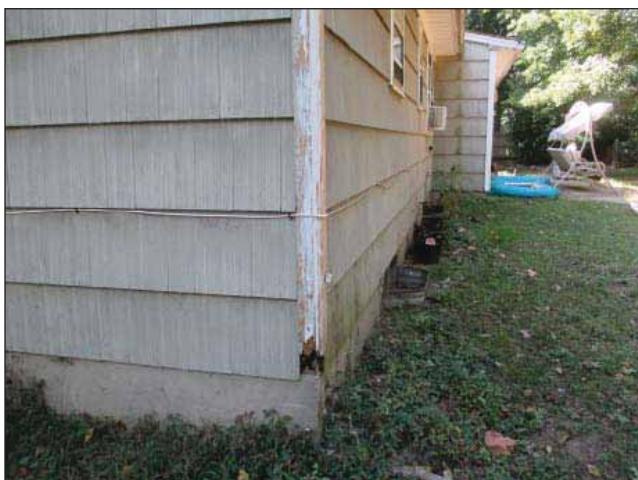
Image 5: Rotting wood along side of rear and side facade.

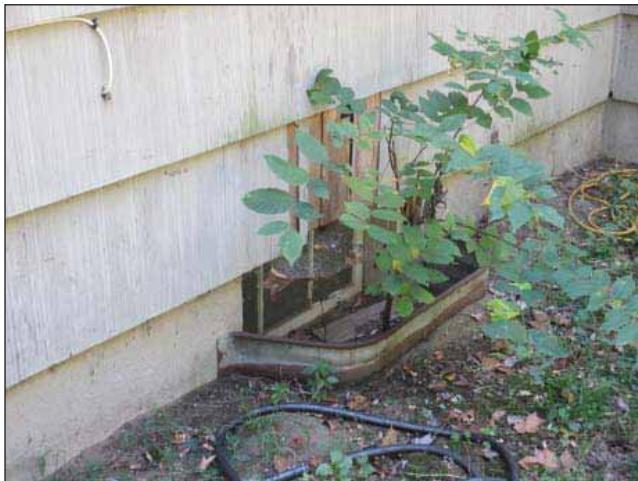
Image 7: Damage to the siding along rear facade.

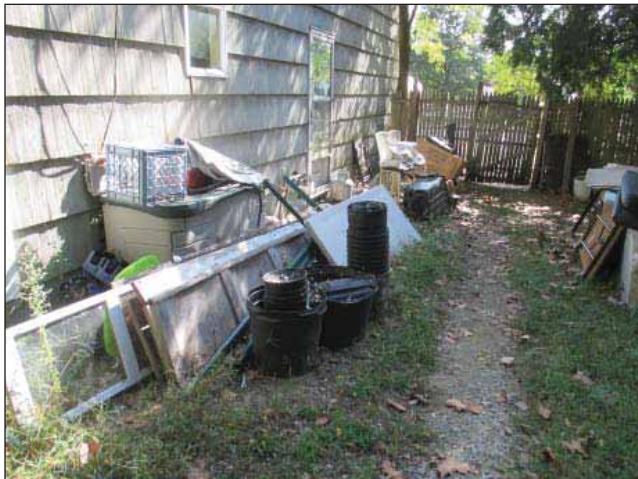
Image 9: Debris and garbage along side of the house.

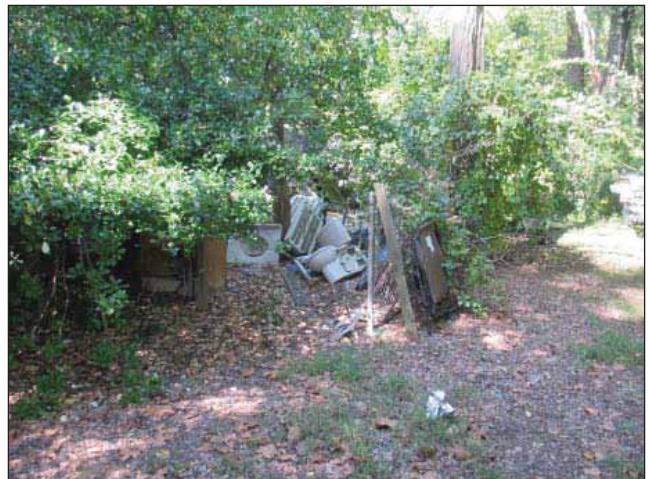
Image 10: Debris (toilets) located in the rear portion of the yard.

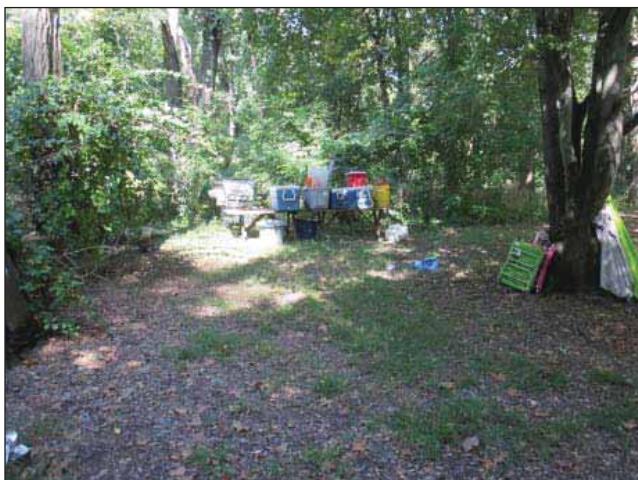
Image 11: Garbage on existing picnic table in the rear yard.

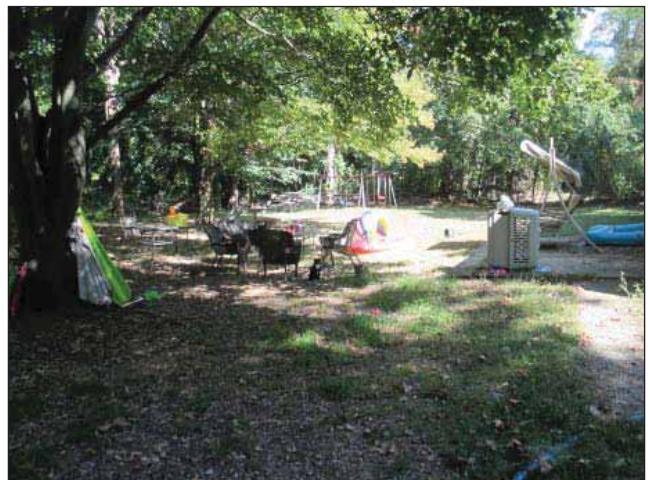
Image 12: Debris located throughout the rear yard.

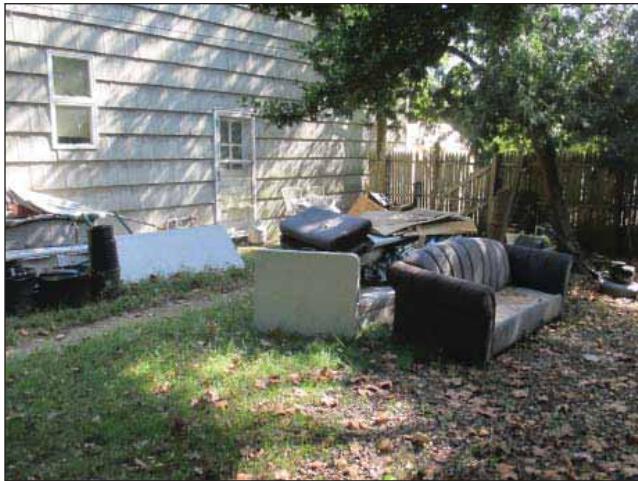
Image 13: Side yard littered with household furniture.

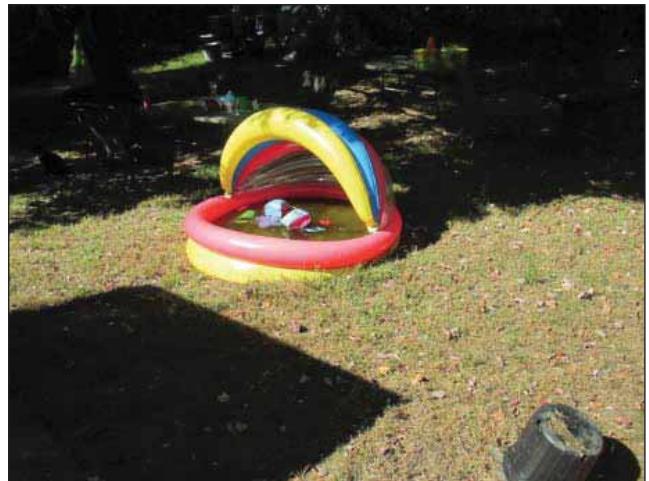
Image 14: Kids pool with standing water and algae.

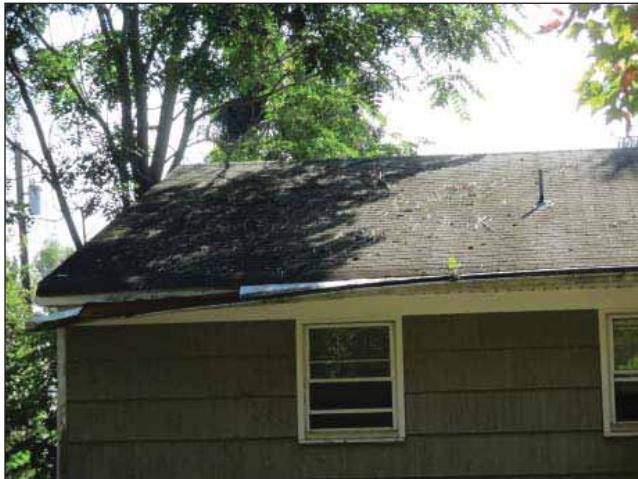
Image 15: Damage to rear roof with rotting fascia boards and moss on the roof.

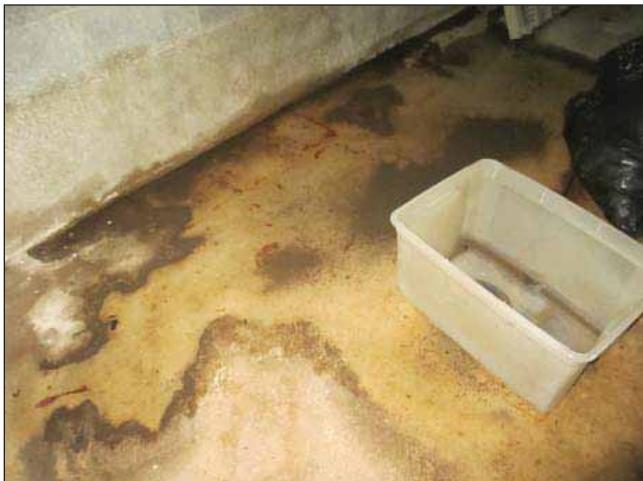
Image 21: Standing water and discoloration of floor.

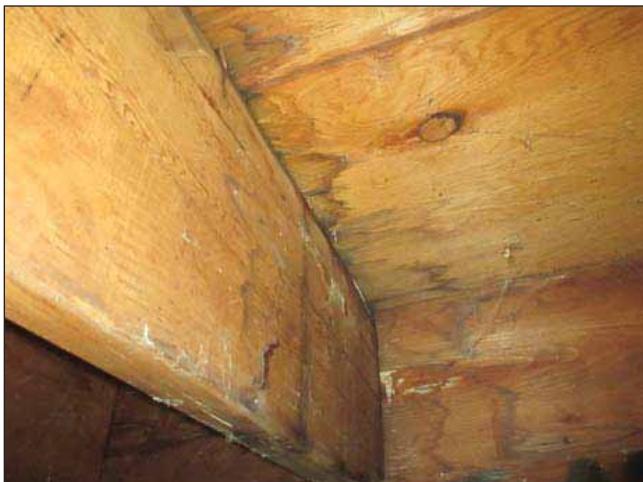
Image 23: Beams in basement with water damage.

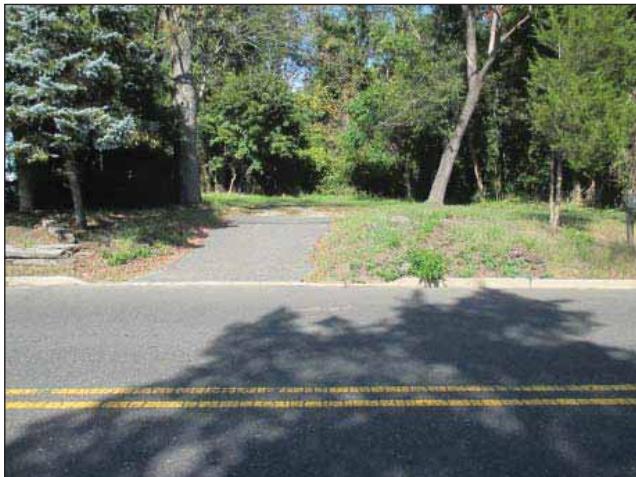
Image 1: Existing driveway pitching toward Kanes Lane

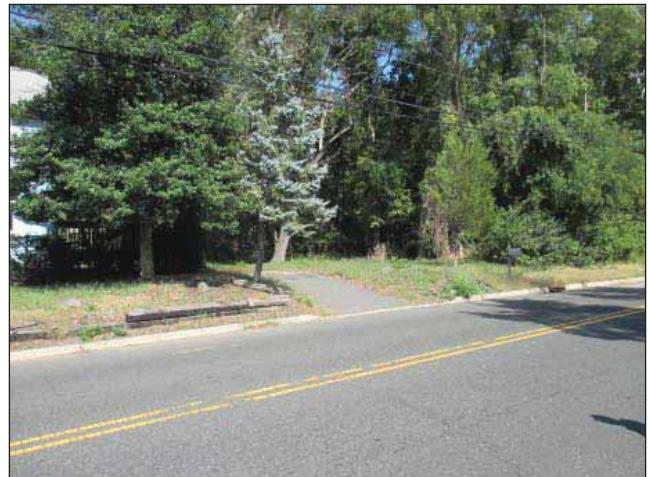
Image 2: Existing driveway pitching toward Kanes Lane.

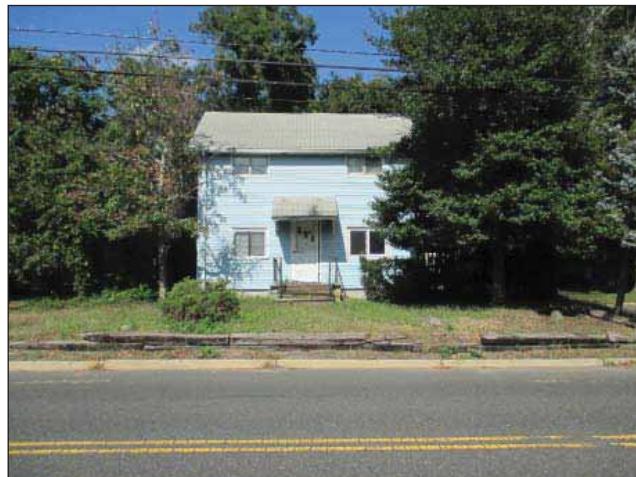
Image 3: Single family house with damage to front steps.

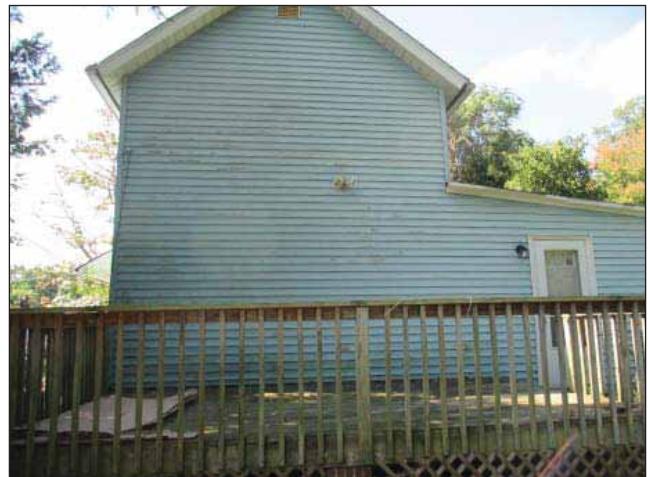
Image 4: Rear porch in poor condition with no windows.

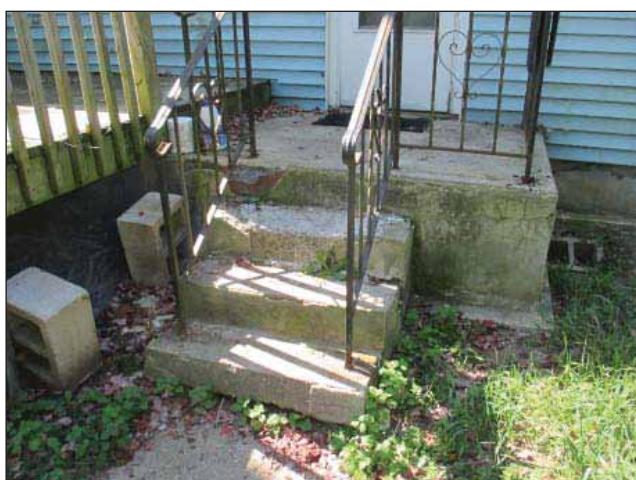
Image 5: Rear steps with corroded and broken concrete steps.

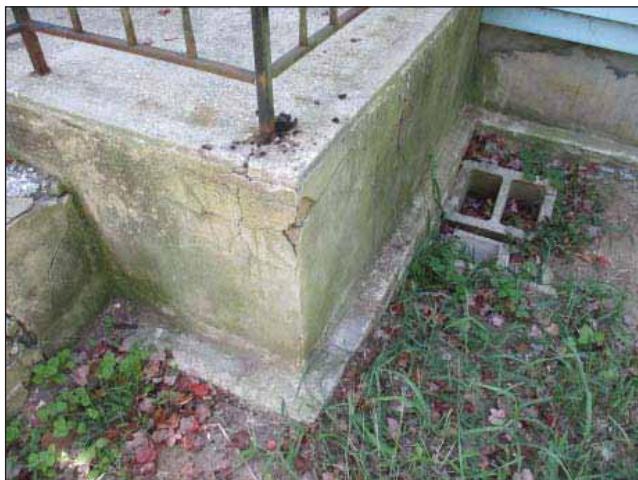
Image 7: Rear steps with corroded and broken concrete steps.

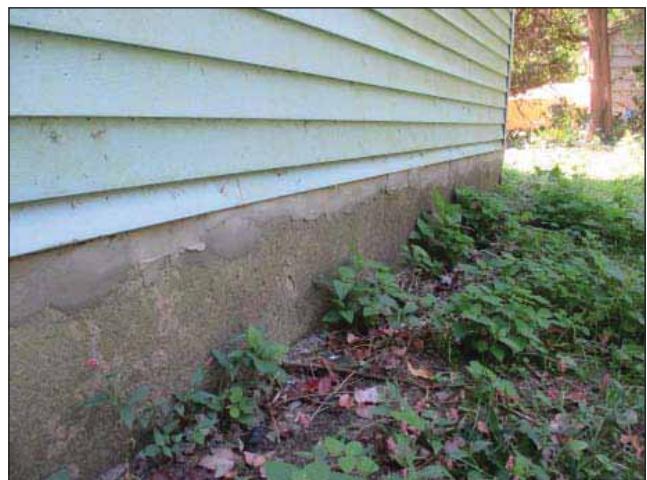
Image 8: Patching along base of single family house

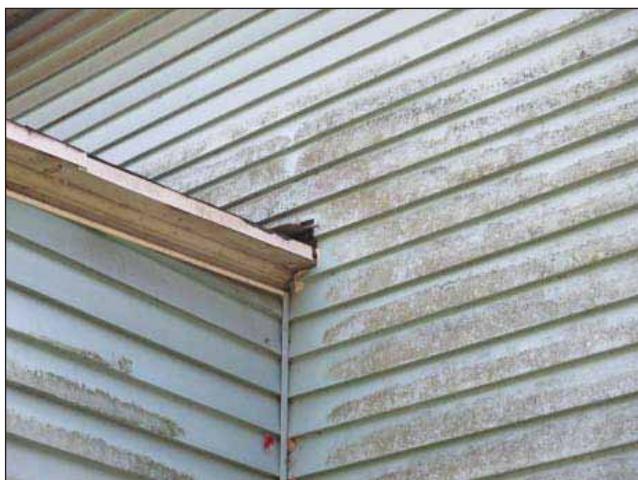
Image 9: Holes at confluence of the side roof and the side siding.
