Report of
**Preliminary Investigation for
Determination of an Area in Need of Redevelopment**

Block 825, Lots: 53, 54, 55, 56, 57, 58, 59, 60, 61, 62, 63, 64, 65, 66, 67, 68, 69.01, 70, 72, 73, 74, 75, 76, 77, 78, 79, 80, and 81 (Mountain Hill), Block 638, Lot 31.01, Block 870, Lot 1 and 2, Block 871, Lot 3 and 7.02

DMR Architects
Francis Reiner, LLA - PP
License #: LI00616700

Township of Middletown
Monmouth County, New Jersey
December, 2017

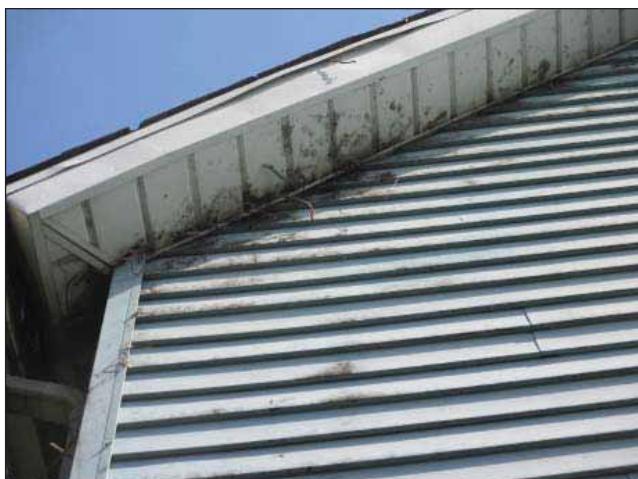
Image 11: Damage from previous plant materials on side of house.

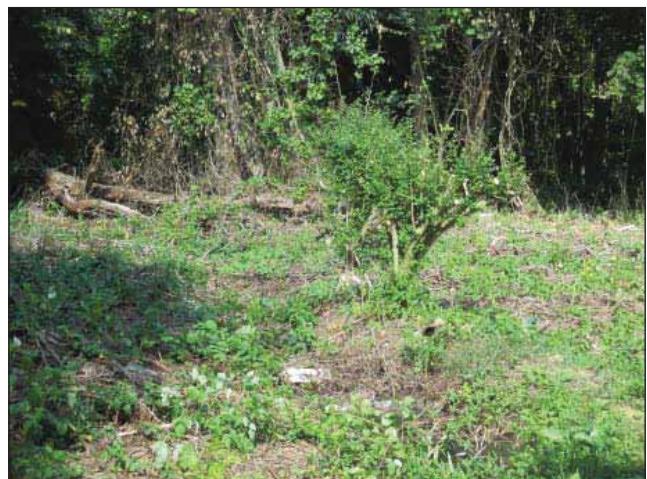
Image 12: Overgrown rear yard.

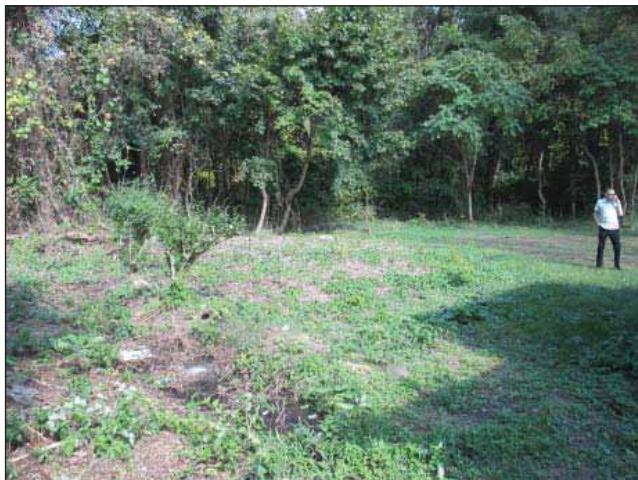
Image 13: Uncared for rear yard with large ditches from drainage.

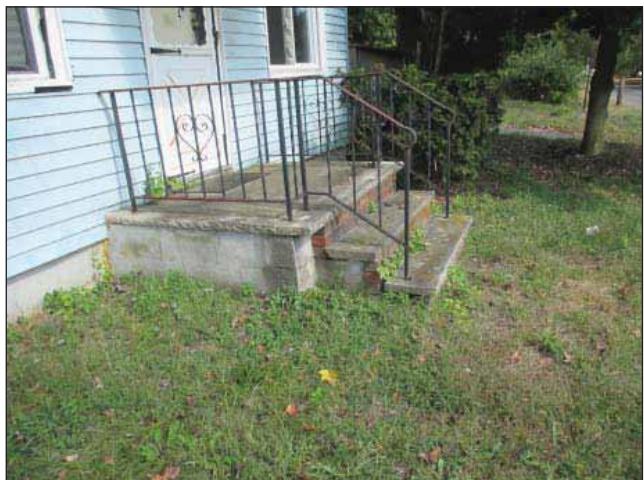
Image 14: Damage along front steps. Missing walk to the drive-way or Kanes Lane.

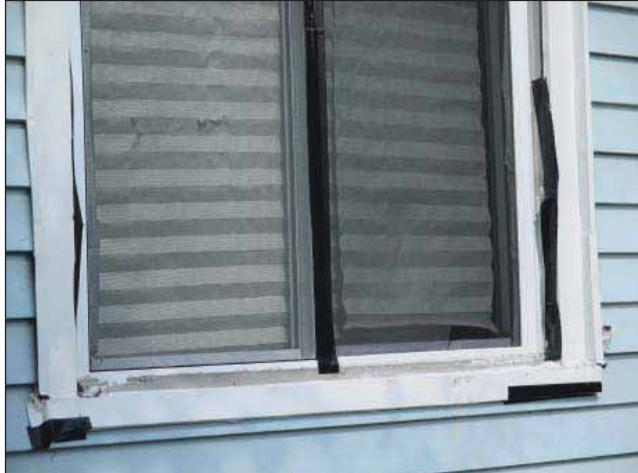
Image 15: Damage along existing window frames.

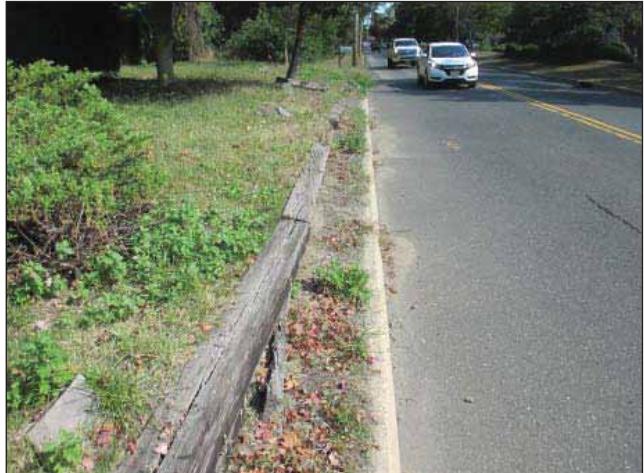
Image 16: Retaining wall along Kanes Road that is leaning toward the street and is damaged and rotting.

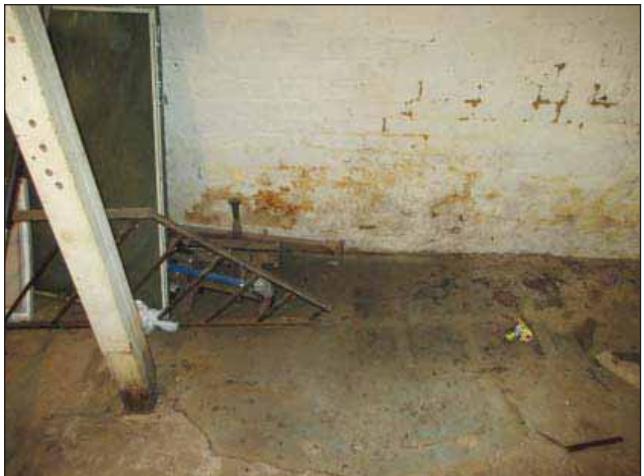
Image 18: Basement with water stains.

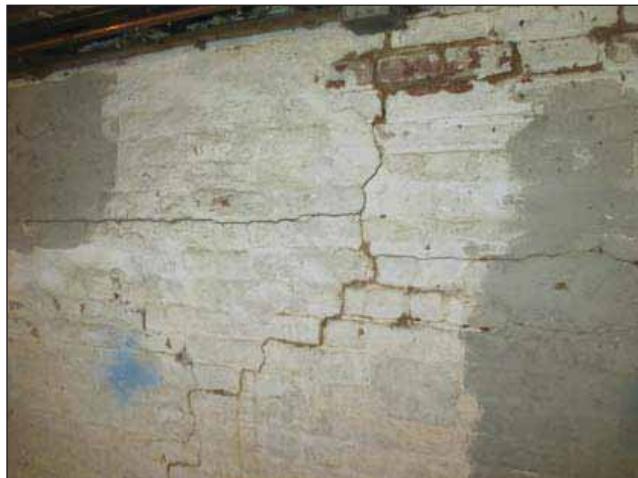
Image 19: Crack in foundation wall in the basement.

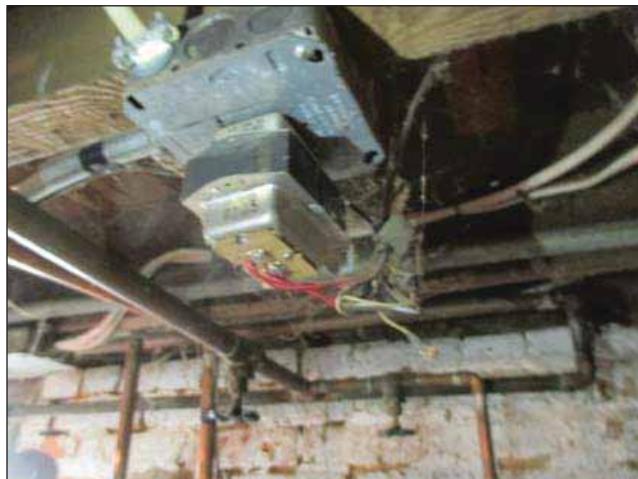
Image 21: Exposed wiring in basement ceiling.

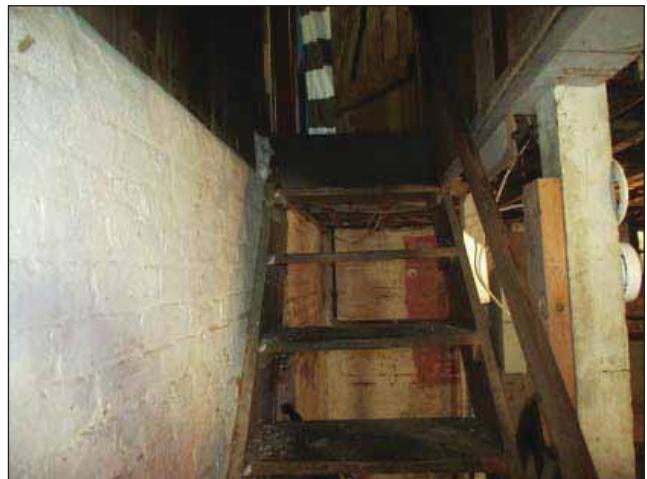
Image 22: Narrow wood stairs to basement.

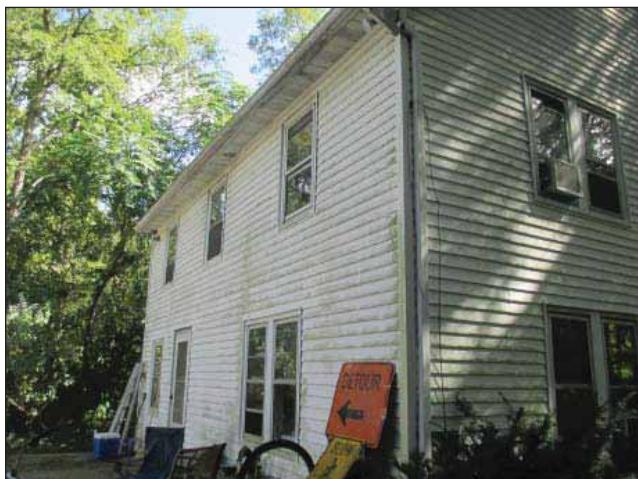
Image 3: Rear facade with mold and mildew on siding.

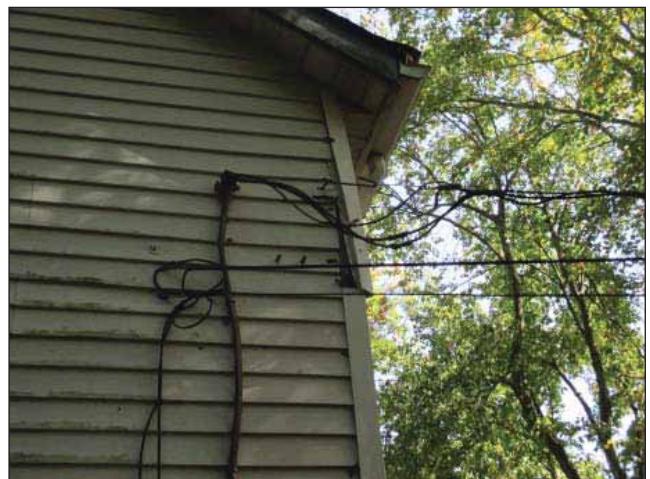
Image 4: Side facade with mold and mildew on siding.

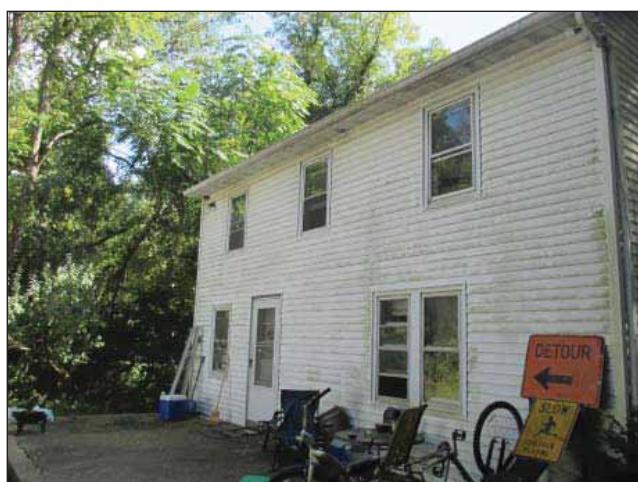
Image 5: Rear facade with mold and mildew on siding.

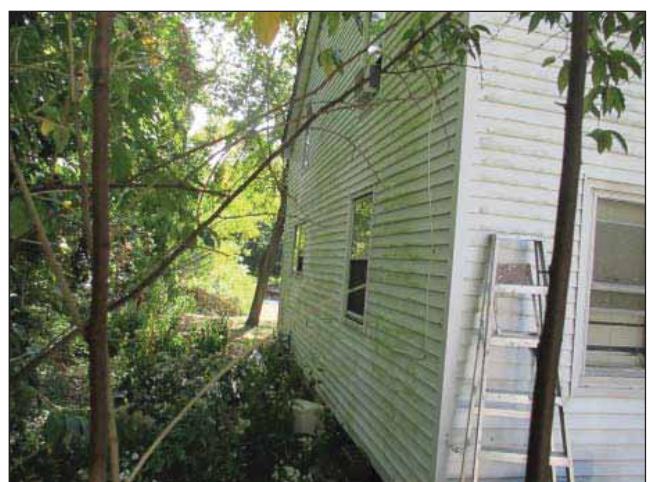
Image 6: Side facade with mold and mildew on siding.

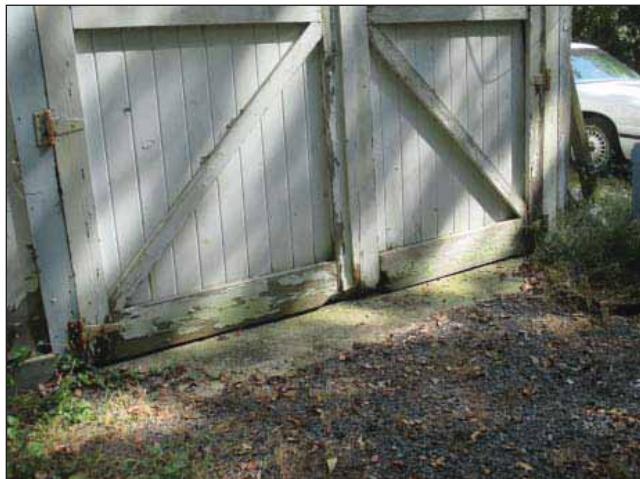
Image 7: Rotting wood along barn door.

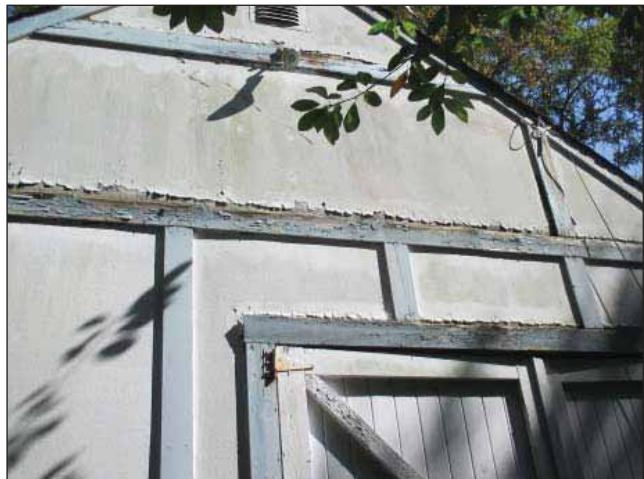
Image 8: Deterioration of side panels at barn.

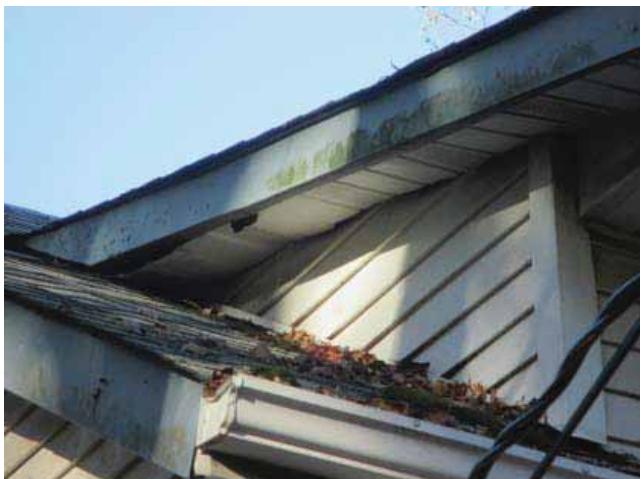
Image 9: Damage to underside of eave.

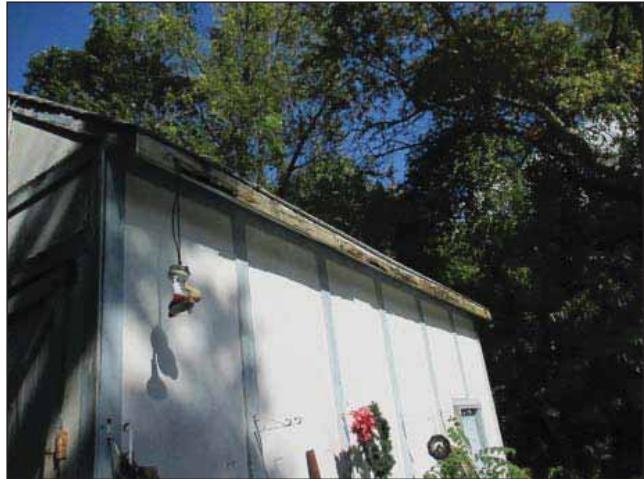
Image 10: Degradation of roof at barn.

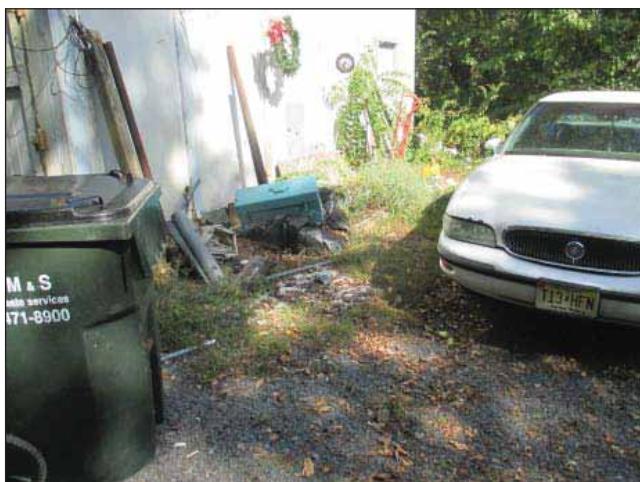
Image 11: Debris at barn.

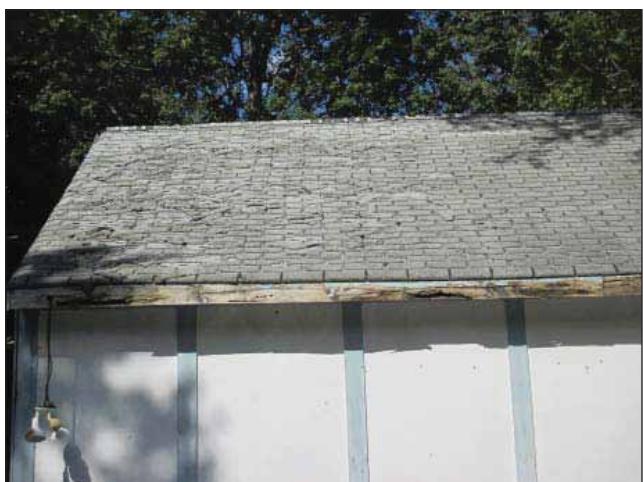
Image 12: Rotting wood along roof line.

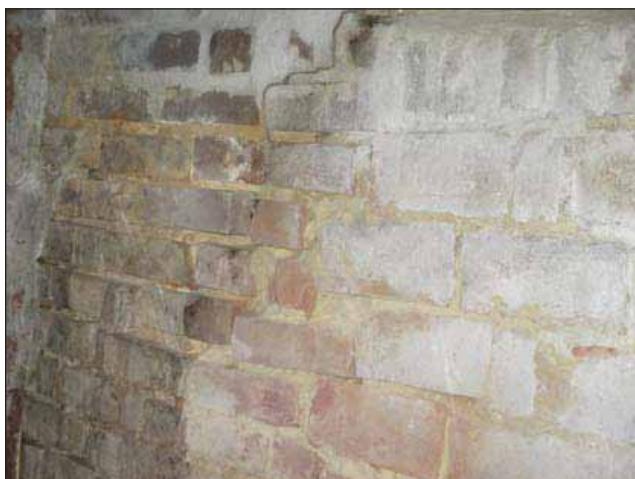
Image 17: Cracking and bowing in basement foundation wall.

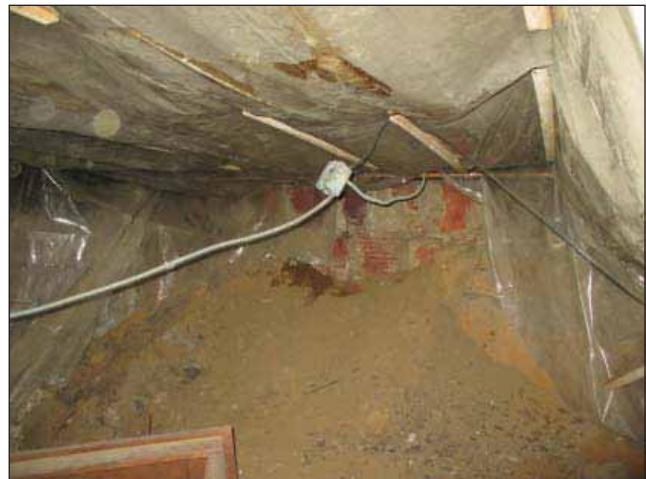
Image 20: Electrical lines hanging in the basement.

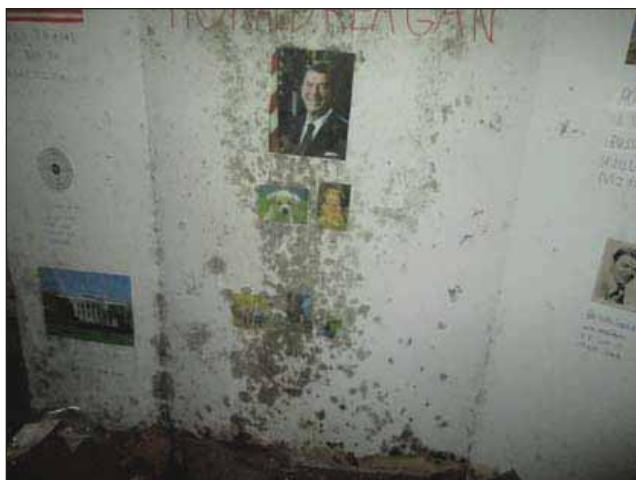
Image 23: Mold in basement.

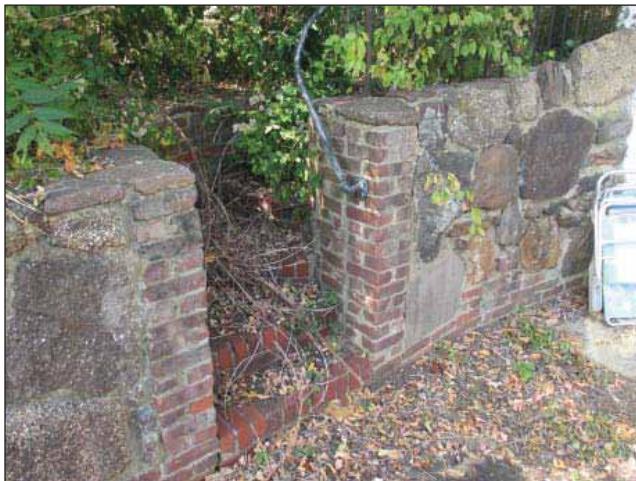
Image 3: Overgrowth of vegetation at steps to rear with concrete patching over areas.

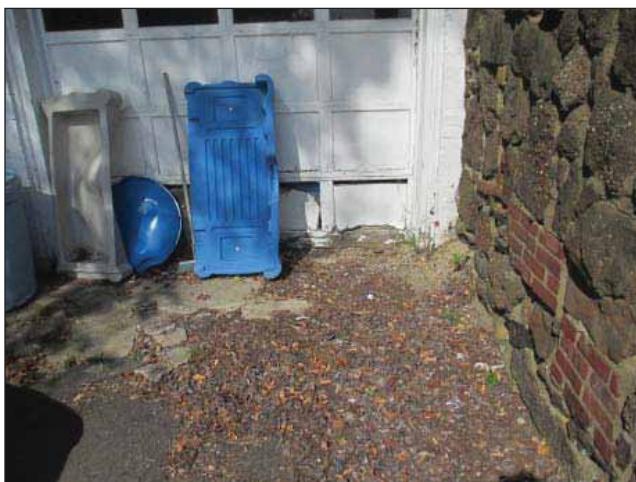
Image 5: Patching and cracking along driveway retaining wall.

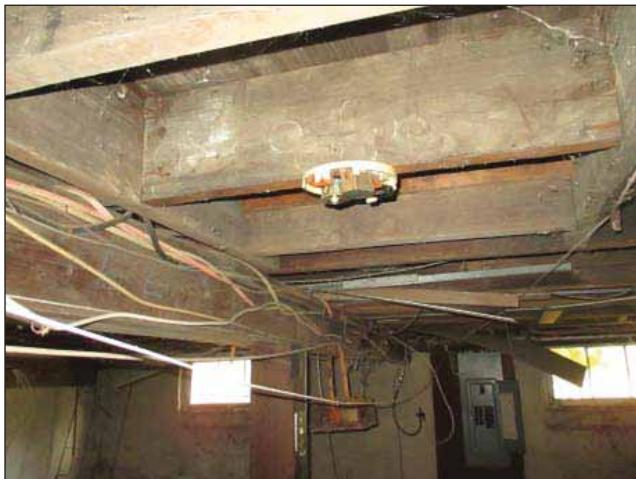
The house is in poor condition with significant signs of water damage evidenced by the moss growing on the roof, wood beams that are rooting and falling apart along the roof line (See images 11 & 14), vegetation growing up and through the attic space (See images 10, 11 & 14), mold and water damage at the base of the building (See image 15). In addition, the garage and basement had standing water and had a distinct oder of mold and mildew and decomposing materials (See images 6, 8 &9). The basement space which was accessed through the garage had opened wires with the fire alarms being detached (See image 7)

Image 7: Exposed and hanging wiring in basement with missing fire alarm.

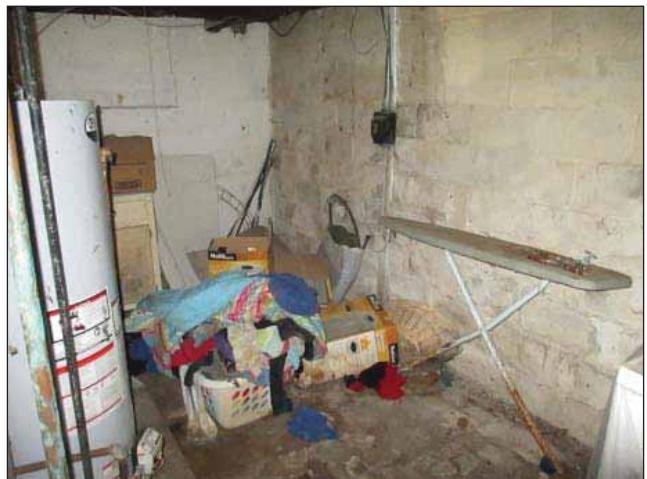
Image 8: Water damage along exterior basement wall.

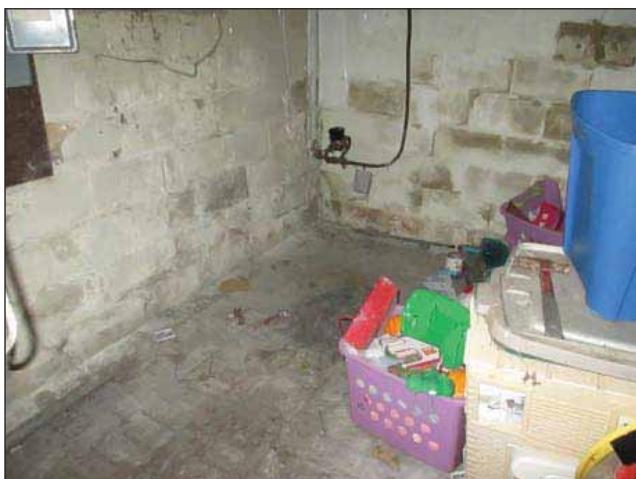
Image 9: Water damage and cracking along exterior basement wall.

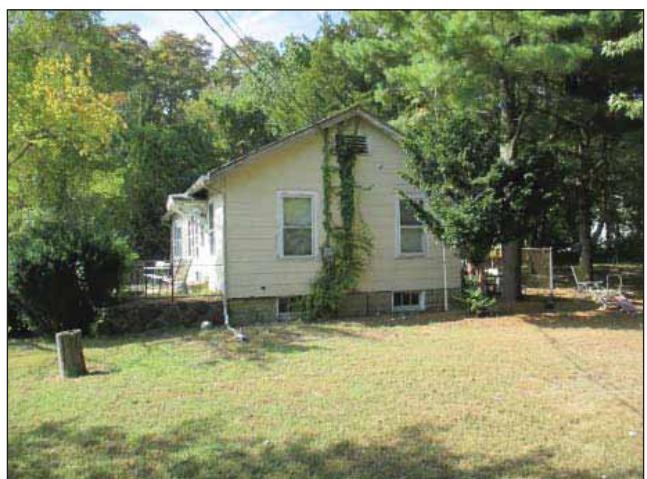
Image 10: Side of house with vegetation growing up the side into the attic space.

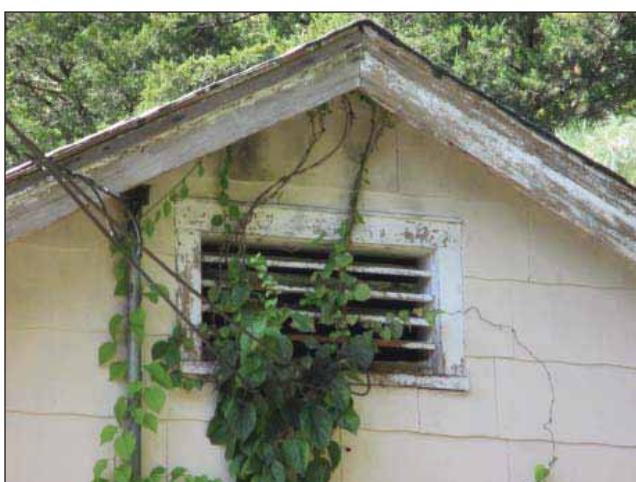
Image 11: Side of house with vegetation growing up the side into the attic space.

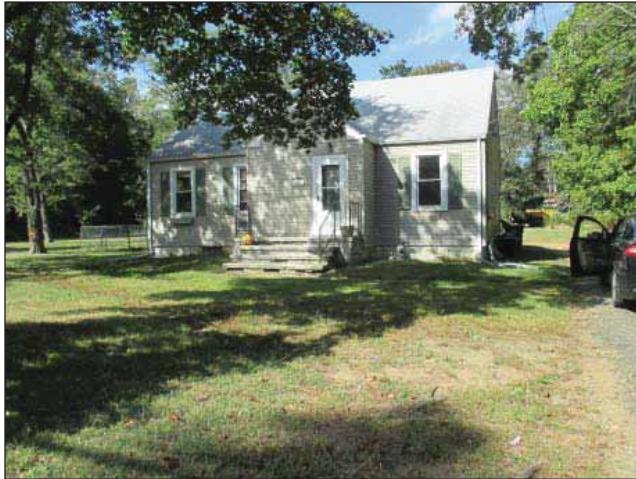
Image 1: Front of single family house with damage to front steps.

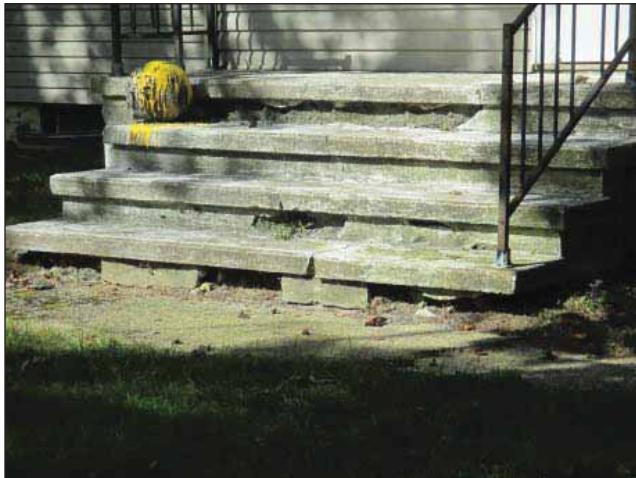
Image 3: Front steps damaged and cracked.

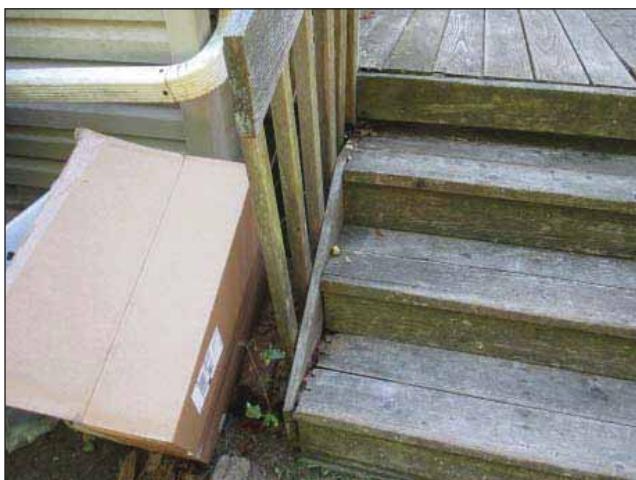
Image 5: Rear porch with rotting wood and deterioration.

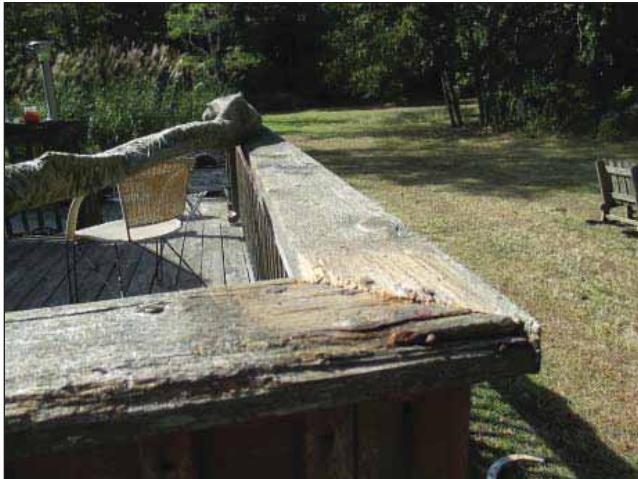
Image 7: Rear porch with rotting wood and deterioration.

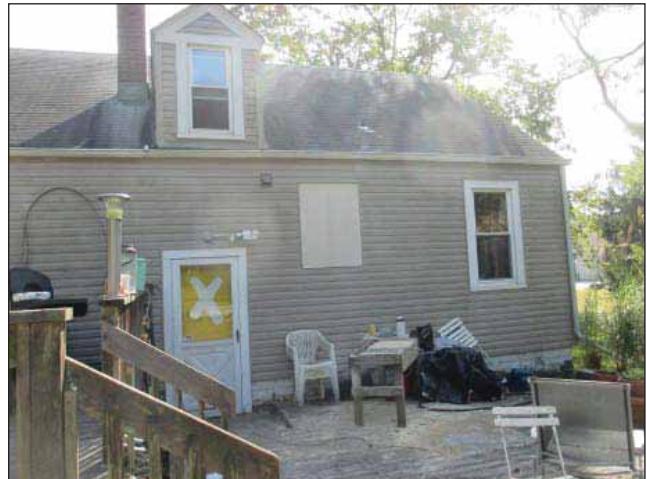
Image 8: Multiple rear door and window patched with wood paneling.

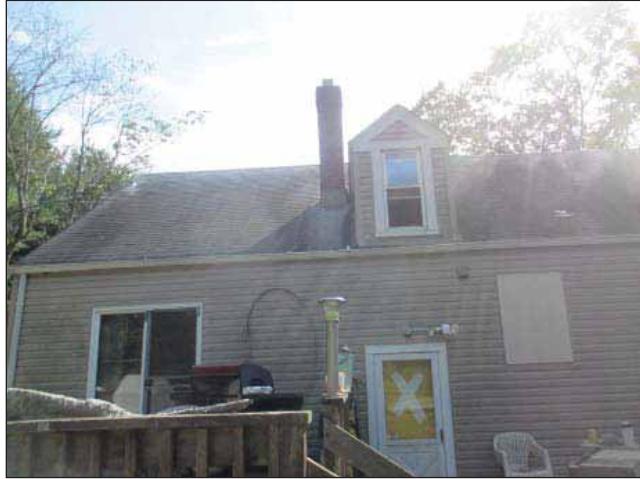
Image 9: Multiple rear door and window patched with wood paneling.

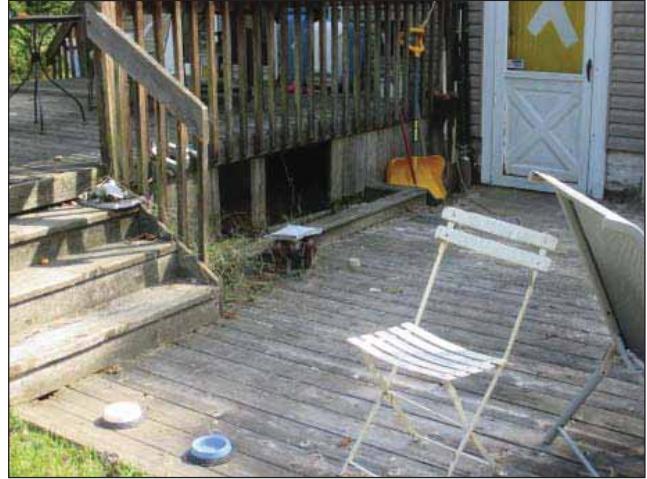
Image 10: Rear at grade porch with rotting wood and wood paneling on rear door.

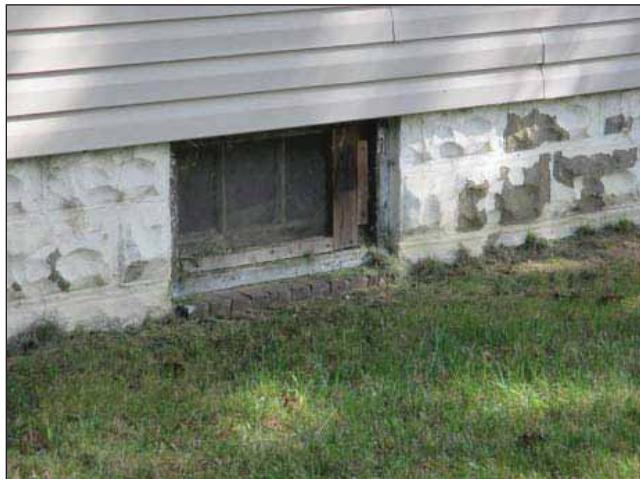
Image 11: Basement window with rotting wood on frame.

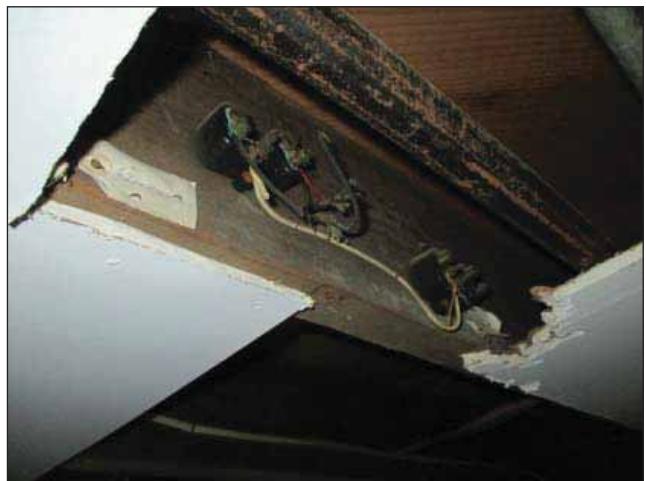
Image 14: Exposed wiring in basement.

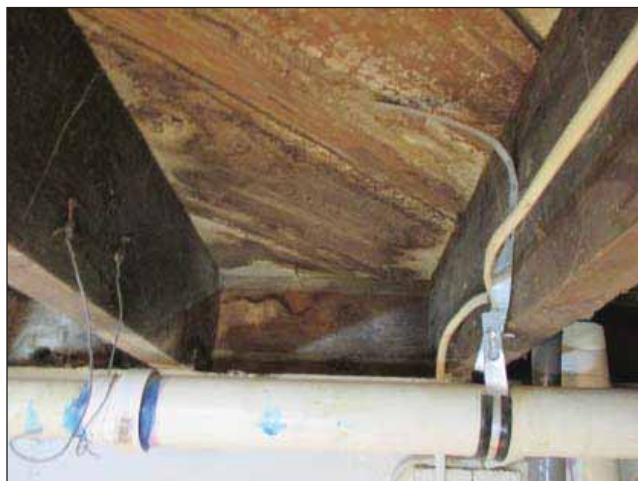
Image 15: Water damage along beams in basement.

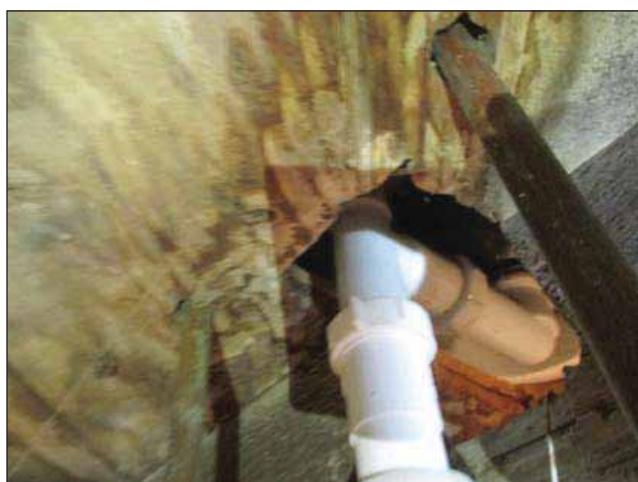
Image 17: Water damage on basement ceiling.

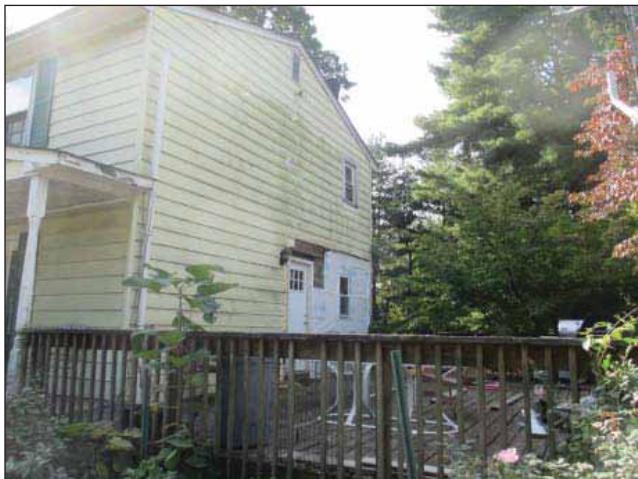
Image 3: Back porch with rotting wood on porch facia and rear portion of siding missing.

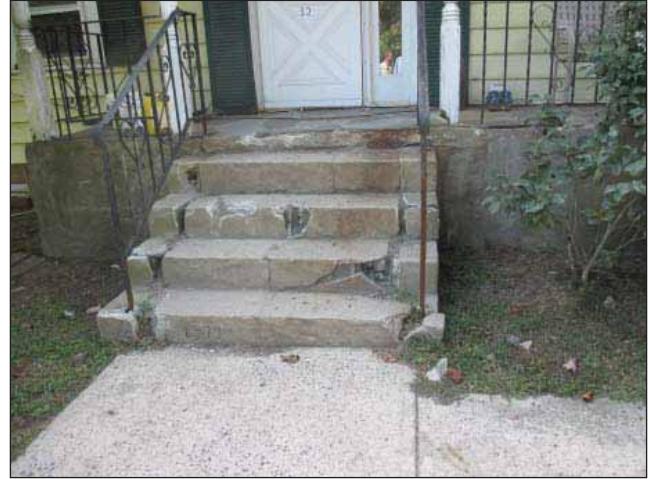
Image 4: Significant deterioration of existing concrete steps to front entrance of the house.

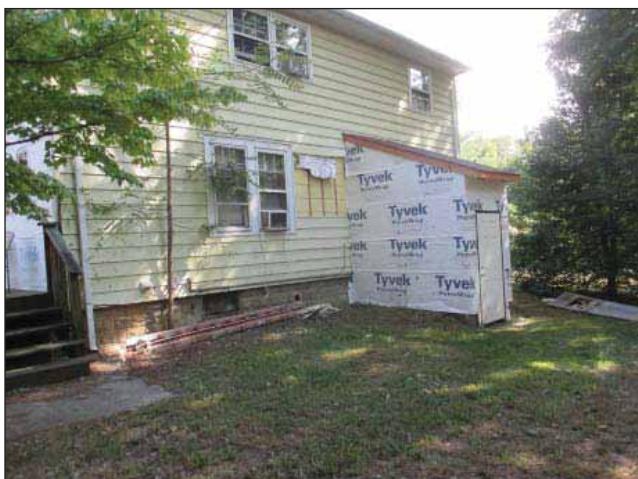
Image 5: Rear siding missing.

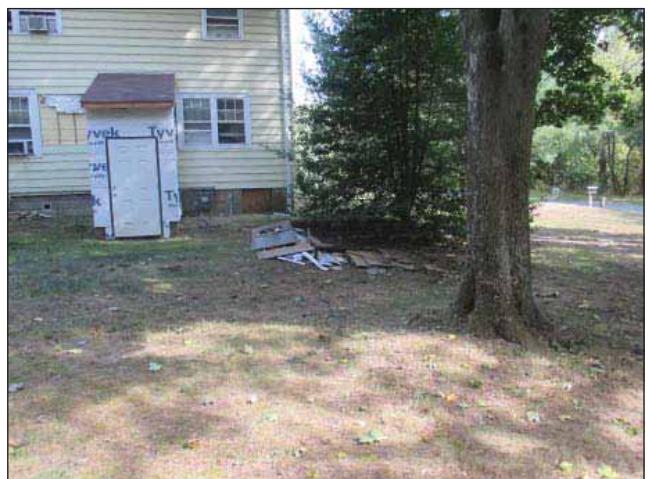
Image 6: Construction debris on side yard.

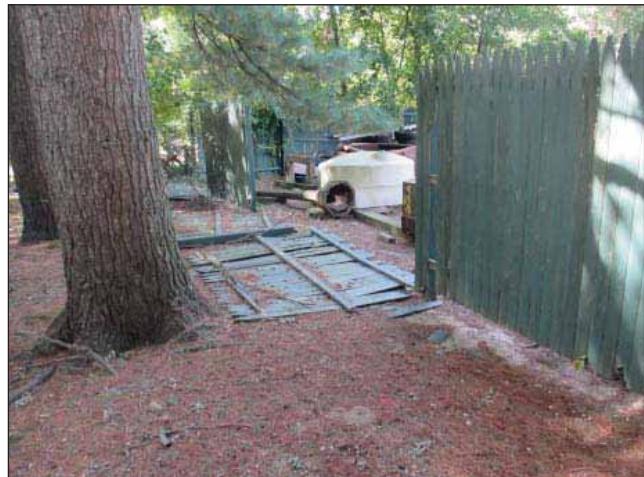
Image 8: Screen fence for debris, parts and rusting metal on side of the property.

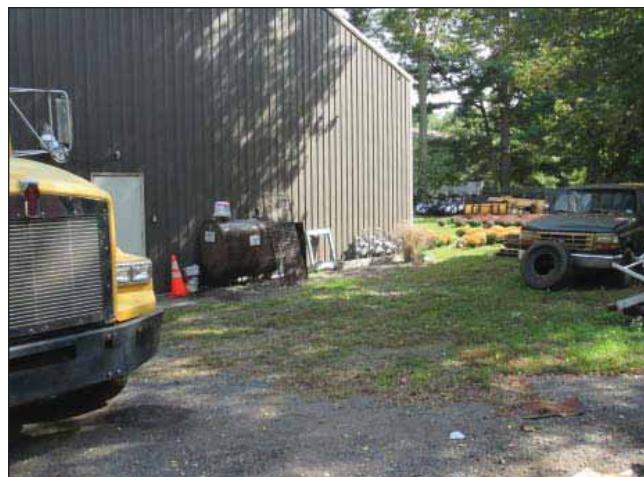
Image 10: Exterior oil tank on the side of one of the metal clad commercial buildings.

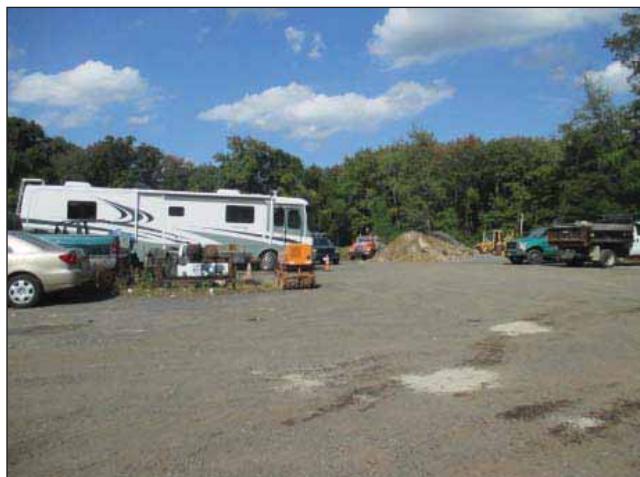
Image 11: Area around commercial buildings in the rear showing landscape materials, abandoned vehicle parts.

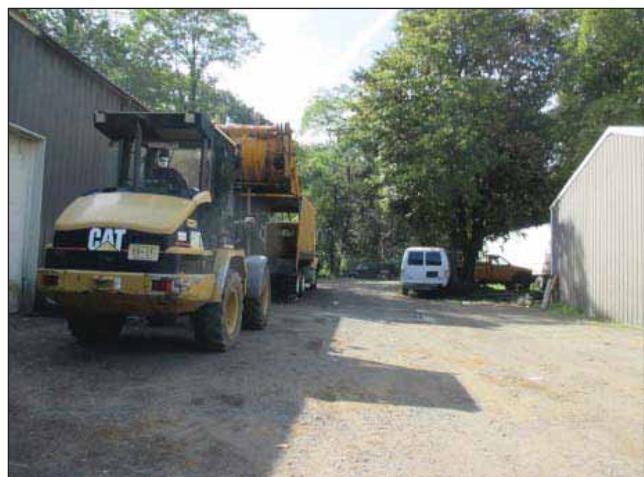
Image 12: Construction equipment between commercial buildings in the rear.

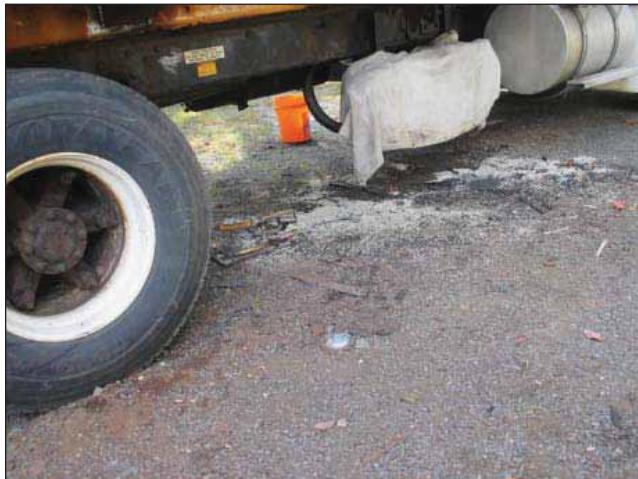
Image 13: Gravel drive areas with leaking vehicular fluids.

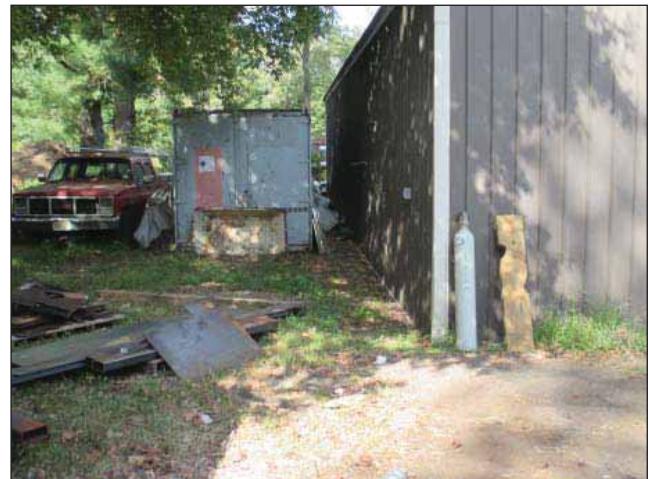
Image 14: Debris along the rear portion of the property.

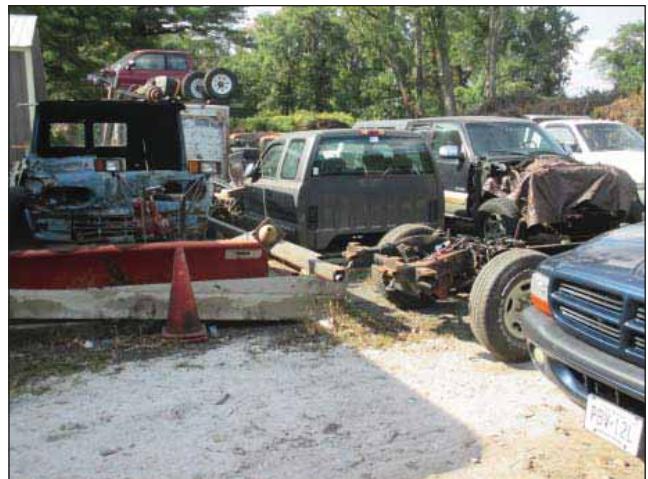
Image 16: Debris, old and used car parts located on the side of the property.

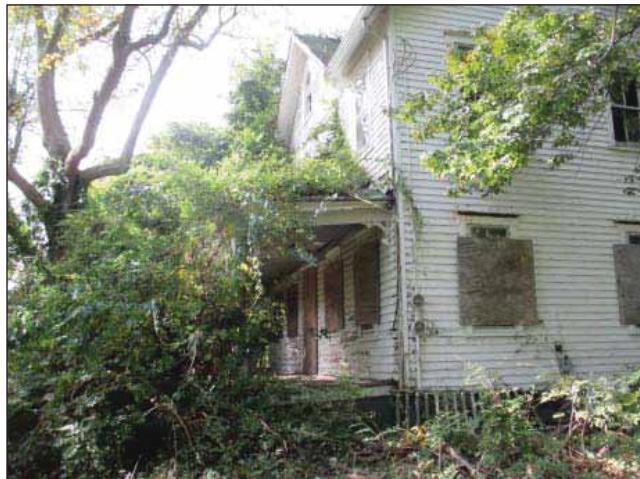
Image 1: Single family house boarded up with porch collapsing.

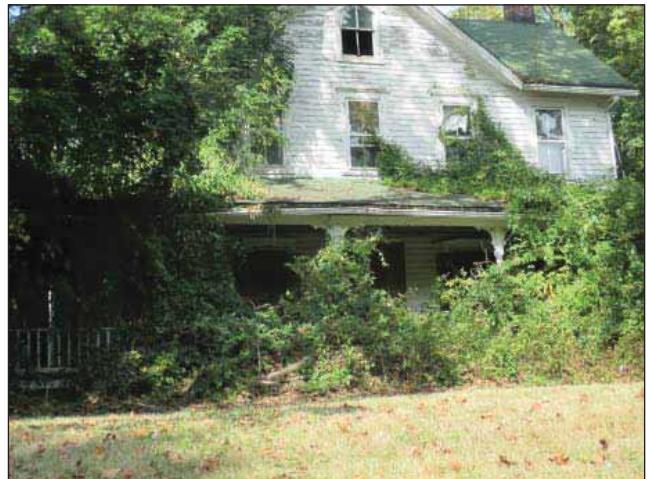
Image 2: Single family house boarded up with porch collapsing.

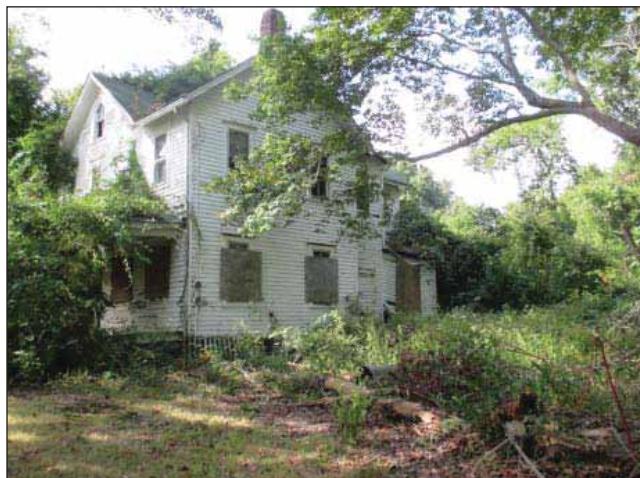
Image 3: Single family house boarded up with porch collapsing.

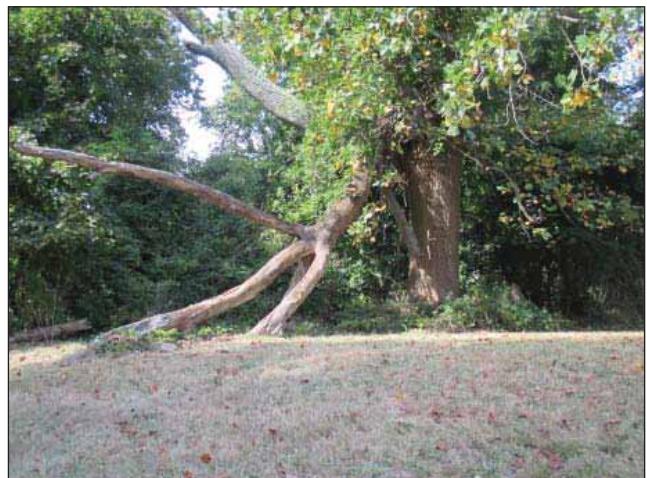
Image 4: Large tree fallen and rotting.

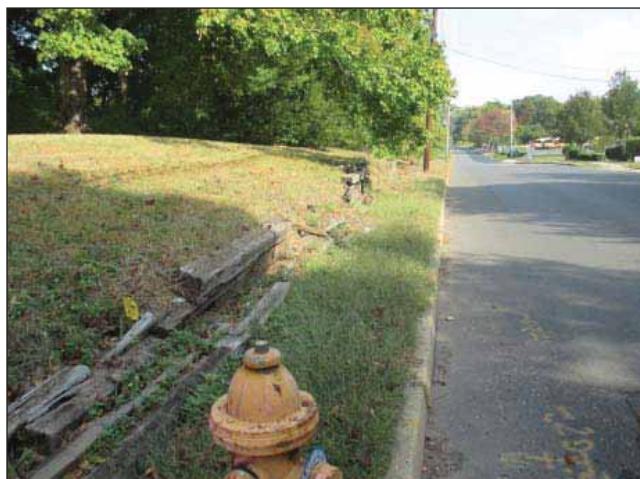
The property has a wood rail tie retaining wall located within feet of the Kanes Lane curb. The retaining wall has deteriorated and is falling into the right of way toward the curb (See image 11). There are no sidewalks along any portion of this property (See images 3, 4, 5 & 11).

Image 5: Wood tie retaining wall on Kanes Lane without any sidewalk that is rotting and leaning toward the road.

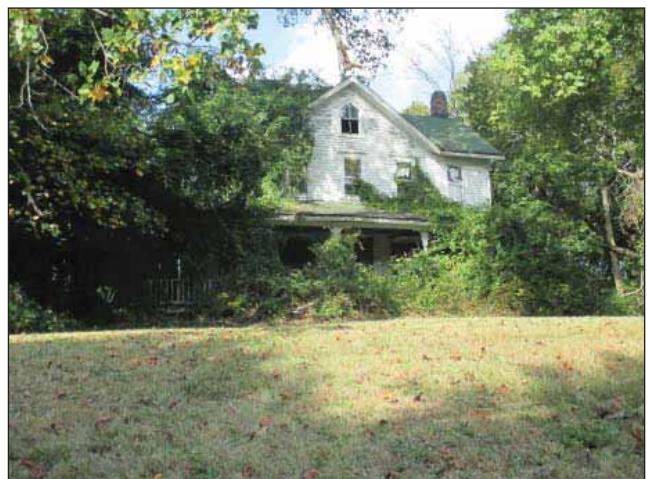
Image 6: Single family house bordered up with porch collapsing.

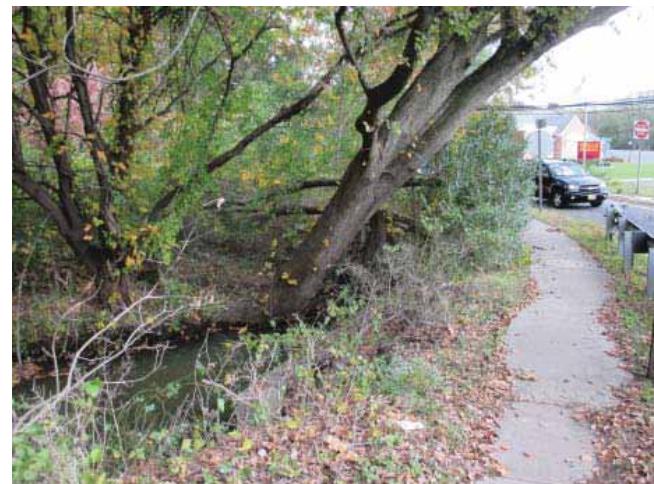
Image 4: Compromised tree hanging over sidewalk and Highway 35.

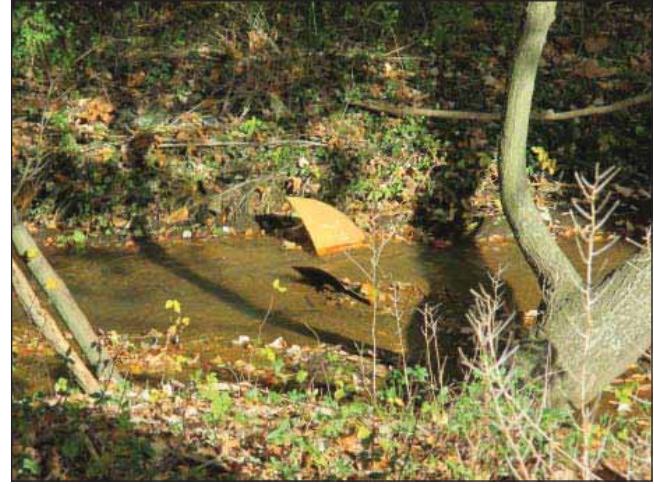
Image 6: Garbage in creek along Highway 35.

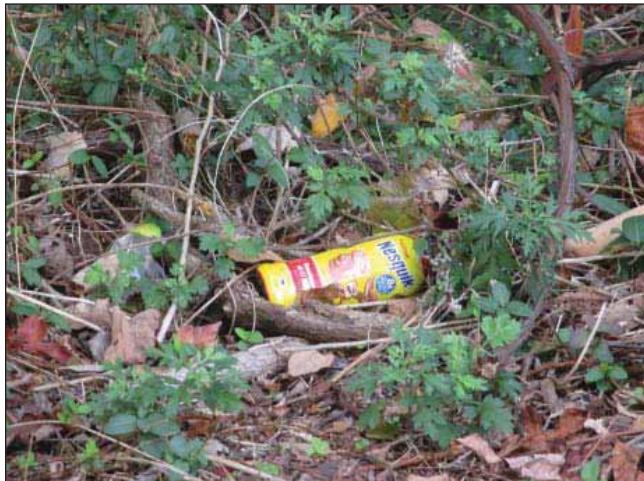
Image 7: Debris on property

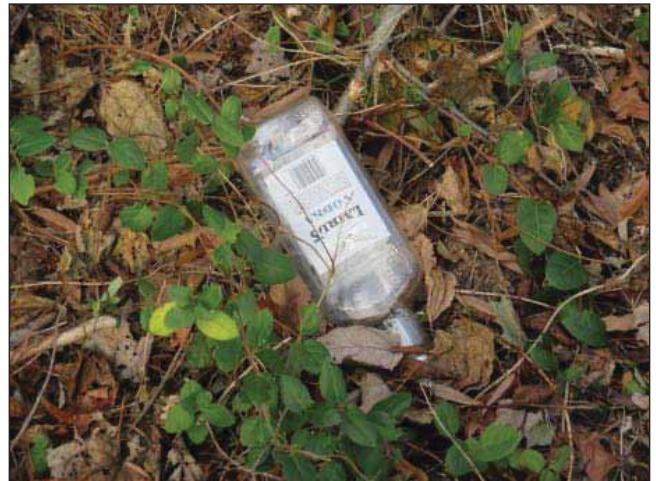
Image 8: Debris on property.

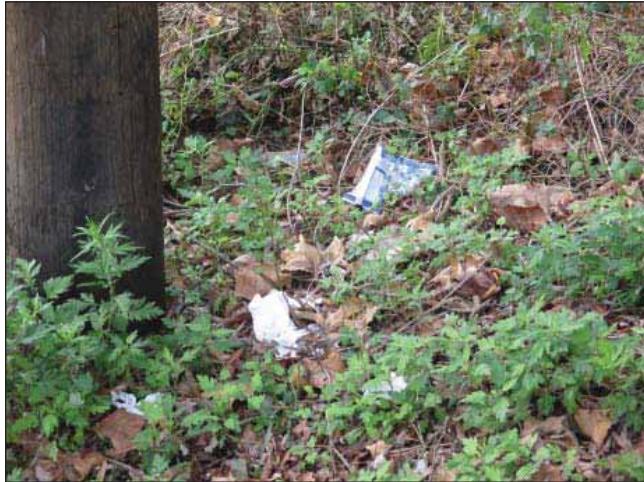
Image 11: Debris on property

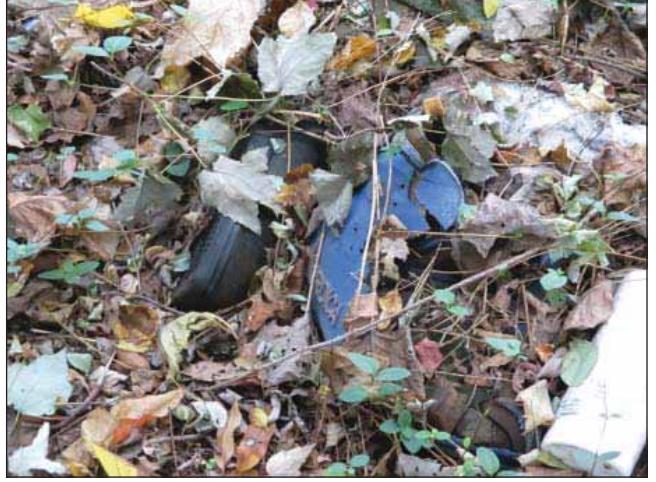
Image 12: Debris on property.

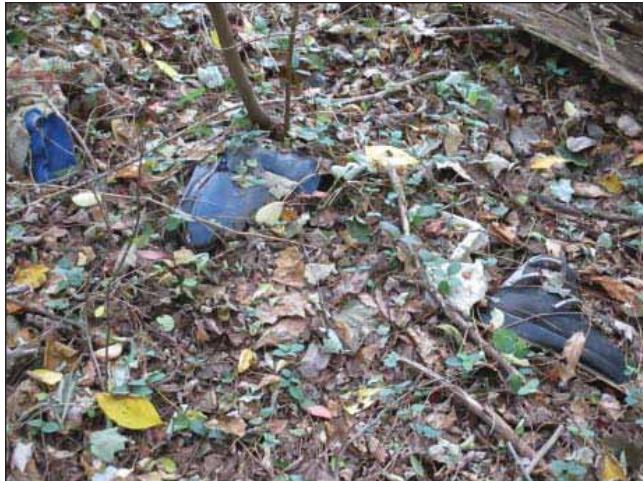
Image 13: Debris on property.

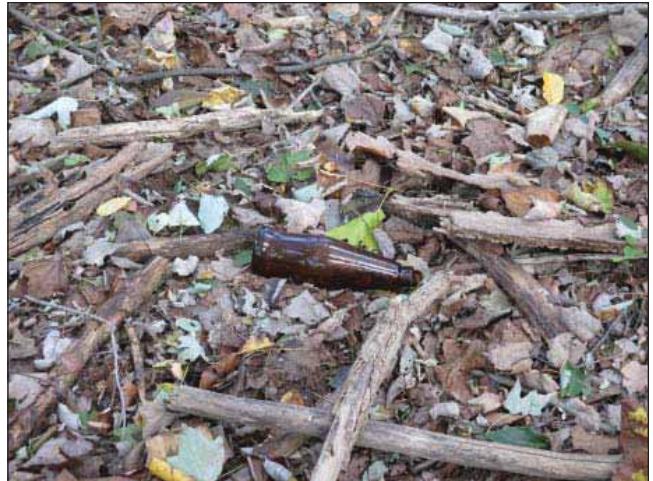
Image 14: Debris on property.

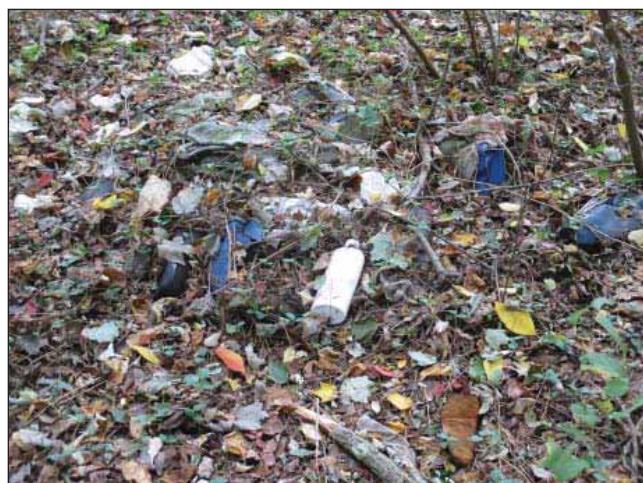
Image 15: Debris on property.

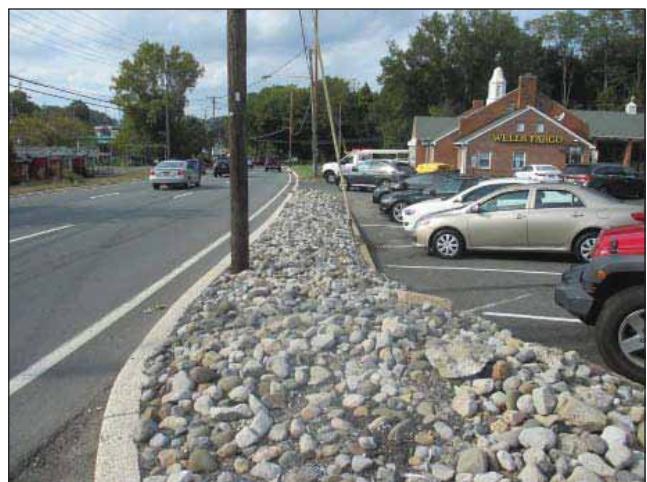
Furthermore, the grading of the property is higher than Highway 35, which allows water to run from the property directly into Highway 35 with no storm water management measures. This along with the sediment and erosion from the adjacent Block 825 Lot 56 is a dangerous condition during storm and freezing events.

Image 3: Grades along property and Highway 35.

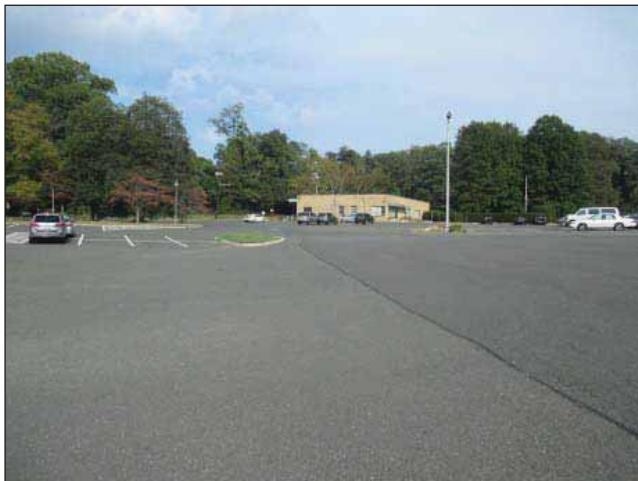
The parking lot lacks lighting and sidewalks and does not provide any pedestrian safety measures from the parking lot to the front entrance and requires vehicles to exit the lot onto Highway 35 with no internal movements. Further, there are no directional lines and conflicts between vehicles and pedestrians evidenced by the location of the drive thru lanes and the existing parking and in the past 5 years there have been over 90 Police violations identified, many of which include traffic stops.

Image 4: Large open asphalt area with no markings or lighting.
