Report of
**Preliminary Investigation for
Determination of an Area in Need of Redevelopment**

Block 825, Lots: 53, 54, 55, 56, 57, 58, 59, 60, 61, 62, 63, 64, 65, 66, 67, 68, 69.01, 70, 72, 73, 74, 75, 76, 77, 78, 79, 80, and 81 (Mountain Hill), Block 638, Lot 31.01, Block 870, Lot 1 and 2, Block 871, Lot 3 and 7.02

DMR Architects
Francis Reiner, LLA - PP
License #: LI00616700

Township of Middletown
Monmouth County, New Jersey
December, 2017

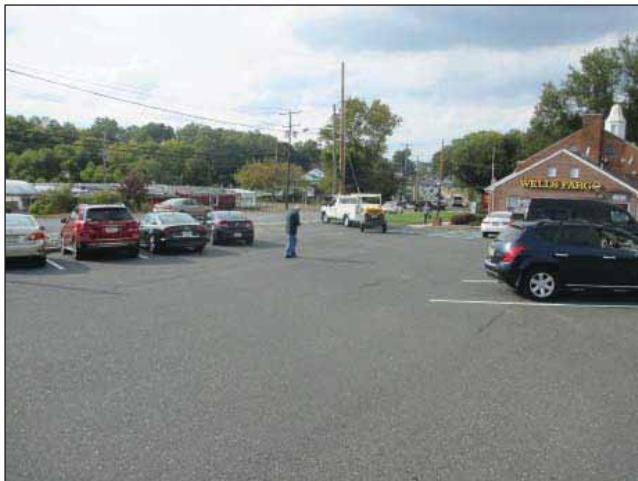
Image 6: One way drive aisle with no internal turn around movements.

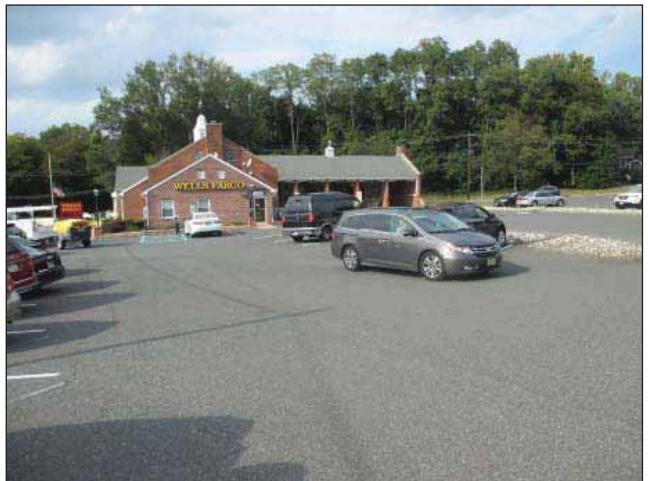
Image 7: Vehicle illegally driving against one way traffic

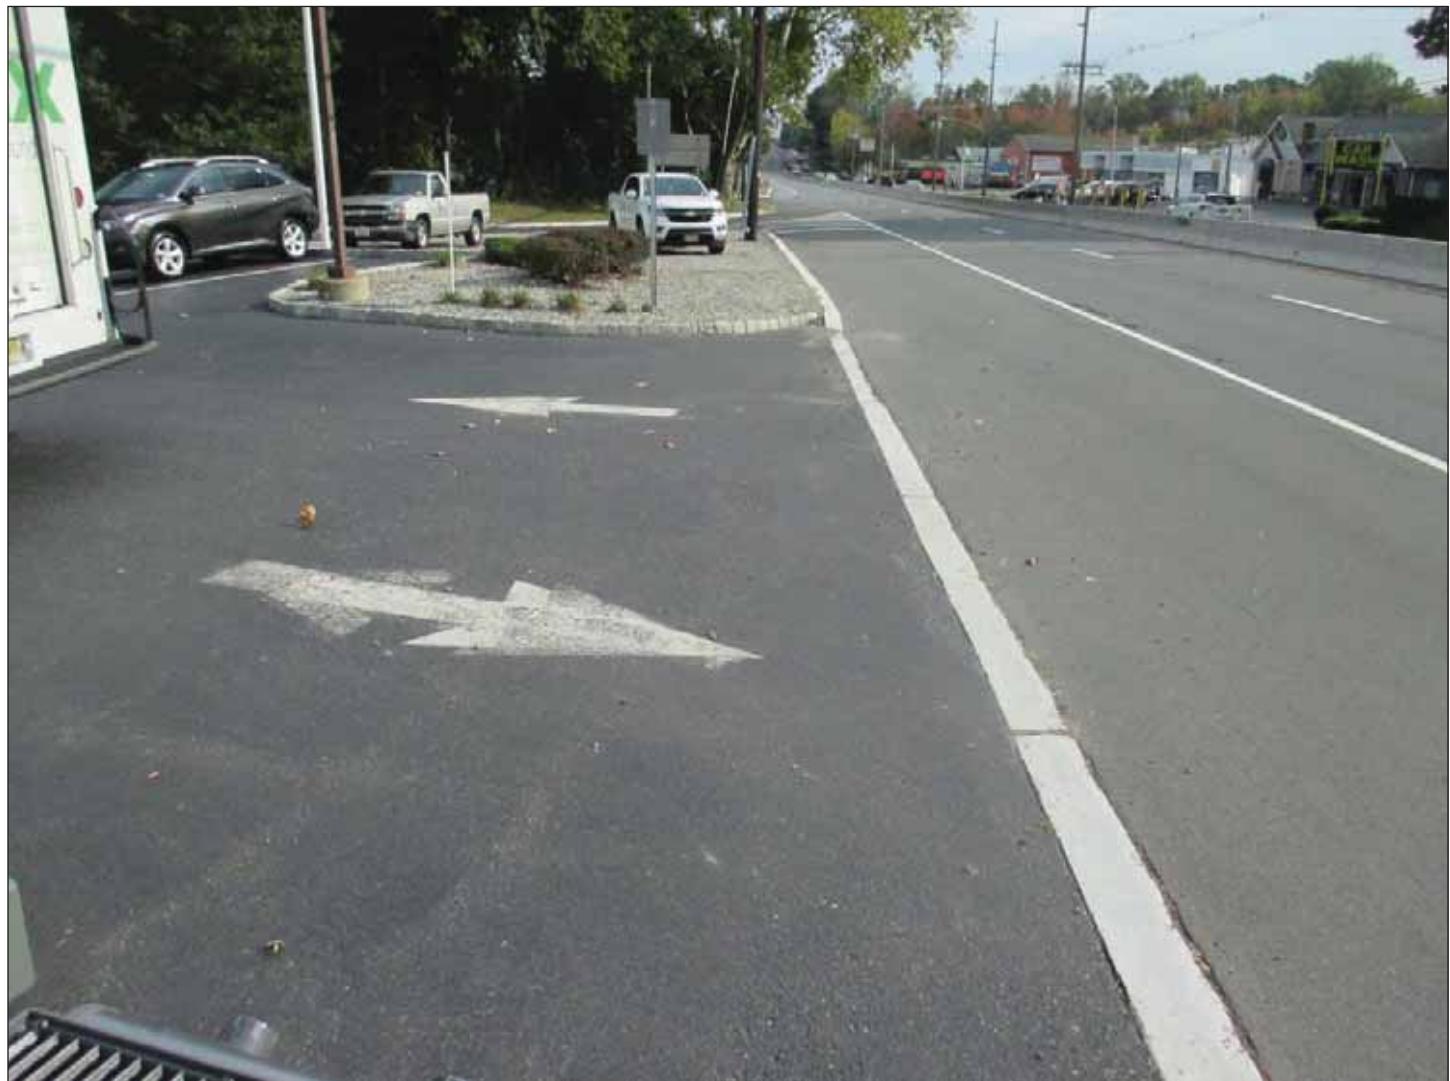
Image 1: Entrance off Highway 35 with FedEx truck parked in exiting lane. Vehicles are parked in the median which creates site line issues entering and exiting the parking lot.

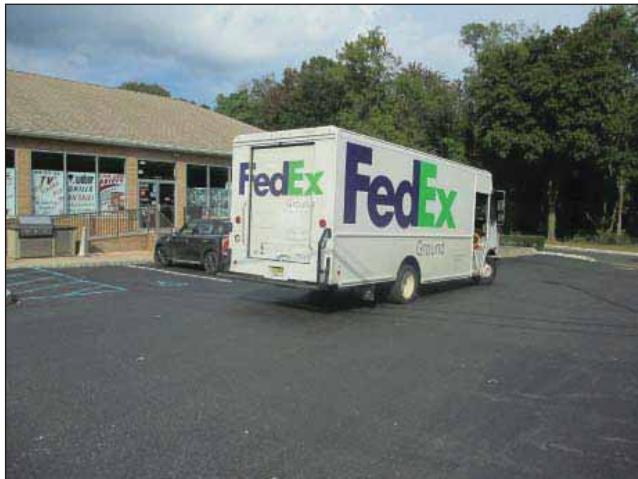
Image 2: Small parking lot, with FedEx truck parked in out bound lane.

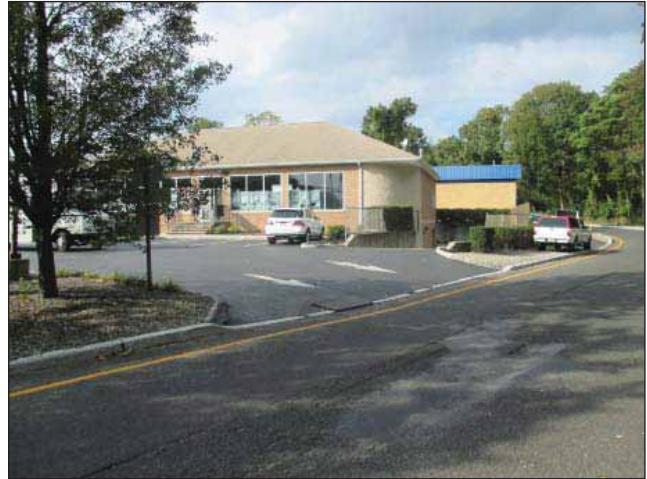
in such a manner as to require the truck to either back into or out of the trash compactor area within the jug handle right of was which represents a dangerous situation.

Image 3: Exit from jug handle with trash compactor located to require vehicle to back in to or out of space in the jug handle ROW.

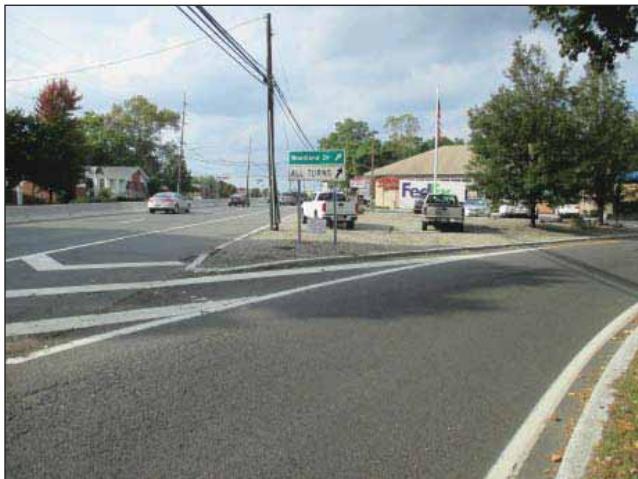
Image 4: Vehicles parked in median block site lines to parking area.

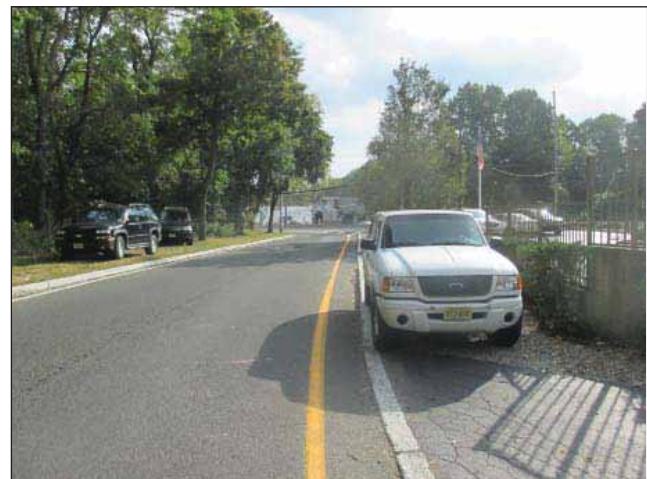
Image 5: Small parking lot has vehicles parked along right of way of jug handle which limits site lines.

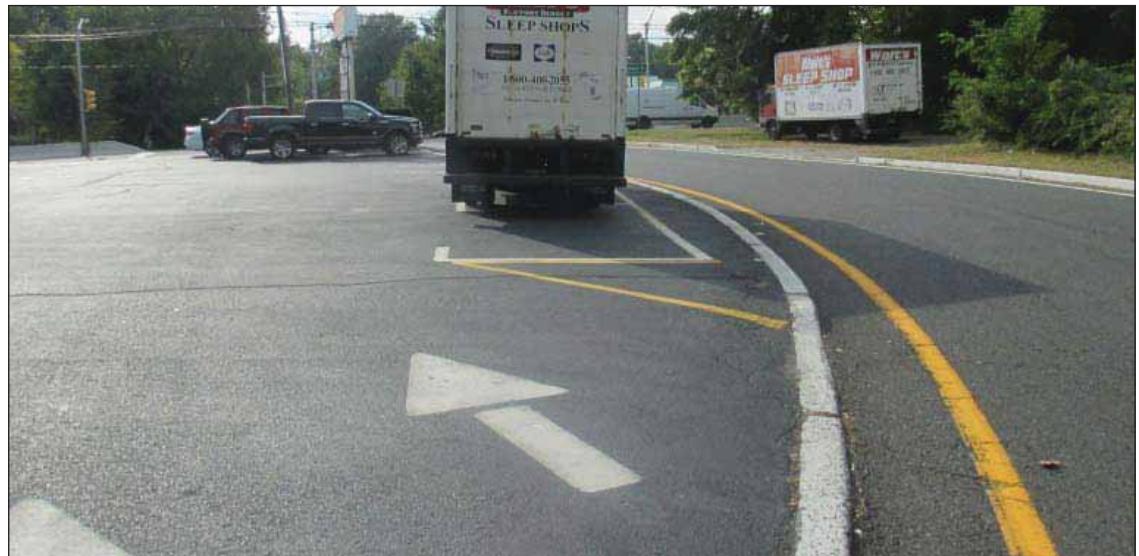
Image 1: Parking space located at the curb of the jug handle with no buffer between.

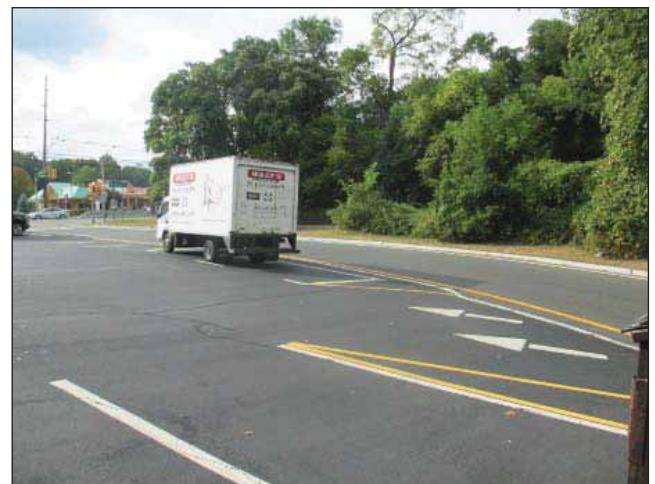
Image 2: Parking space located at the curb of the jug handle with no buffer between.

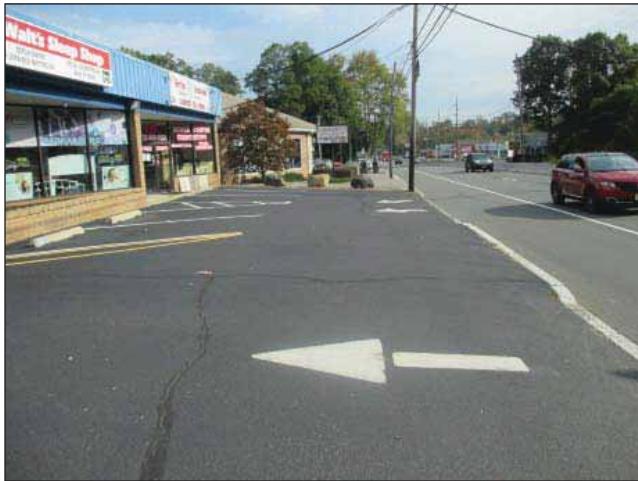
There are three vehicular entrances into the parking lot, two off Highway 35 and one off the jug handle. The entrance in front of the building include angled and head in parking that backs directly into the entrance area off Highway 35 (See image 4 & 16). This creates a dangerous condition for vehicles traveling along Highway 35 with a posted speed limit of 50 mph entering into the site where vehicles are parked and would need to back into the entrance in order to get out of the parking spaces. In addition the parking located along the side of the building has a drive aisle that is not straight which is caused by parking along the building and parking along the jug handle. This condition is atypical and can create confusion in a small area with potential vehicles entering from Highway 35 into the site.

Image 1: Parking space located in front of store in entrance aisle off Highway 35.

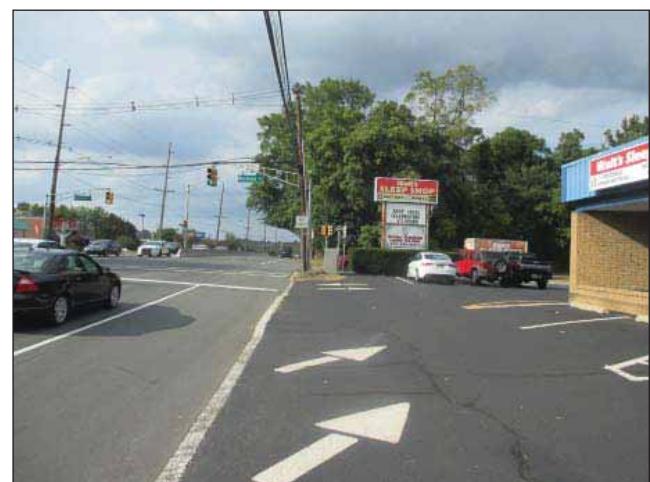
Image 4: One way entrance from Highway 35 in conflict with angle parking egress.

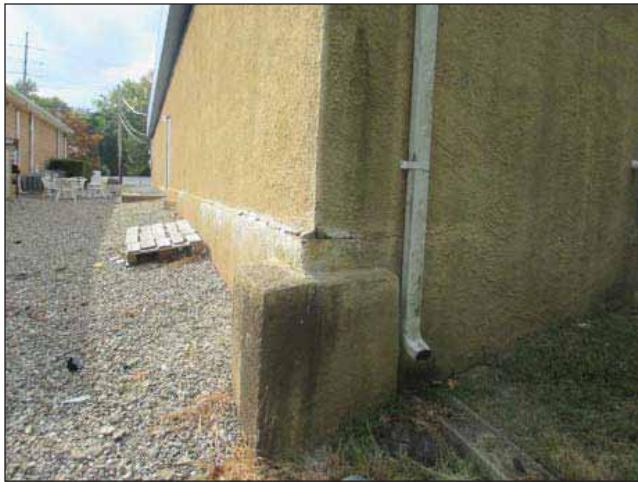
The exterior of the building has signs of water damage and deterioration along the sides and rear of the building. The rear steps and sidewalk have significant water damage, molding and deterioration of the sidewalks which create unsafe walking conditions (See images 6, 7, 8, 9, 10, 11, 12, 13 & 14). The issues include washing away of the rear sidewalk, as well as deterioration of the sides of the walk. Signs of the rear stairs pulling away from the building, water damage along the base of the building and washing away of the ground caused by a lack of proper drainage. In addition the building is located higher than the surrounding roads along the rear, side and front of the building and does not

Image 5: Water damage along rear base of building with cracking in efface.

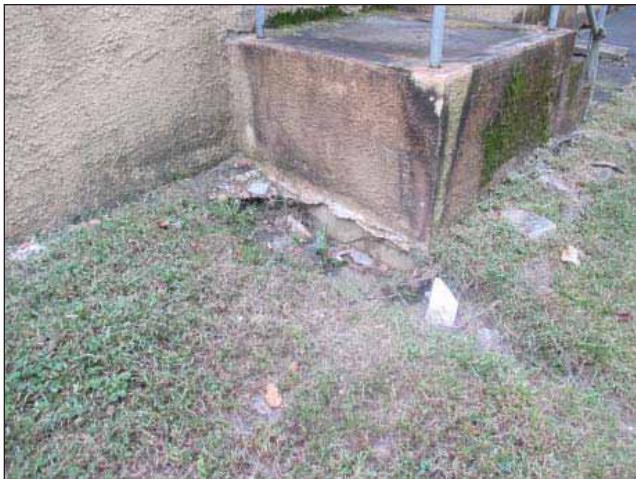
Image 7: Rear stairs with erosion caused by water run-off from roof.

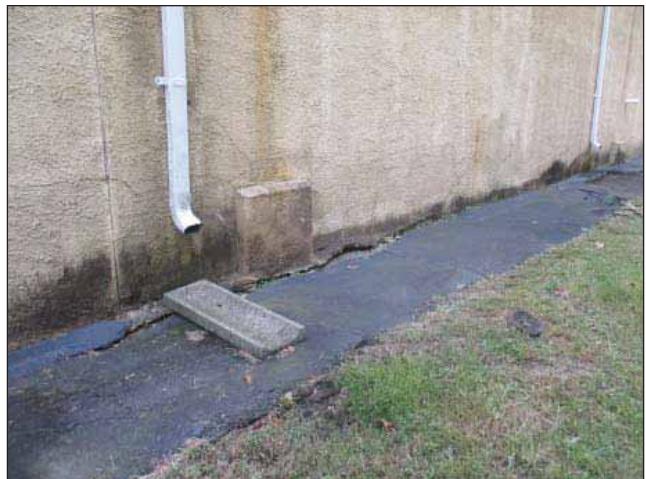
Image 8: Water damage along asphalt sidewalk at rear of the building with erosion.

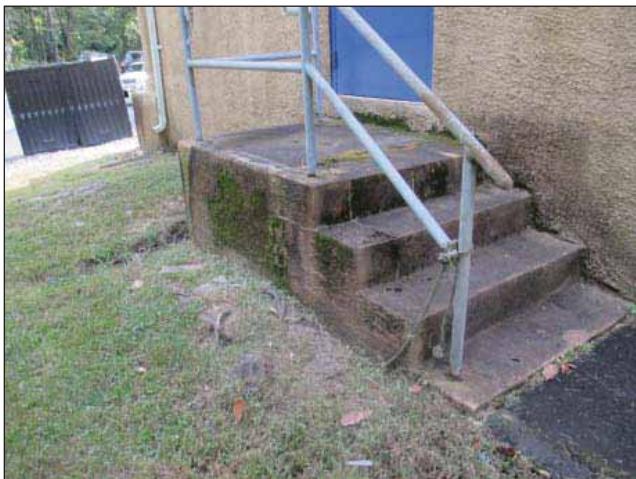
Image 9: Rear stairs with erosion caused by water run-off from roof.

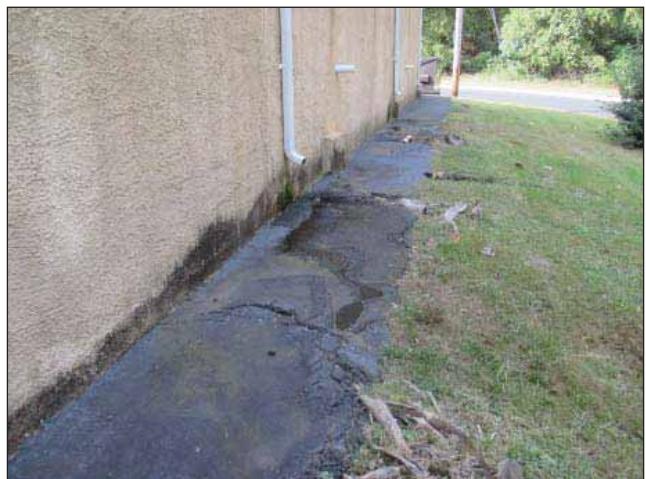
Image 10: Water damage along asphalt sidewalk at rear of the building with erosion.

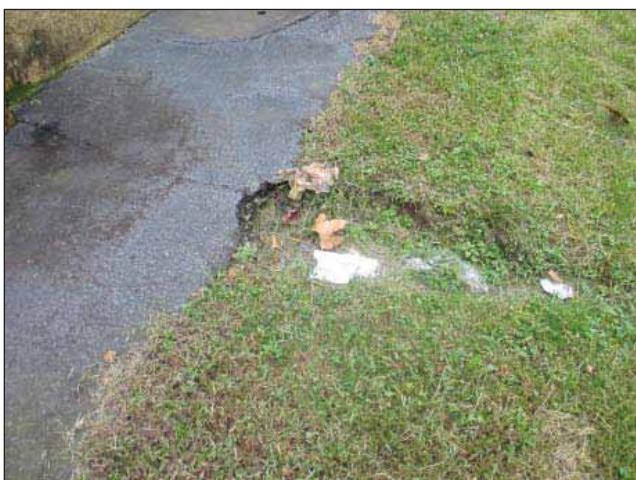
Image 11: Water damage along asphalt sidewalk at rear of the building with erosion.

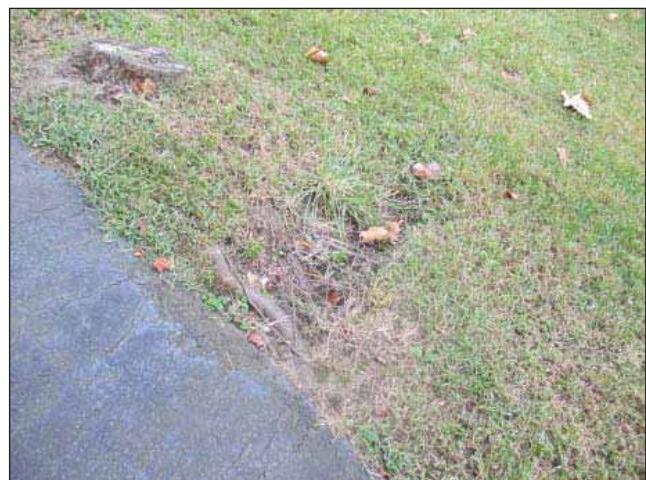
Image 12: Water damage along asphalt sidewalk at rear of the building with erosion.

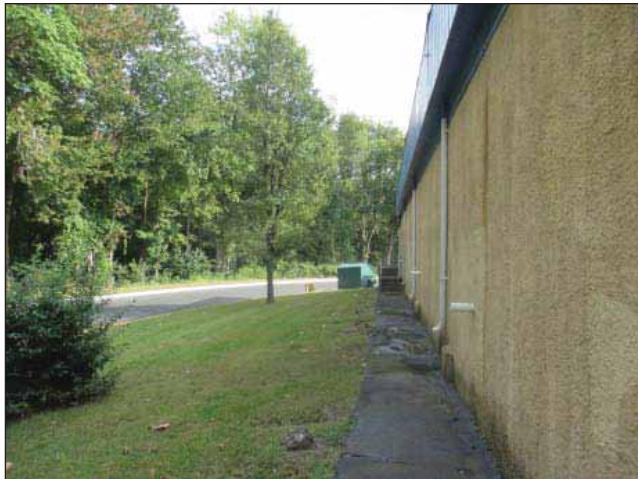
Image 13: Water damage along asphalt sidewalk at rear of the building with erosion.

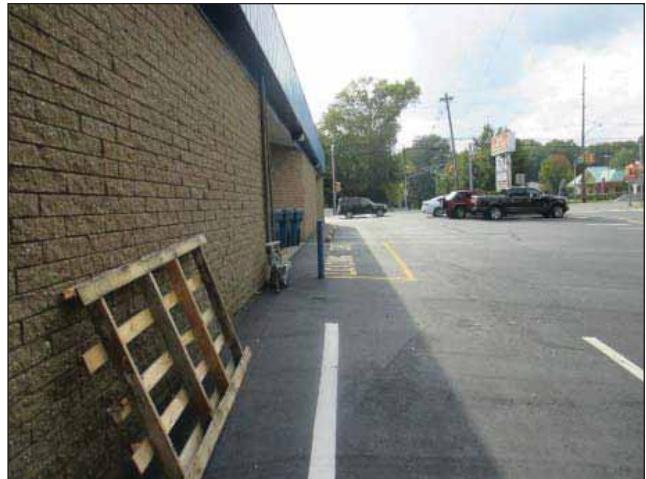
Image 14: Parking located on side of building with inadequate space for back out.

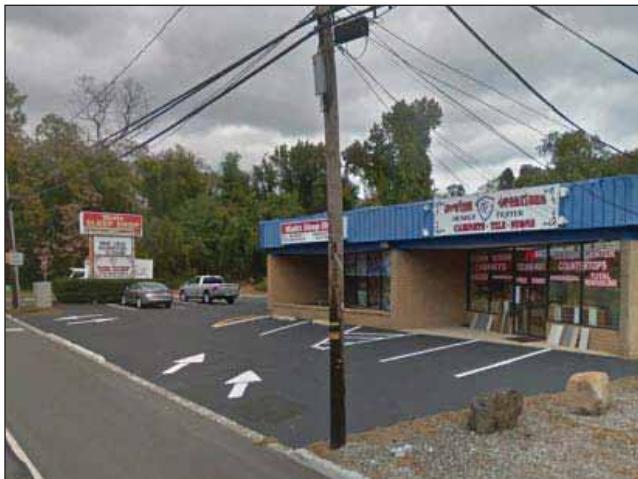
Image 15: One way entrance from Highway 35 in conflict with angle parking egress.

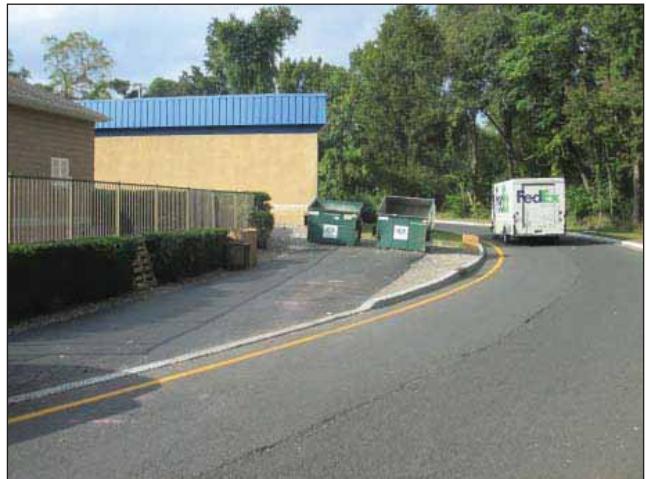
to either back into or out of the trash compactor area within the jug handle right of was which represents a dangerous situation. Furthermore the building has signs of significant water damage along the exterior facade at the side and rear of the building.

Image 16: Trash compactor location for both buildings with access directly from the jug handle.

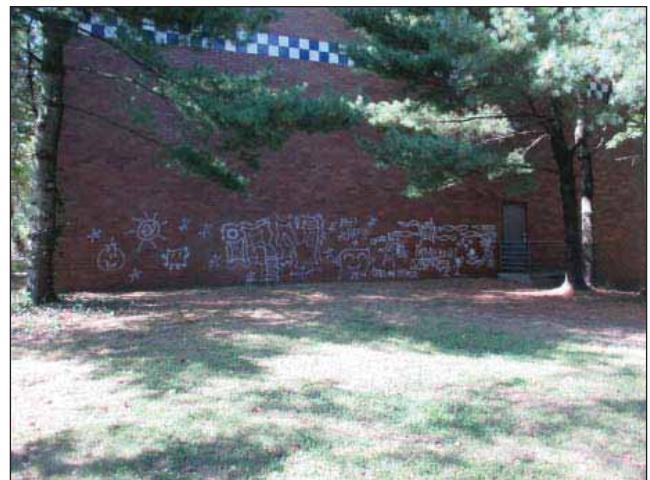
Image 10: Graffiti on the rear portion of the building.

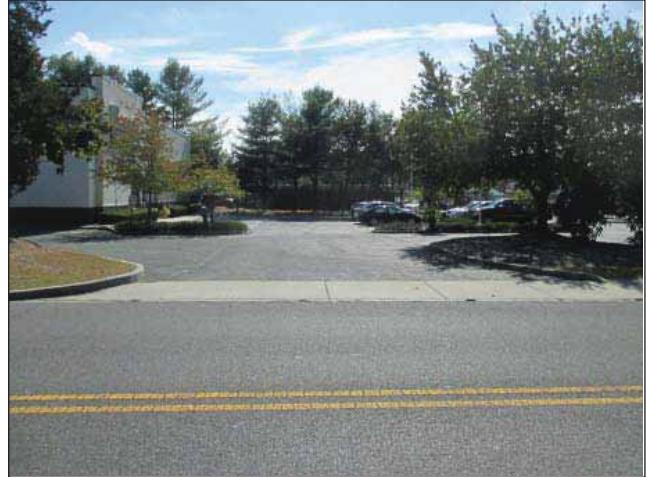
Image 12: Entrance off Kanes Lane to the front parking area.

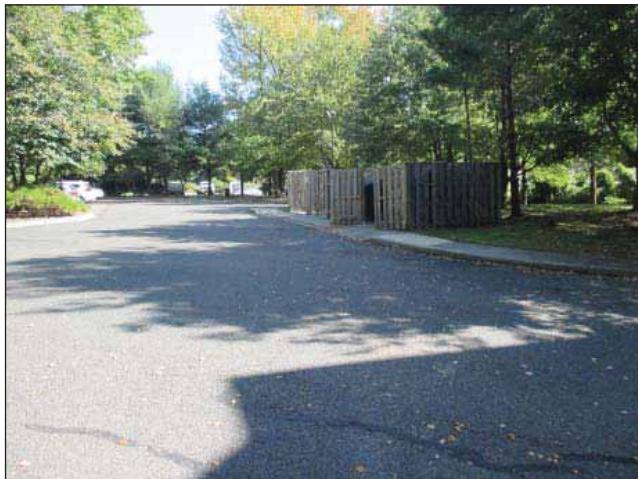
Image 13: Rear parking area.

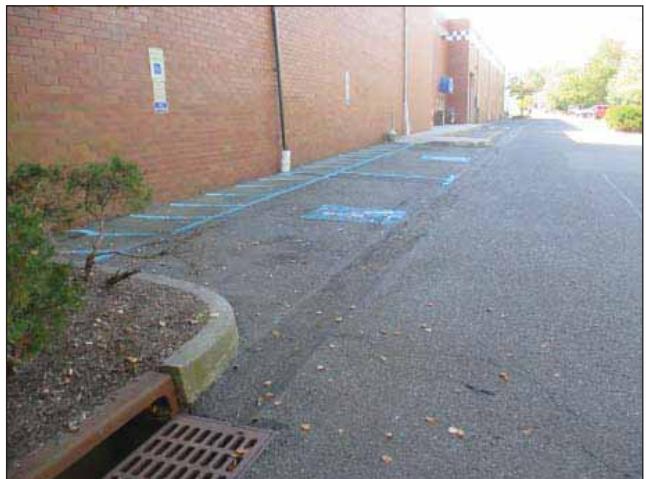
Image 14: Handicap parking along side entrance area.

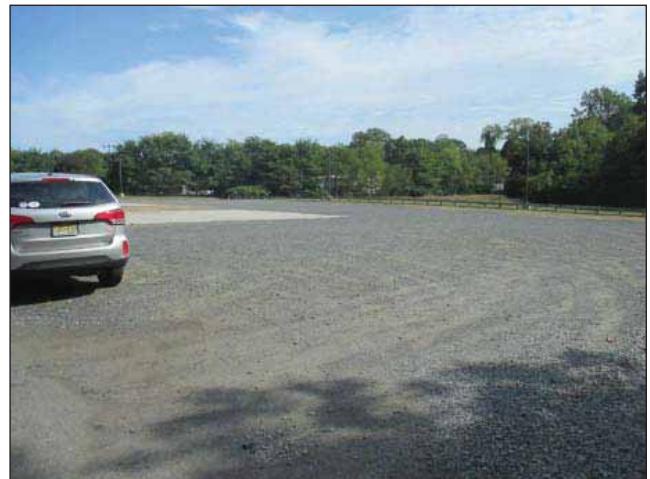
The Area of Investigation consists of several of the qualities described in Criteria 'd' which include a faulty arrangement and design (Criterion 'd') evidenced by the design deficiencies in the rear lot including the lack of defined spaces, lighting, sidewalks, and erosion control measures at both drains. The parking lot is a gravel lot with no safety measures for lighting, the significant amounts of gravel and debris are clogging the existing drains and there is a lack of delineation for the spaces and for any pedestrian movements. In addition the front entrances to all three commercial spaces include degradation of the concrete sidewalks caused by water erosion due to improper drainage. All of these conditions represent a faulty arrangement and design as well as an obsolete layout.

Image 4: Rear gravel parking lot with no curb or delineation of parking stalls

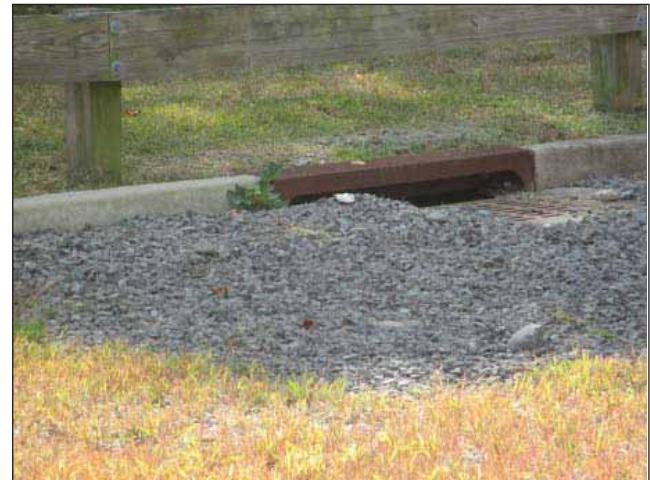
The property has parking on both sides and in the rear. The parking areas on the sides of the building are comprised of asphalt with delineated parking stalls (See images 2 & 21), while the rear parking area is comprised of gravel and does not include any parking delineation (See images 4 & 7). The rear parking lot includes two drain inlets, with one on either side of the parking lot. Both drain inlets have significant gravel and debris within and surrounding the inlet. This is most likely caused by improper drainage from the lot to the drain inlets. The gravel and debris in and surrounding the inlets can create drainage issues during storm events (See images 6 & 8). Located behind the drain inlets is a storm water detention basin.

Image 6: Eastern drain inlet at the rear parking area with significant gravel around the inlet

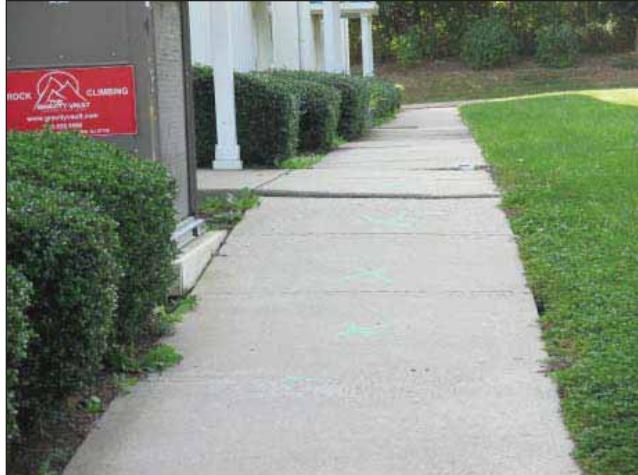
and heaving of the sidewalks in various locations (See images 9, 11, 12, 15, 18, 19 & 20). In addition there appears to be molding and damage at the door frames and windows along the front of the building also most likely caused by proper drainage off the building (See images 13, 14, & 19).

Image 9: Front entrance with sidewalk heaving.

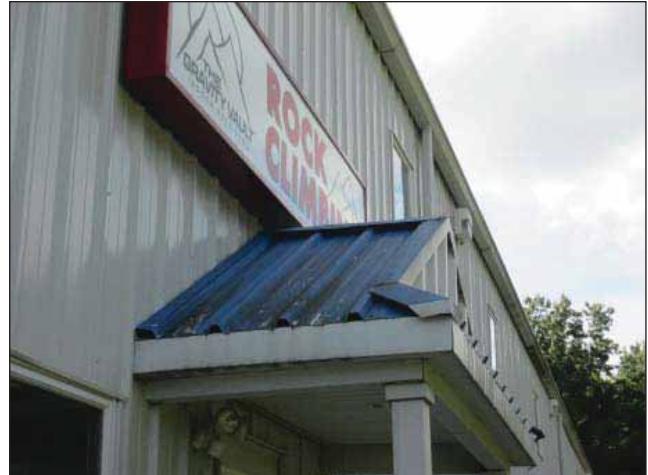
The front of the commercial building has three entrances one for each tenant while the rear of the building has a raised loading dock. The entrances to the building show signs of water damage, molding and deterioration (See images 10, 14 & 17). In addition to the deterioration of the roof structures, the concrete sidewalk in front of the building and the entrance walkways show signs of water damage and deterioration of the sub-base most likely caused by water run off and a lack of proper drainage along the front of the building. The conditions manifest themselves in the form of cracking, deterioration of the concrete

Image 10: Entrance with water damage and mold

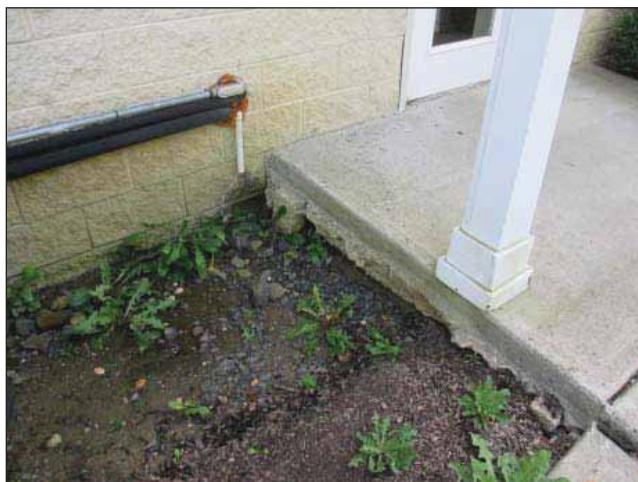
Image 11: Entrance concrete with erosion of the sub-base area most likely caused by a lack of proper drainage

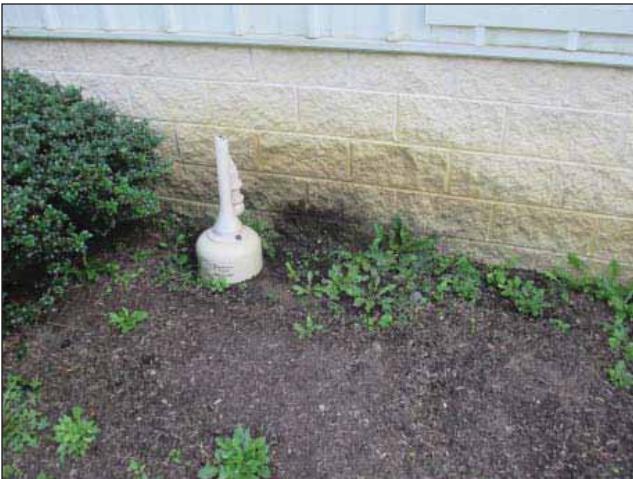
Image 13: Water damage at the front base of the building caused by a lack of proper drainage

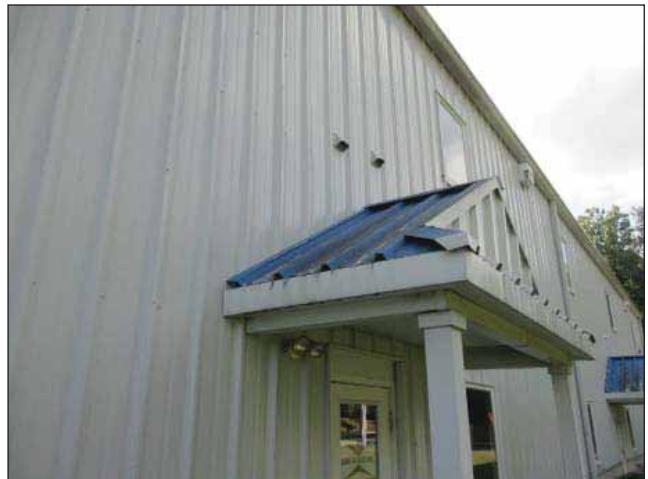
Image 14: Entrance with water damage and mold

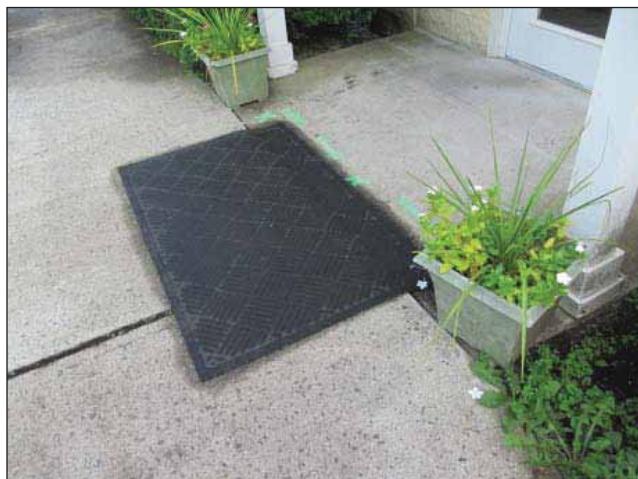
Image 15: Mat at entrance to cover water damage that cracked entrance step caused by water damage

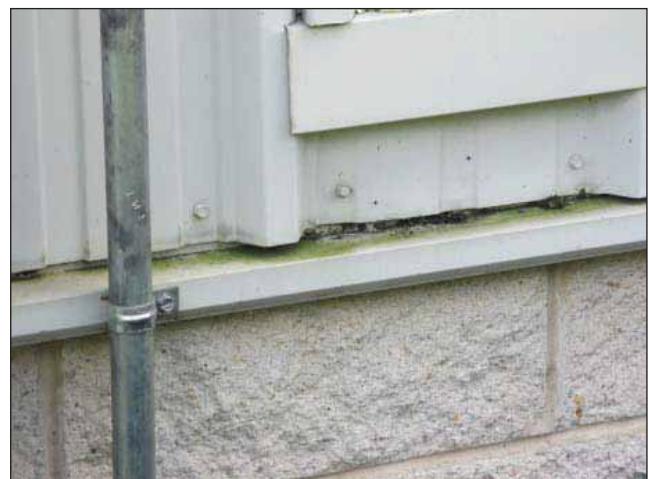
Image 16: Window and frame with molding caused by a lack of proper drainage

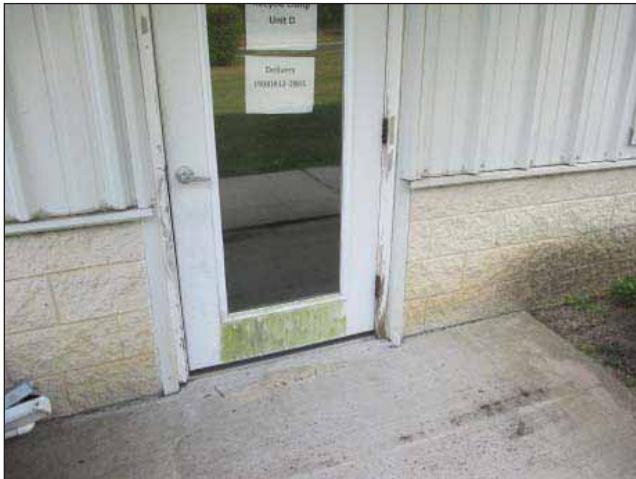
Image 19: Water damage and signs of mold at the base of the building entrance

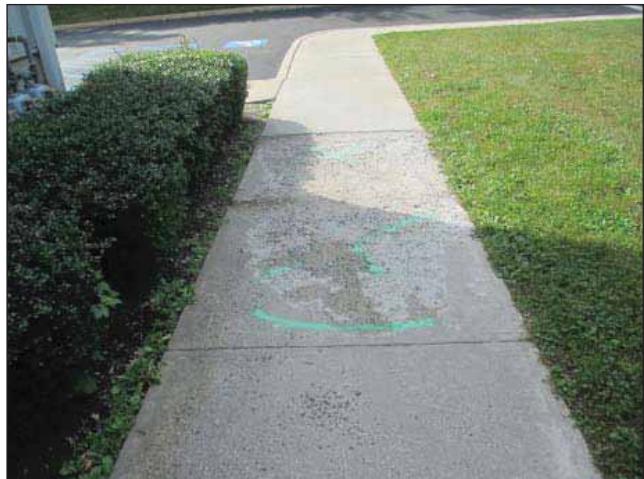
Image 20: Deterioration of the sidewalk caused by water damage

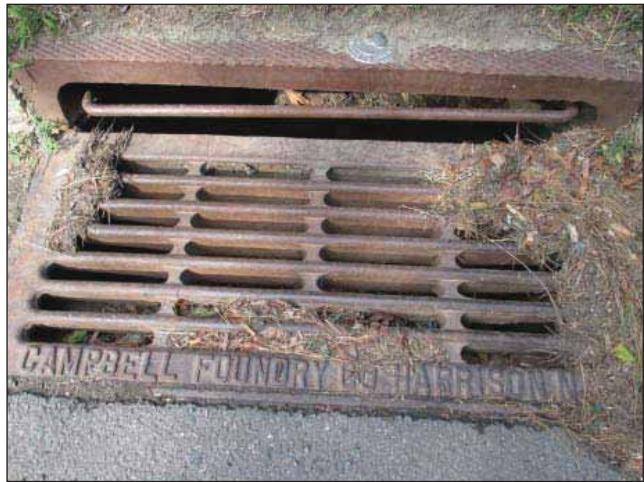
Image 24: Drain inlet with debris

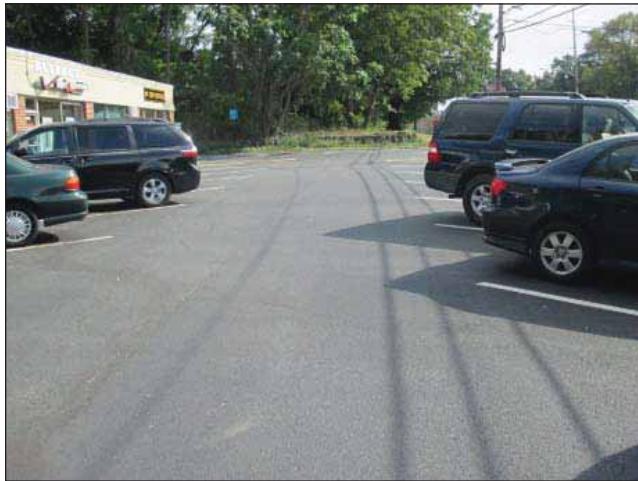
The Area of Investigation consists of several of the qualities described in Criterion 'd' which include a faulty arrangement and design (Criterion 'd') evidenced by the design deficiencies for the angle parking, given the location in proximity to vehicles accessing the property off Highway 35 as well as the overall width of the drive aisles in front of and to the north of the property. In addition, the location of the handicap spaces and the lack of lighting in the parking lots represent a faulty arrangement and design that is detrimental to the safety, health and welfare of the community. The roof drains flow directly onto the rear drive aisle creating safety issues during rain and freezing events.

Image 1: One way angled parking in front of the buildings with limited area for vehicles to maneuver.

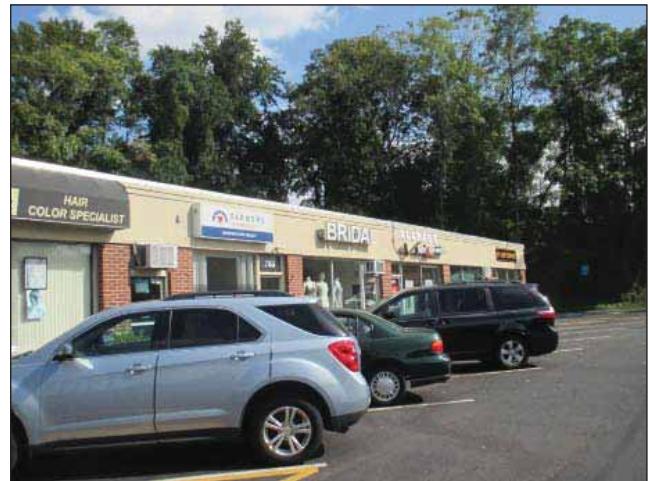
Image 2: One way angled parking in front of the buildings with limited area for vehicles to maneuver.

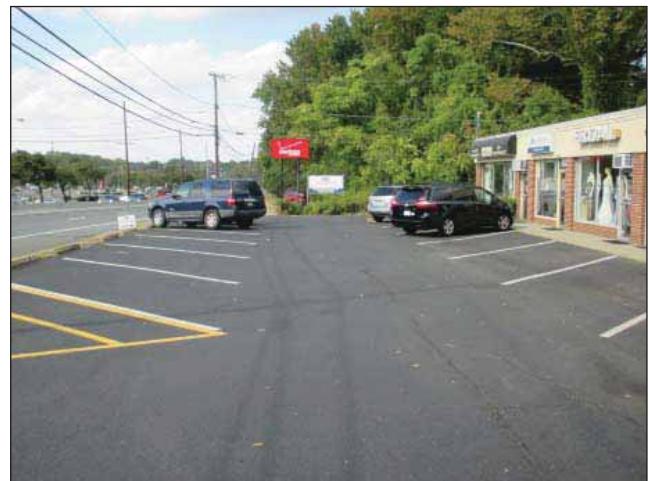
Image 4: One way angled parking in front of the buildings with limited area for vehicles to maneuver.

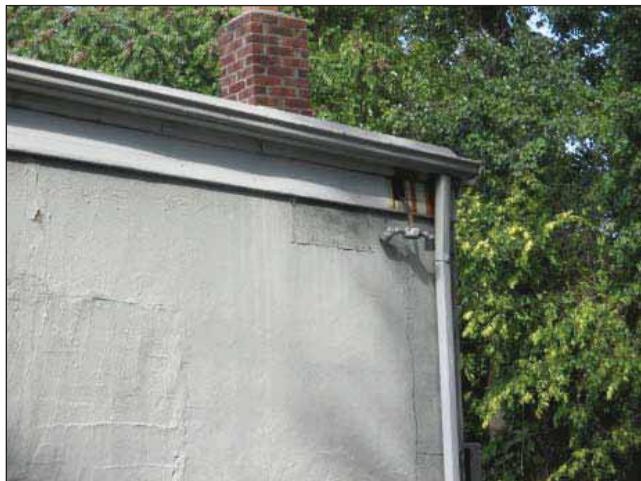
Image 7: South wall with water damage.

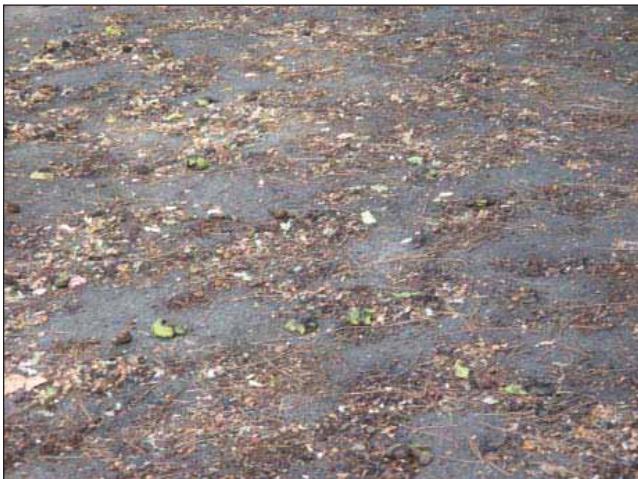
Image 9: Condition of existing drive aisle.

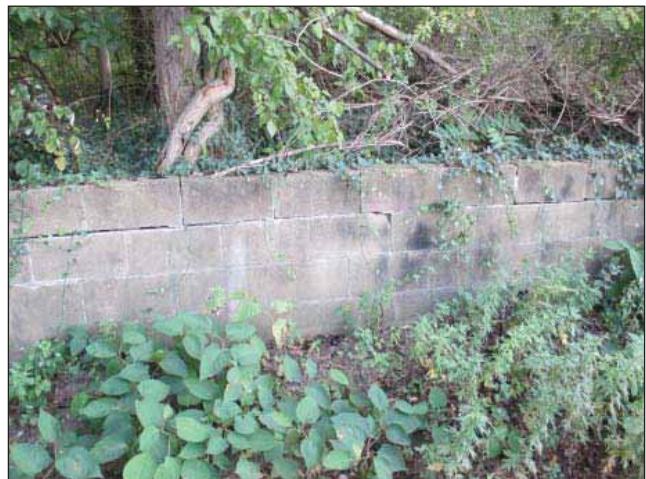
Image 10: Retaining wall damage along the side property.

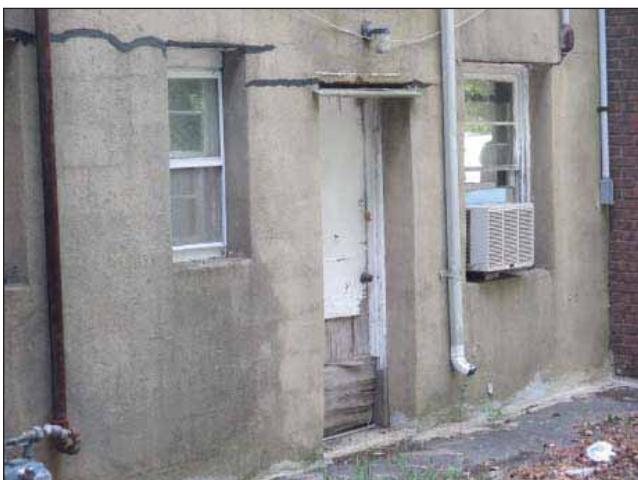
Image 11: Rear wall with cracking and repairs. Downspouts directly onto the rear drive.

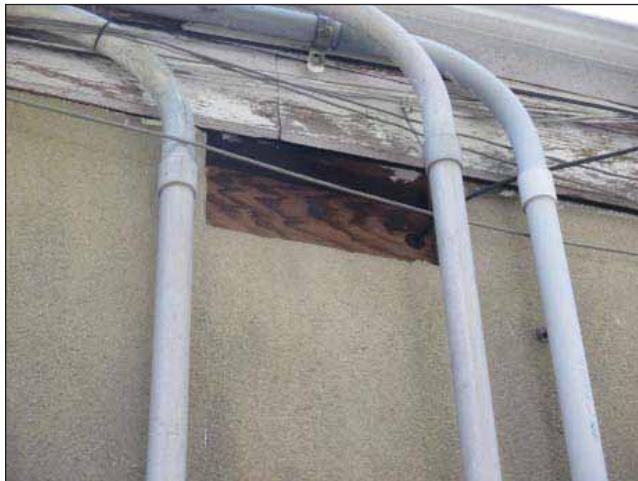
Image 13: Patch of hole in rear part of the building with wood.

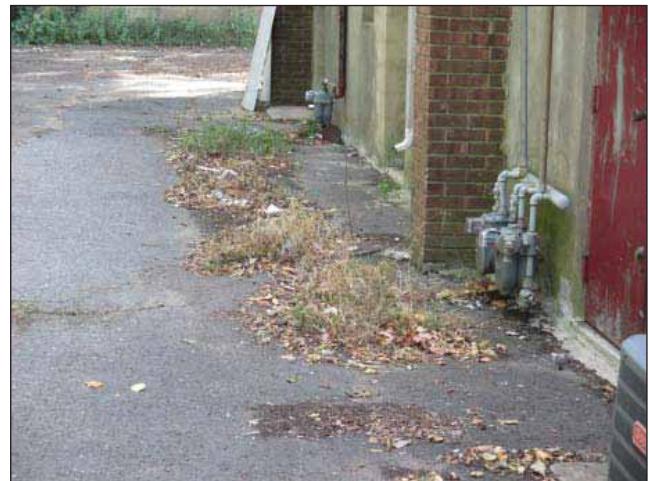
Image 14: Roof drains directly onto the asphalt area.

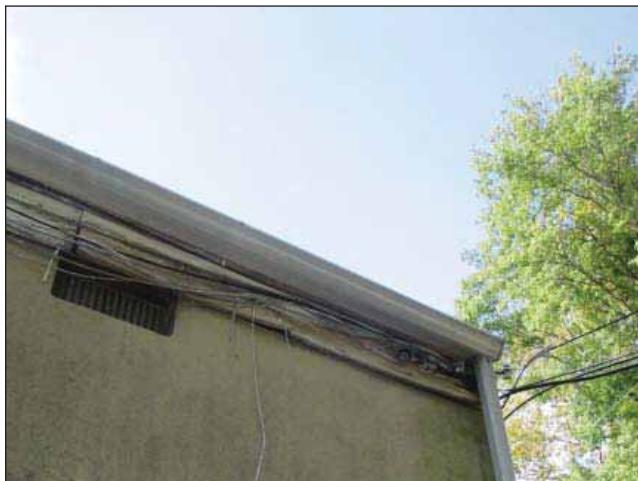
Image 15: Water damage and rotting along rear roof line.

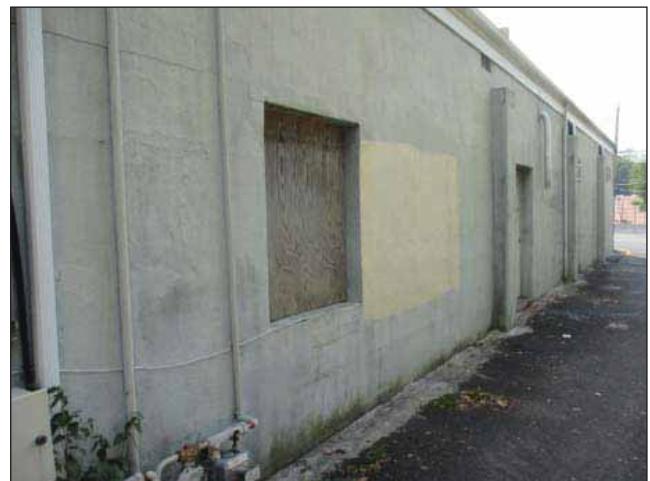
Image 16: Bordered window at rear of the building.

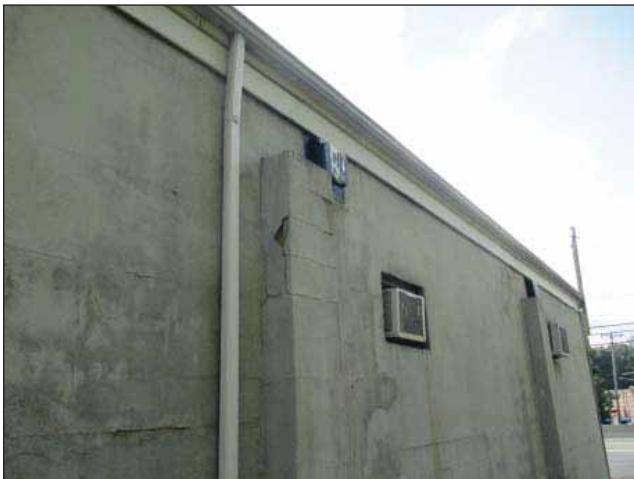
Image 19: Cracking and peeling of facade along rear wall of building.

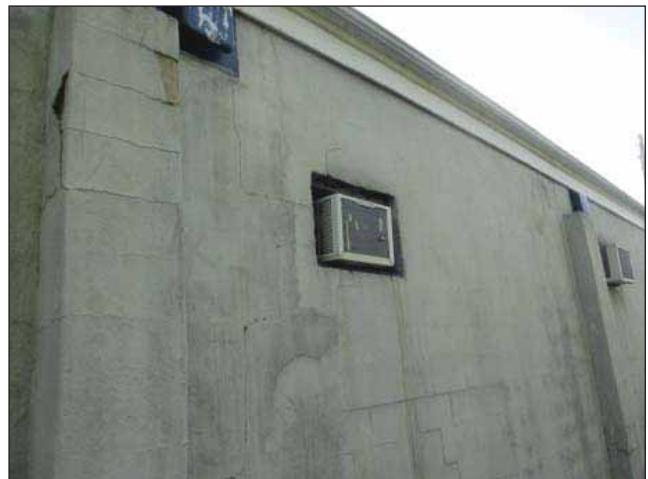
Image 20: Cracking and peeling of facade along rear wall of building.

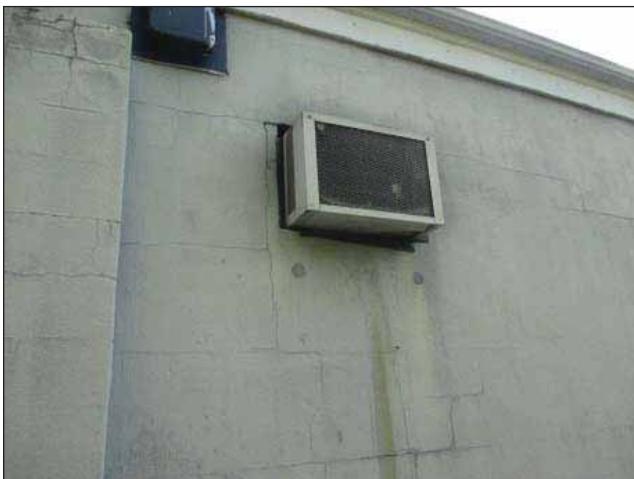
Image 21: HVAC unit has been installed where it appears a previous window was located.

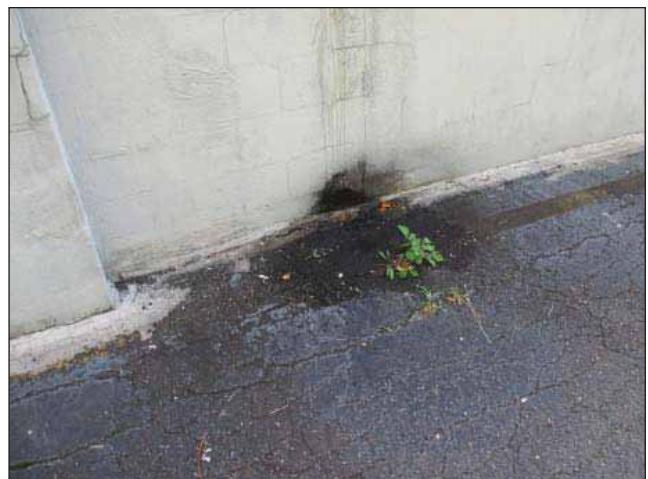
Image 22: Water damage at the rear base of the building.

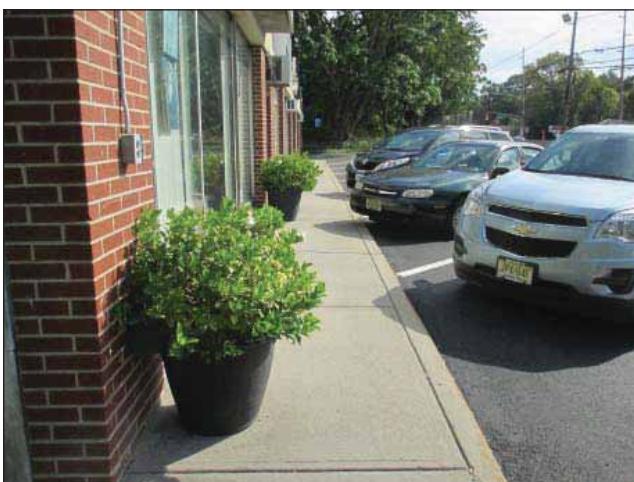
Image 23: Overhang of bumpers and potted plants diminish the sidewalk width along the front of the building.
